SOL-20 “POWER ON” LOCKUP PROBLEM USING THREE 16KRA PROCESSOR TECHNOLOGY (PT) RAM BOARDS.

(H. Holden, Oct.2018).

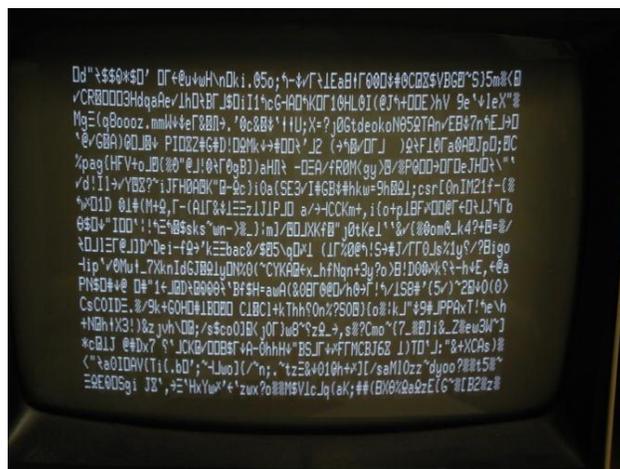
All seemed to be going well, until I powered the computer up with the three 16KRA cards and the North Star card. It would not boot to Solos normally and locked up with a screen of graphic symbols. No cursor appeared and the keyboard was non responsive too. In addition the hard CPU reset provided by pressing the upper case and repeat key, did nothing. Nor did a manual reset applied to the CPU. I found that if I unplugged the North Star card all seemed well on power up, making me initially suspect the North Star card (how wrong was I there). The picture below shows the locked up state. When I changed the video ram IC’s on the main board for a batch of other IC’s, it just showed different symbols.

After many power on attempts I discovered that very occasionally, about 1 in to 20 power-up attempts, just with the three PT 16k cards present, the lockup state would still occur without the North Star card present. That took the suspicion off the North Star card. The fault also never presented with any two, or any one, of the 16KRA ram cards on the bus. There had to be three PT 16KRA cards present on the bus to get the condition. The photo below shows a typical “locked up state” at power up.

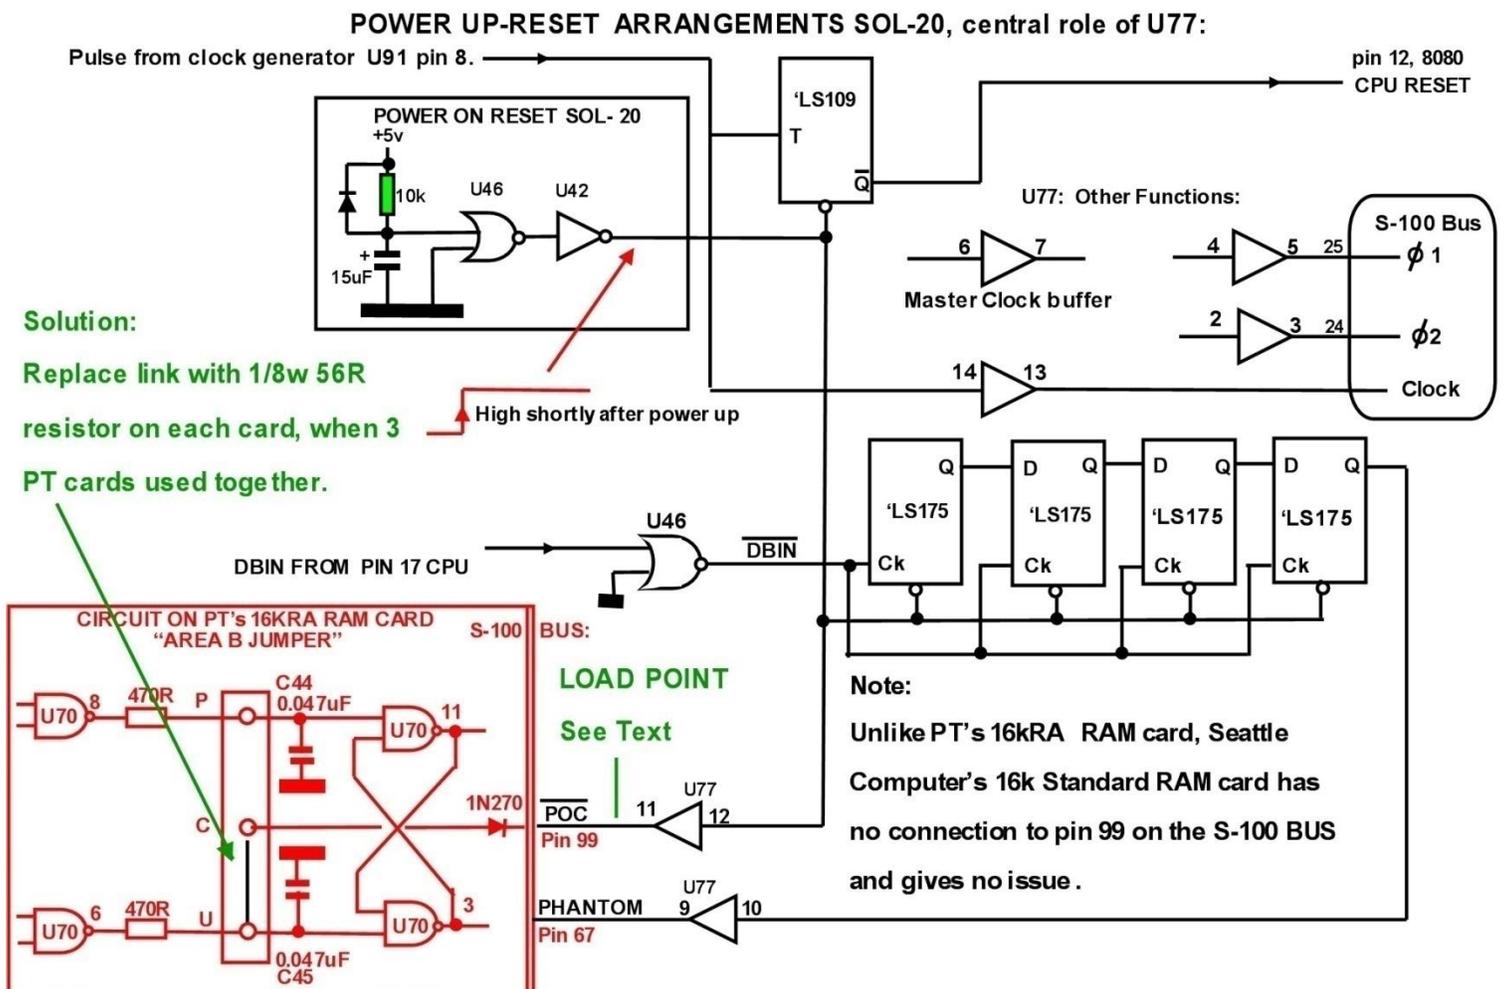
So I investigated the IC, U77 that drives pin 99 of the bus and the circuitry on the bus. U77 plays multiple roles in the clock and power reset circuitry, see simplified diagram below:

The circuit on PT’s 16KRA ram cards in “area B” has substantial capacitance. With, three cards in operation together, then three 0.047uF capacitors (one per card involved at a time depending on the jumper) are present, bringing the total capacity, albeit coupled by diodes, to about 0.14uF.

In addition, at power turn on, pin 8 and pin 6 of the Nand gates U70 are high (although pin 6 has a negative going 1uS long pulse on it, but this integrated to a logic high level by the series 470R and 0.047uF capacitor to ground). This means that the 1N270 diodes, initially at least, are in forward conduction coupling (or switching) this capacitance to pin 11 of U77, because at power up, pin 11 of U77 is low until the power on reset circuit times out. But this diode coupling is not exactly the same as coupling the total capacitance directly to pin 99 of the bus. This is because when the bus line pin 99 or output of U77 pin 11 goes high, the diodes are not conducting.

So given that I had already demonstrated that any capacitance greater than about 350pF to 400pF loading pin 11 of U77 would cause the malfunction, how could it have ever worked, even with one card, with at least a 0.047uF capacitive load ? But I had also noted that a large value capacitor was tolerated, loading pin 11 of U77, provided there was a series resistance was greater than about 40 Ohms.

The answer why it worked at all is likely the effect of the 1N270 diode, but as noted as the voltage on pin 11 rises, the diode current falls and eventually the diode effectively uncouples the drive signal from pin 11 of U77 from the 0.047uF capacitors. So the loading on U77 is more complex than a direct connection to the capacitor. The diode has an effective forward resistance too, and the voltage drop does depend to an extent on the current.

It transpired that with one or two 16KRA cards on the bus, there was no apparent issue. However with three 16KRA cards a borderline case, with the occasional lock up on power up. But with a small additional load (the North Star controller card makes a connection to pin 99) added, enough to make the lockup or malfunction present at nearly every attempted power up.

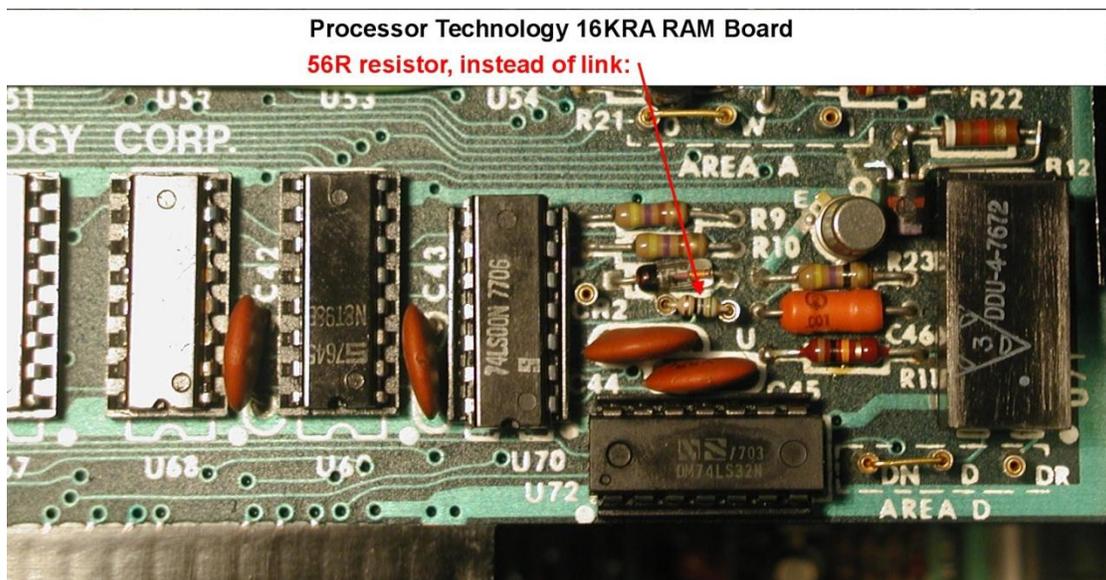
The photo below shows the resistor in "Area B" inserted in to the pcb sockets, instead of the wire link:

I decided to simply replace the wire link in Area B with a 56R 1/8W resistor (see photo below) on each of the three 16KRA ram cards. This still takes the junction of the 470R and 56R resistor (the inputs to the S-R flip flop) below logic 0 (to about 0.95V) when pin 11 of U77 is low, but it electrically isolates enough of the load capacitance that even when **three** 16KRA ram boards are used, as well as the North Star card present too, that the worst IC 8T97 IC specimen for this problem (placed in location U77) does not malfunction and no lockup state occurs at power up.

I would therefore recommend that if three 16KRA processor technology ram boards are used in the same Sol-20, and especially if another card is used that connects to pin 99 of the S-100 bus, that 56R resistors are used instead of wire links in the Area B jumper option of the 16KRA ram board.
