TEKTRONIX 2465B A5 RANDOM CPU LOCKUP PROBLEM.

Dr. H.Holden. March. 2026.

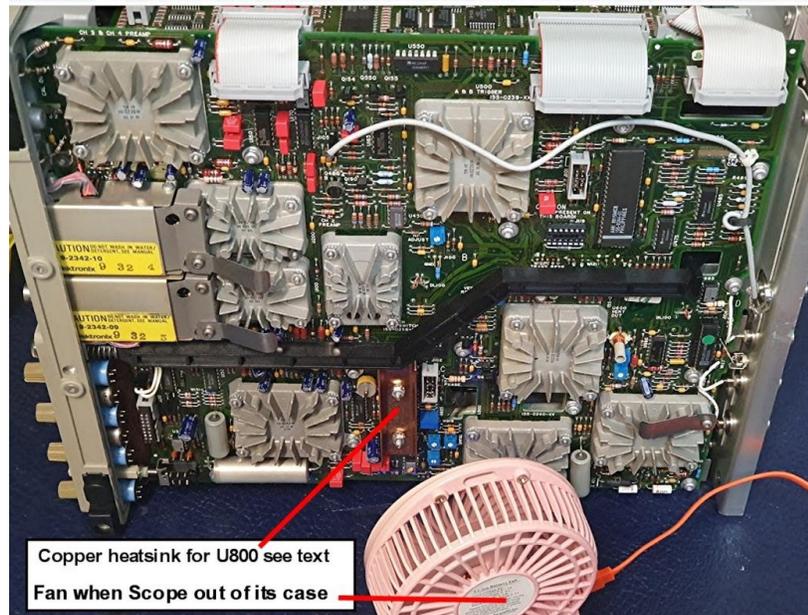
Of note, with the 2465B when it is running out of its housing, it is important to apply a Fan to U800. This is because the air flow across U800 is lower and that U800 is cooled primarily by convection. High level thermal cycling of U800 encourages delamination of the output transistors in its package. In my scopes I have fitted copper heat-sink that

attached with a custom machined copper bush to U800's "TO-220 like" metal tab, this also helps, it is much better than just applying a heat-sink to U800's epoxy case.

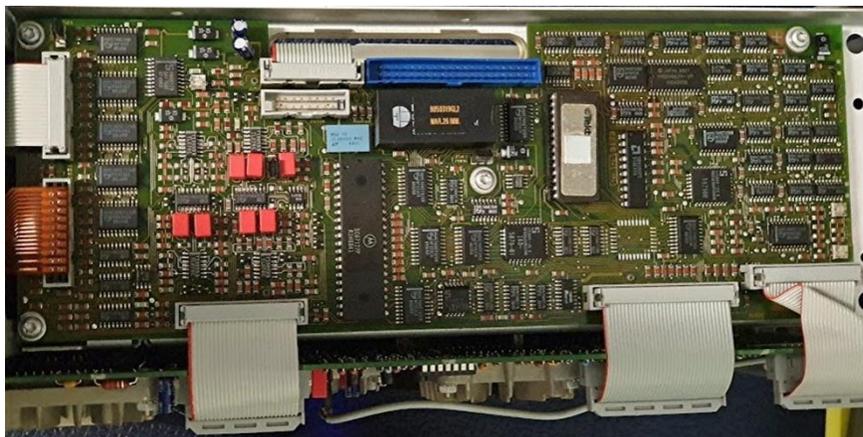
The 2465B's A5 Board.

The CPU board (A5 Board) in my scope is the later version which uses the Dallas DS1225 non volatile battery backed up SRAM.

Fortunately this A5 board was a variant that had mostly Tantalum Capacitors rather than the physically leaky & destructive surface mount Electrolytic Capacitors of some of Tek's A5 boards. The two electrolytic capacitors it does have are a Radial type which stand off the board and not prone to leaking electrolyte.

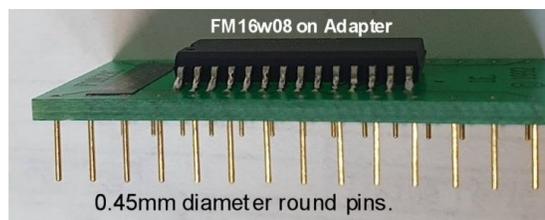
The adapter board previously used was fitted with FM16w08 FRAM. They were some of the smallest pin sized adapters I could find at the time. Thin pin adapters, which resemble IC pins, are available and those would have been a superior choice.

This FRAM & Adapter board was from a previous historical project where I fitted FRAM to the scope. After I did this and Web published the paper on it back in 2013, many 2465B scope owners followed suit and converted to FRAM:

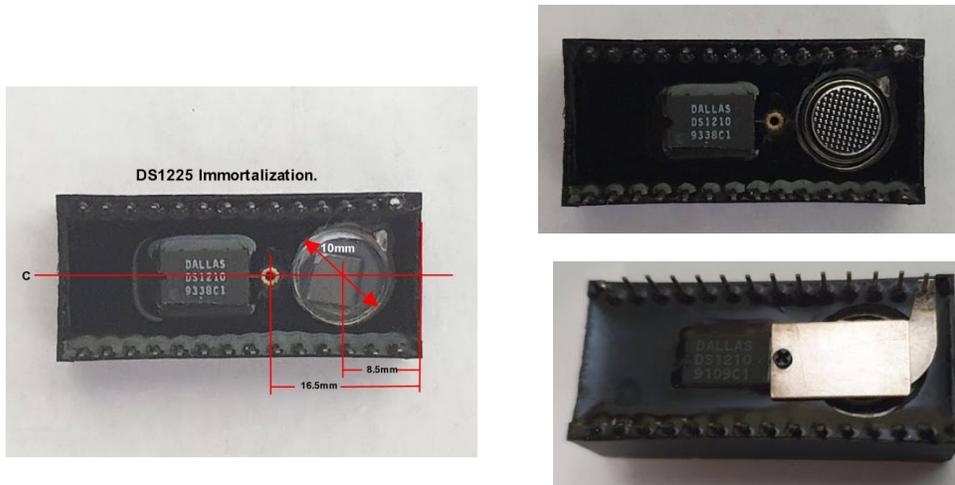
Despite having started the FRAM solution to the DS1225/2465B scope dilemma, I had moved back to the Dallas DS1225 after devising a way to immortalize them by replacing the battery with what amounted to a battery compartment. The battery could be changed at will. In the end I settled on a 10mm Milling tool as it tends to cut just a little over a 10 mm Diameter with the one procedure and provides satisfactory clearance for the battery:

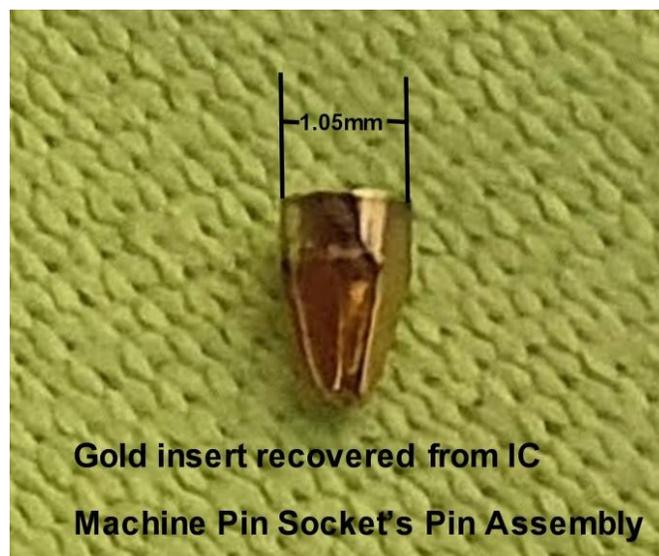
Advantage; There is a very favourable feature of the machine pin IC socket I call "*the two chance effect*" This is because of the anatomy of the four prong gold ferrule in the socket. Here is a photo of the typical 4 pronged insert from a machine pin socket:

In the case of fitting a standard IC pin to the machine pin socket (typical geometry 0.25mm x 0.5mm), only the two prongs on the 0.5mm wide axis of the IC pin are pushed apart to any extent and engage the IC pin side edges.

If a round pin is pushed into the socket in the range of 0.45mm (better) or even 0.5mm (at worst) the 4 prongs engage the pin surface equally. If that round pin is then removed, the socket's insert still works for the flat IC pin because the two prongs on either side that are the main operational ones for the flat IC pin and are undamaged. The other two prongs played no significant role anyway for the 0.25mm to 0.3mm wide flat faces of the IC's pin.

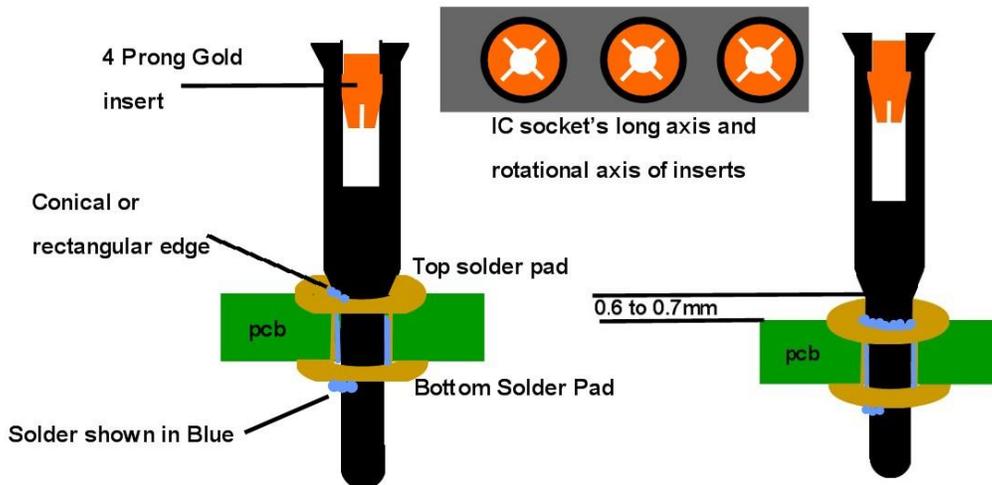
The Machine Pin Socket De- Soldering Problem- See Text.

Disadvantage; The machine pin socket is somewhat diabolical in one respect. It has a conical area where the diameter of the pin tapers down to the part of the pin that passes through the pcb's holes.

What this does is that it often occludes the mouth of the plated through hole on the top surface of the pcb. That blocks the flow of air that allows the solder sucker to work effectively. And it really needs to work effectively, because the round pin occupies a greater cross sectional area in the hole, leaving more opportunity for the pin to remain stuck to the inner wall of the plated through hole, around some of its circumference.

Problem = Occlusion of hole in upper PCB pad:

After a number of experiments with this problem, I found that the answer was simple. All that is required, when fitting the machine pin socket to the pcb, is to simply elevate it a little off the pcb 0.6mm to 0.7mm is plenty. This prevents occlusion of the mouth of the plated through holes and provides an annulus for the air & solder to flow. And it means that the solder sucker again becomes highly effective if the socket requires removal & replacement again, with a lot less risk to the pcb's pads & plated through holes.

Solution = Elevate socket off pcb:
