TEKTRONIX 2465B OSCILLOSCOPE: MAIN BOARD INTER-TRACK LEAKAGE.

Dr. H. Holden. June 2014.

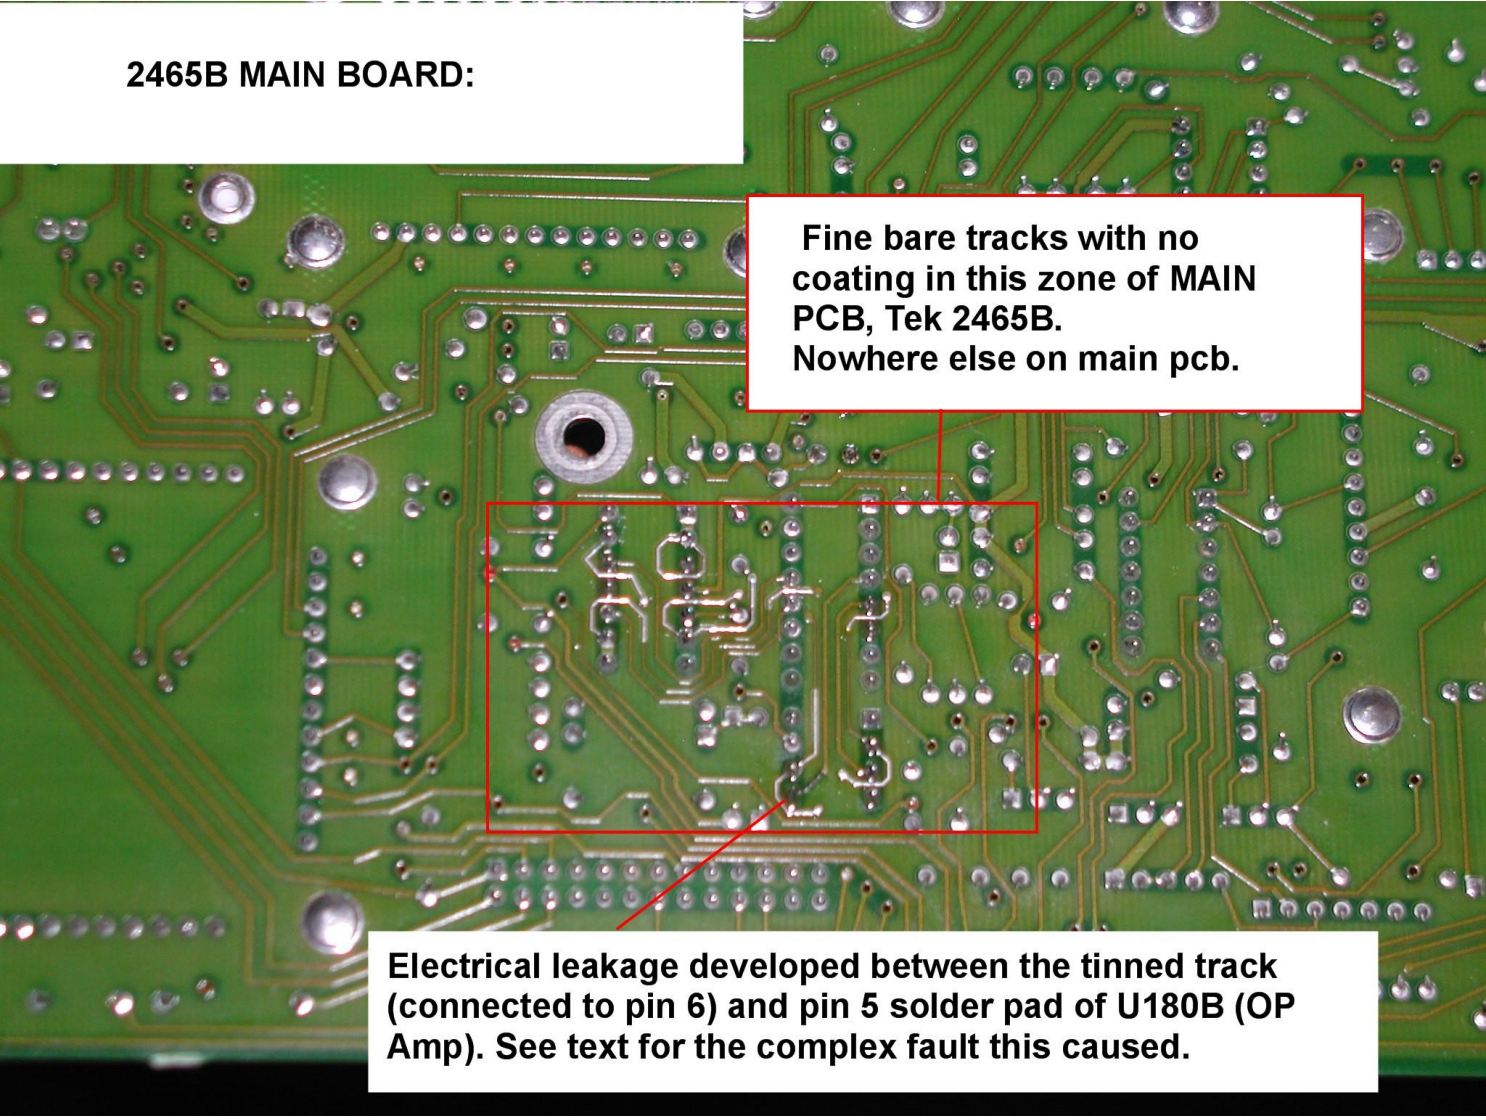
2465B MAIN BOARD:

Fine bare tracks with no coating in this zone of MAIN PCB, Tek 2465B. Nowhere else on main pcb.

Electrical leakage developed between the tinned track (connected to pin 6) and pin 5 solder pad of U180B (OP Amp). See text for the complex fault this caused.

A leakage conduction pathway between pins 5 & 6 of U180B developed with time.

Testing with a digital meter showed a variable resistance of around 2Meg Ohms. It was not a direct short. Pin 5 is the + input to an OP amp (U180B) which acts as a sample hold in conjunction with U170 which is a de-multiplexer. U170 is controlled by 4 data bits and selects a specific DC output present from the DAC, this level is held until the next update by the charge in the 0.22uF (C182) capacitor on pin 5 of U180B. The circuit impedance here is very high. Only a small amount of leakage is required to discharge

the 0.22uF capacitor between updates. This resulted in both an average DC offset and sometimes an inverted and erratic sawtooth like wave appearing on the CH2 trace.

At first I suspected that there was leakage within the multilayer pcb. However it was not until the main board was removed from the scope for inspection that I found a small very fine bridge that appeared to be a tin whisker. One stroke with the tip of a scalpel cleared it immediately. Then it was too late to take a photo.

The fault was found by concentrating on the abnormality of the CH2 preamp IC, in that it had a DC offset at its outputs. Ultimately the leakage between pin 5 & 6 was isolated by removing U180 from the pcb by cutting its pins near to the IC body and mounting another on the cut pins and isolating pin 5 of U180 and using a separate 0.22uF capacitor and isolating pin 4 of U170 and creating a wire link. This restored the scope to normal, and the leakage between the tracks previously connected to U180 pin 5 & 6 was easily measured with the meter.

Due to the fact these fine bare circuit tracks run near other IC pins, they were all thoroughly cleaned and painted with marine grade varnish. These bare tracks run past IC pins on U180, U170, & U160. So a very large number of interesting and difficult faults could occur if electrically conductive pathways developed between any of these tracks and the IC pins.

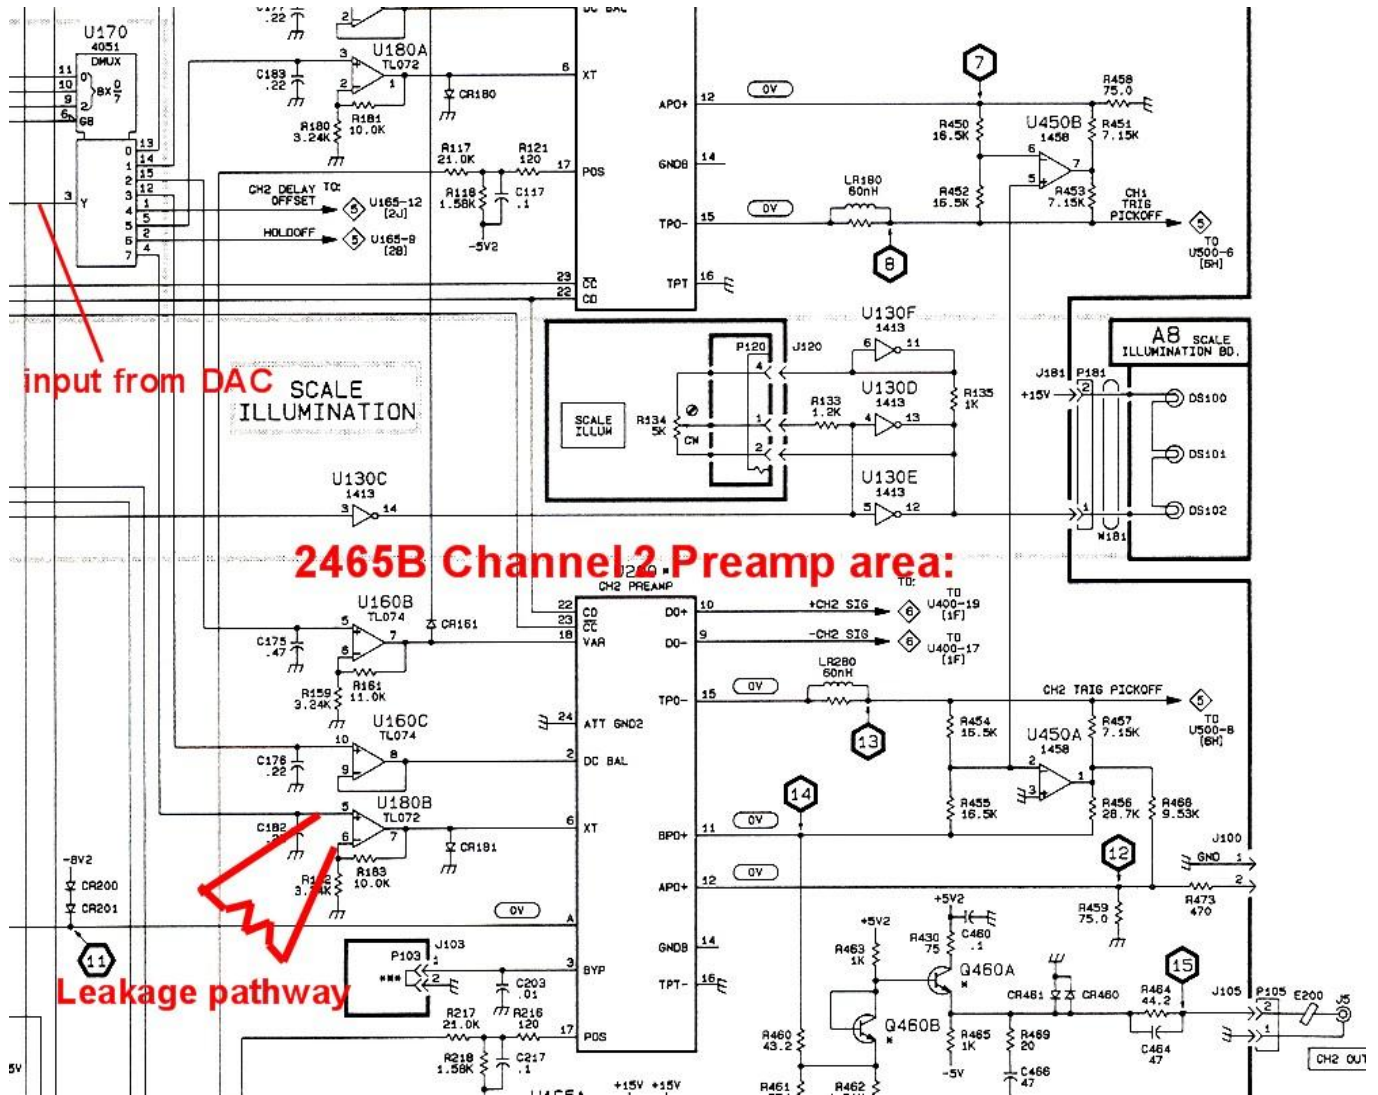
The circuit is shown below with the leakage resistance drawn in.

The effect of the leakage alters the DC input to the XT input of U200, the CH2 preamp IC. This resulted in a DC offset from U200's output. Surprisingly, further down the line this upset the operating conditions of U400 (the Channel Switch IC). This caused interactions of CH 2 with the other 3 channels and with the On Screen Data display.
