THE BUBBLES THAT CRIPPLED A KING:

2002 TOYOTA LANDCRUISER SAHARA SERIES 100 IGNITION SWITCH SHAFT FRACTURE. Dr H. Holden. 2015.

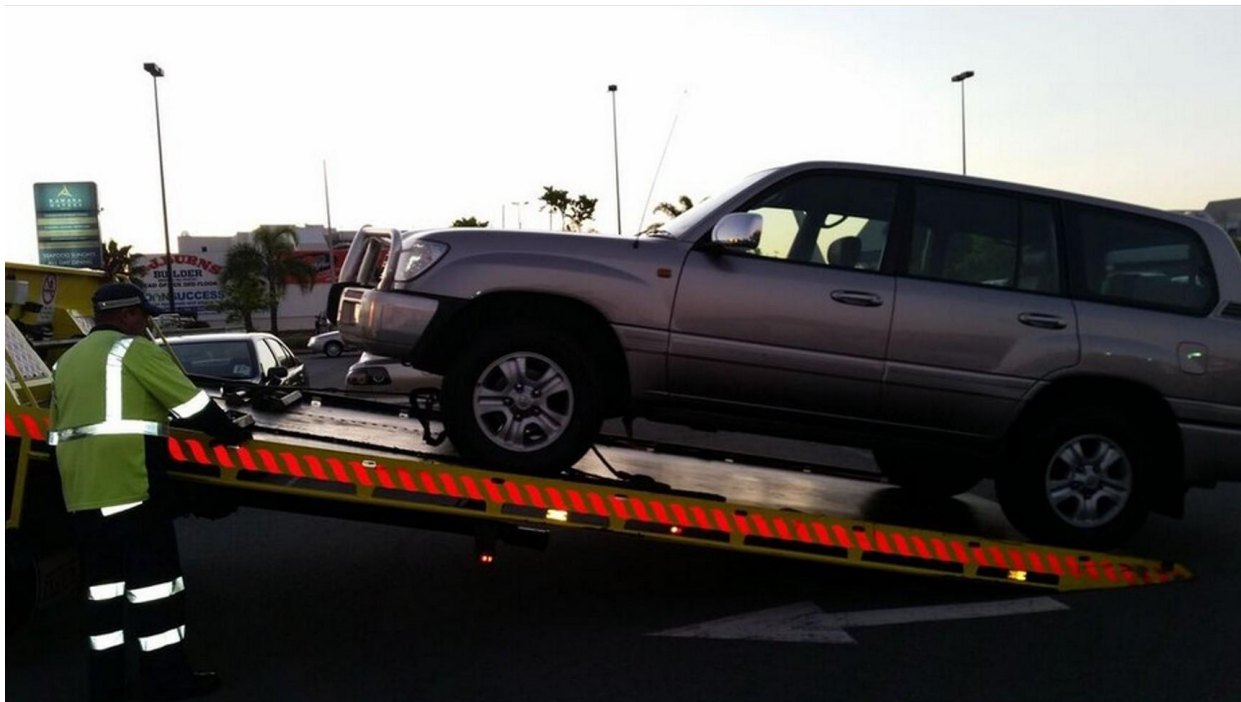
So I was astonished when the vehicle failed stranding my wife and I (luckily only at the local shops) and had to be towed home. The ignition key and barrel assembly had suddenly lost mechanical coupling with the electrical part of the ignition switch. A photo below shows the car on the back of an RACQ tow truck. A sad sight for such a great machine:

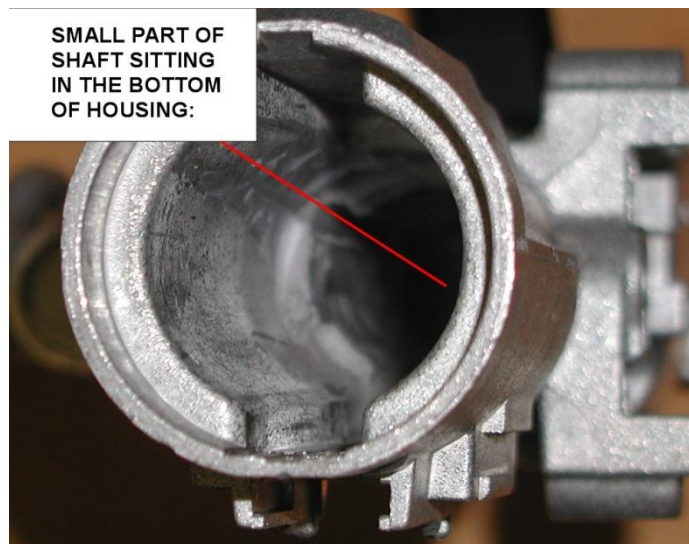
On attempting to remove the smaller section of shaft from the bottom of the housing it simply tipped over onto its side and remained loose at the bottom of the housing. It was well out of reach of any long nosed pliers and also it is made of non magnetic material:

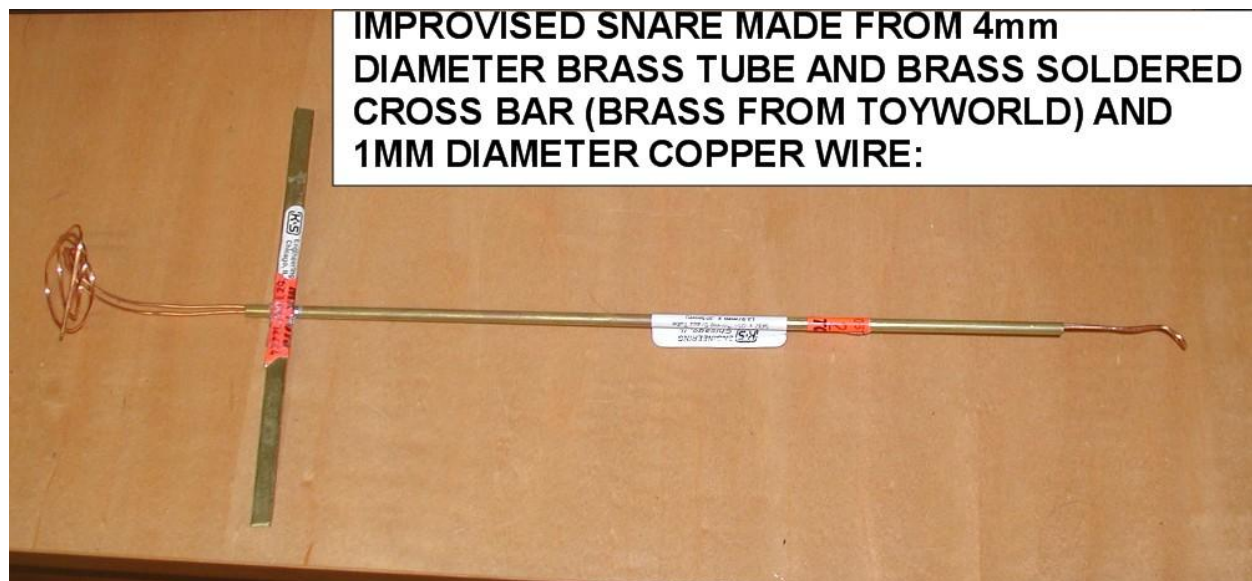
So a Snare was improvised from some brass tube and copper wire to retrieve it:

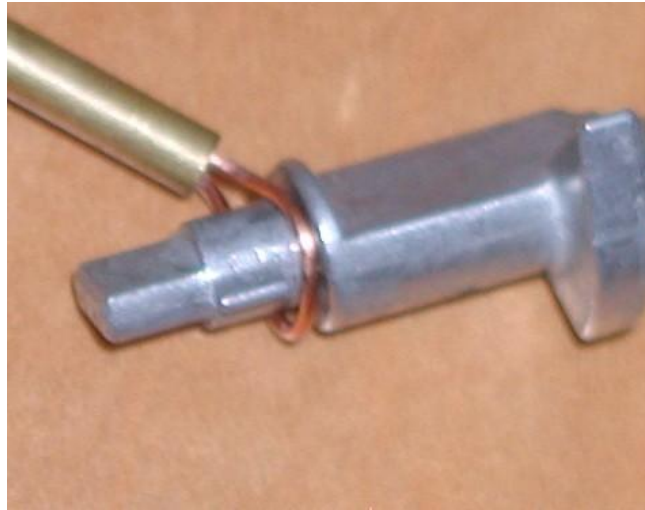
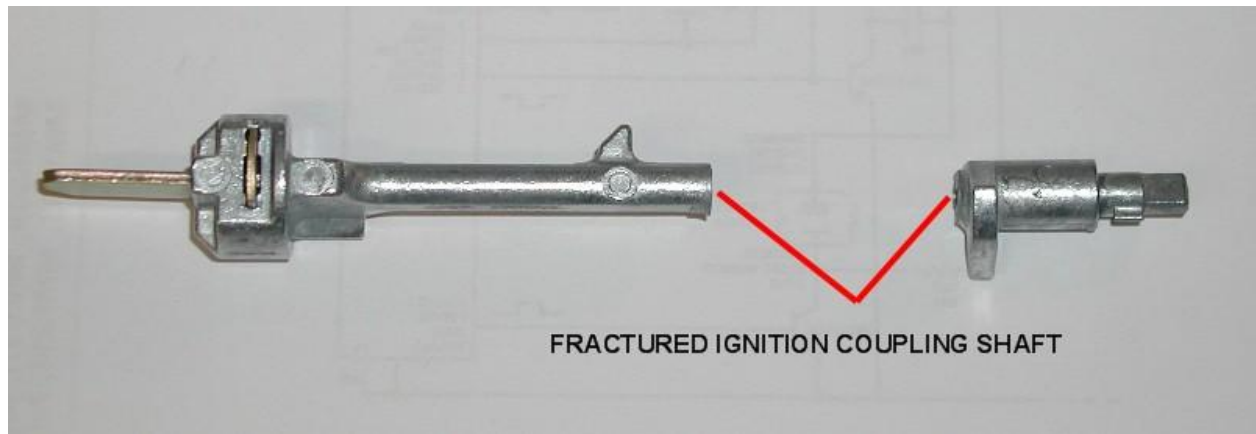
FRACTURED IGNITION COUPLING SHAFT

The small part of the broken shaft is the part that has a cam on it to operate the steering wheel lock and it also projects out of the rear housing to operate the electrical part of the ignition switch (which also must be removed to replace the shaft). There was a keyway on it which provided a convenient place to put the snare wire around it:

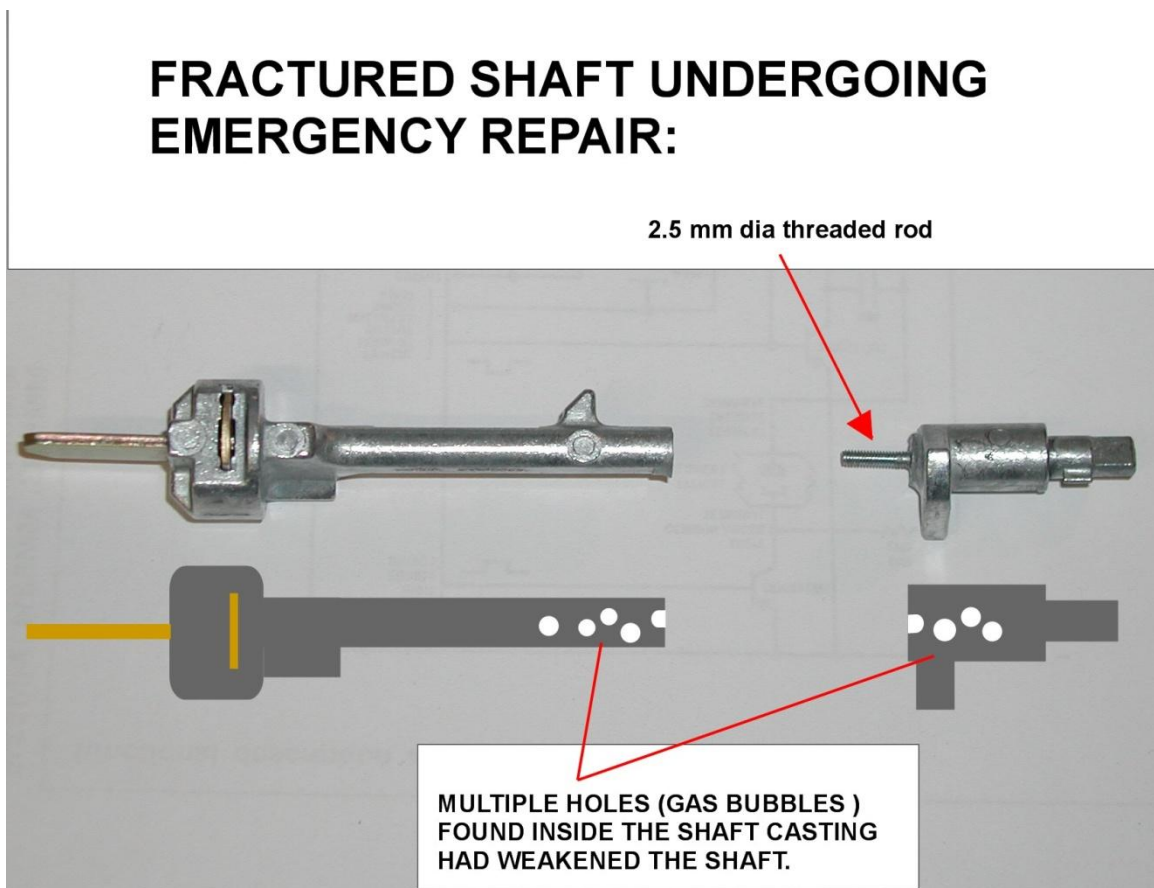
On drilling the shaft and inspecting the holes and threads I had cut I found the reason why the shaft had fractured in the first place. There was a problem with the casting and the shaft was compromised by multiple internal cavities. This had weakened it and allowed it to fracture.

So this was in fact a manufacturing fault, not a design fault. I do not believe this shaft would have fractured if it were not for the many bubbles. Presumably there were some impurities in the metal that evolved gas during the casting:

Once the small part was removed I decided to repair the shaft as I did not know how long it would take to get the replacement part. I drilled the shaft and fitted a steel 2.5 mm diameter x 20 mm long threaded rod with liberal application of epoxy resin on the threads.
