Tek Oscilloscope 2465B: The Power Supply's Electrolytic Capacitors - The Alkaline Shift.

Dr. H. Holden Jan. 2025.

THE 2465B's PSU:

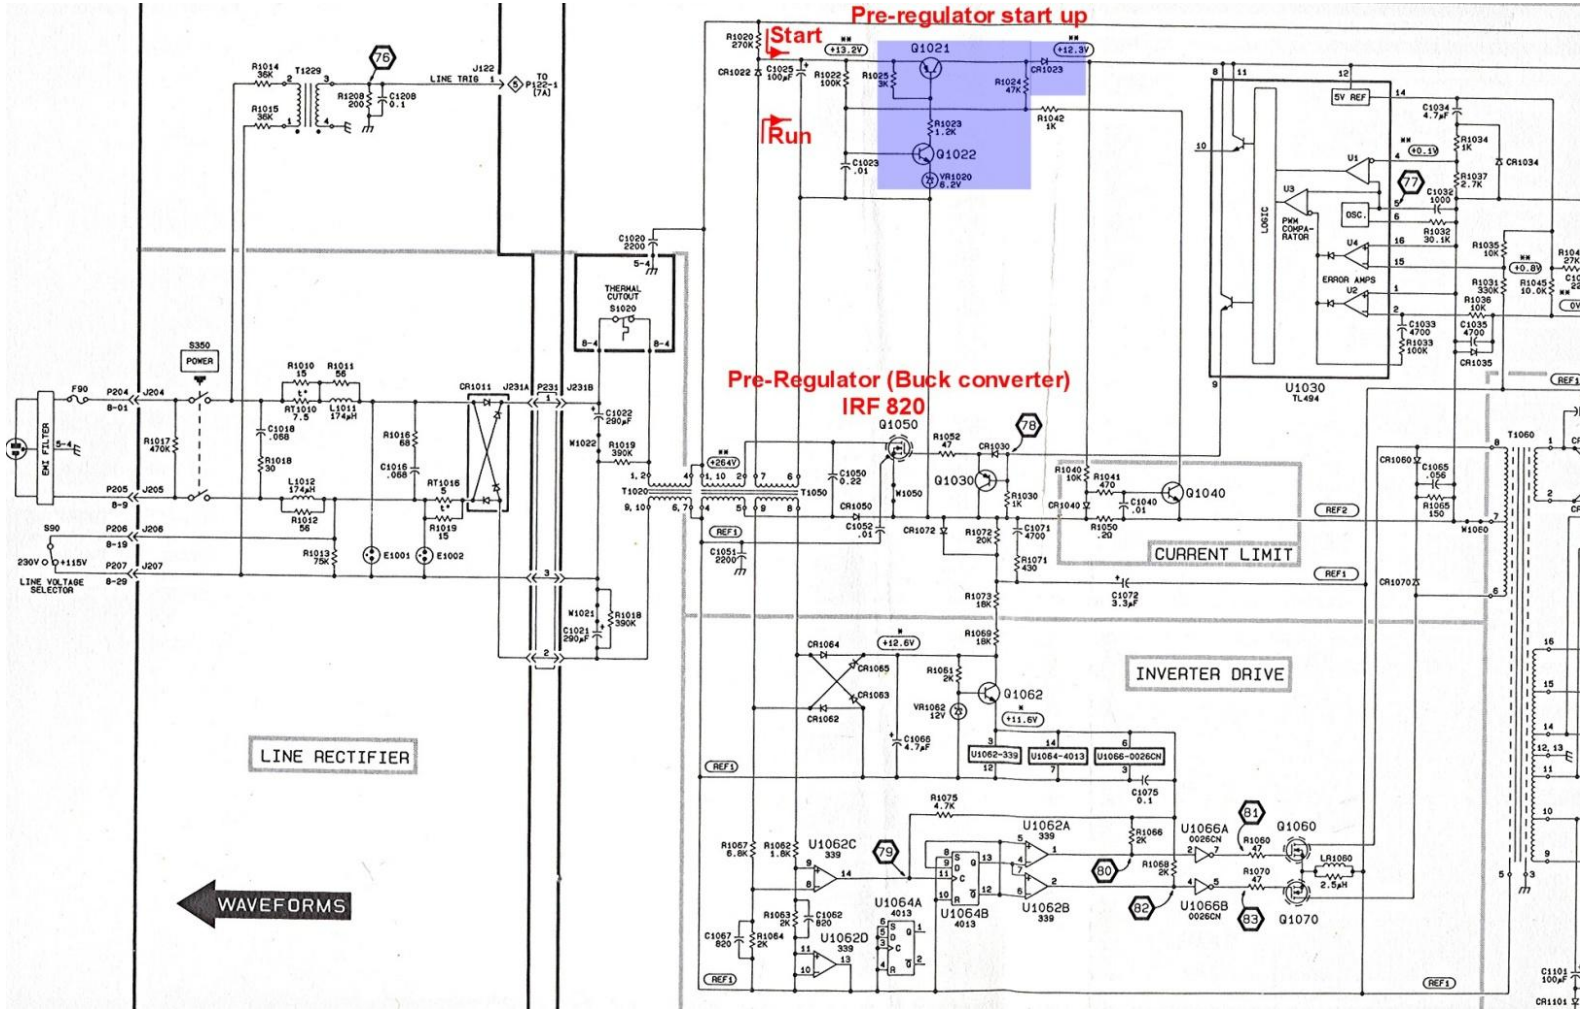
The partial PSU schematic is shown below. The *whole area shaded in blue* is the one up for discussion, because it had malfunctioned in my oldest 2465B.

The electrical leakage from the electrolyte was enough to stop Q1022 being brought into conduction at power up, likely by shunting current around the 47k resistor R1024. This explained the fault and why the start up circuit was totally disabled.

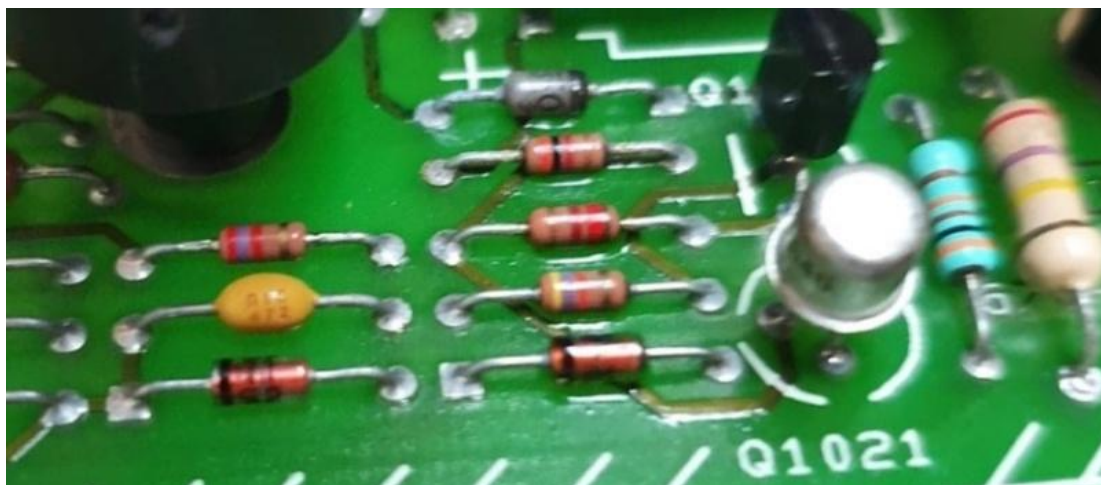
In essence, the whole area shaded in Blue on the schematic had become a conductive blanket from leaked electrolyte from C1025. But, exactly why did the leaked electrolyte prevent start up?

The photo below shows most of the leaked electrolyte had not evaporated yet. There is corrosion of the solder. Looking closely at the silver Zener diode on the top of the image, its left anode leg is somewhat corroded. This is the hallmark of chemical corrosion caused by leaked electrolyte. Note also on the pcb surface, just near where the anode lead of the silver coloured Zener diode is soldered on the left side, there is a white salty looking deposit on the PCB surface too:

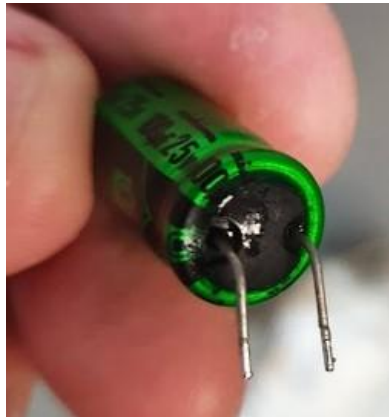
Leakage from the base of the capacitor C1025, sitting above these five parts, was very easy to see after it was removed for inspection. Despite this the capacitor measured normally, at close to 100uF on the Capacitance Meter:

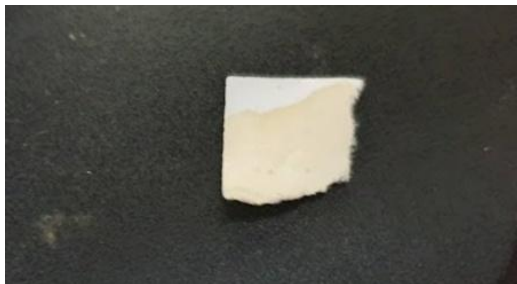
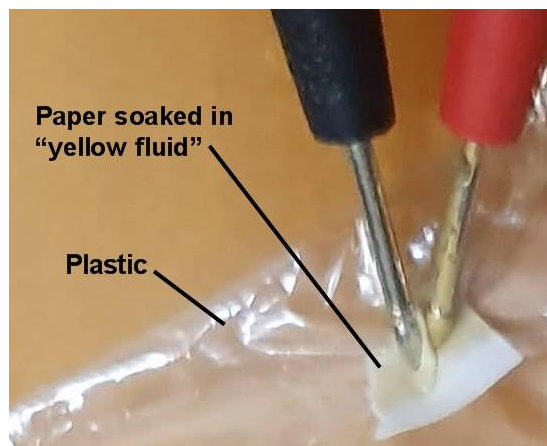
The rubber bung in the base was softened and swollen and electrically conductive with the meter probes. I tore the corner off a piece of A4 paper to use it in a similar manner to blotting paper to extract the fluid from under the components. The fluid was a yellow colour and soaked into nearly the entire square centimetre of paper:

A quick test with the meter probes indicated that the fluid was quite electrically conductive. There may have been some reaction with the Nickel plated Brass probes but very little time for it to occur. The resistance measured in the order of 100k Ohms across a small section of the soaked paper.

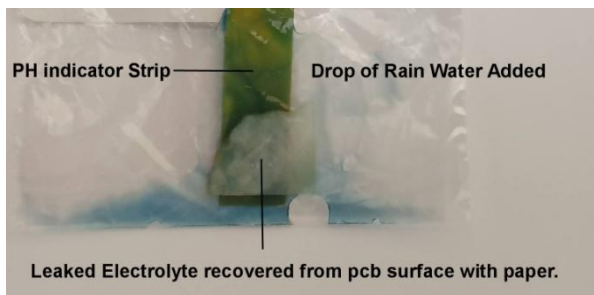
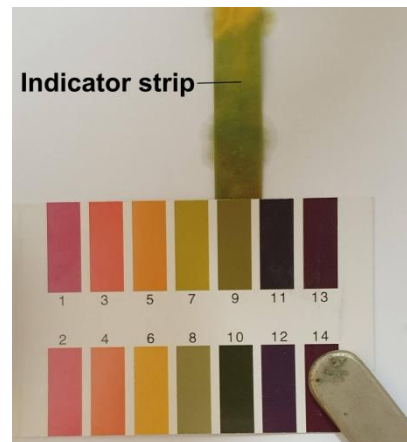
Luckily, I had saved the paper fragment that I used as blotting paper to scavenge the leaked electrolyte from around the pcb components, it had dried out. As an experiment I put it in a small plastic bag with a pH indicator strip and a drop of rain water. It was quite Alkaline with a pH around the 9 area. I also put a sample of the A4 paper I used in another bag with the indicator strip and a drop of rain water. It was neutral at pH = 7, just to make sure there wasn't any contamination in the paper I had used confounding the test.

Not only is an Alkaline solution corrosive it is much more electrically conductive than a neutral solution and this explained the Ohm meter's resistance readings.

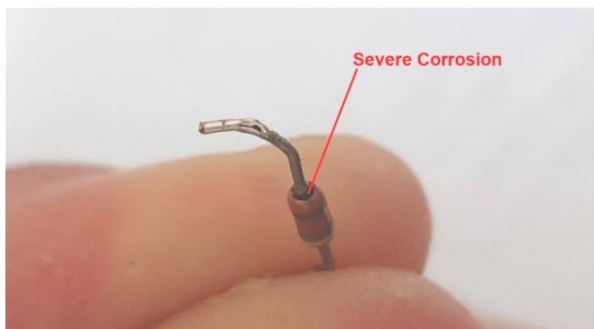
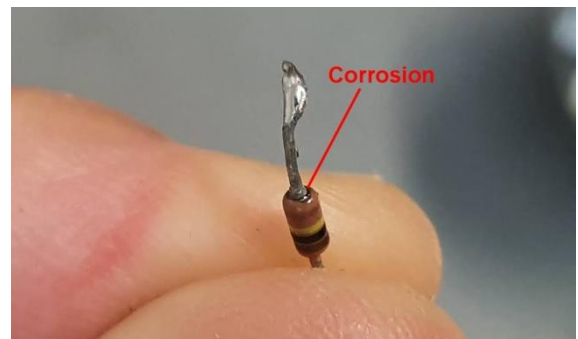
The photo below shows how the corrosion had already entered the ends of the resistor bodies in the 2465B where the wire lead was inserted. Although the 3k, 1.2k and 47k resistors tested ok, I replaced them for this reason. Also the 100k resistor had one leg affected

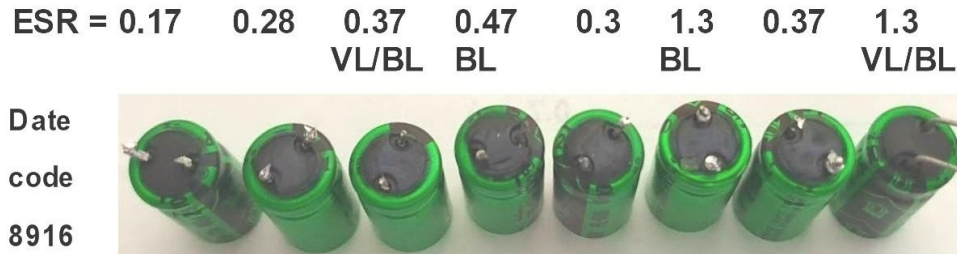
100uF 25v VL= visible fluid leakage. BL = bung electrical leakage.

Some of the capacitors had “visible electrolyte leakage” VL. Others had electrical leakage detected with the DVM on Ohms range on their rubber bung, or “bung leakage” BL. This is something not all Technicians are aware of:

All of these capacitors had one thing in common, aside from the date code of 8916, the rubber bung on the base had become soft and a little swollen. The capacitor on the far right in the photo above, with the long leads, is the one removed from the A3 board which leaked electrolyte disabling the scope’s power up circuitry.

The other two to the left of it were removed from the A3 board also. The five to the left of those were removed from the A2A1 board which was working normally still, even though two of them had leaked electrolyte onto the PCB.

However one part, the 3rd from the left in the photo above, had both VL & BL and had an ESR of 0.37. Therefore the ESR meter's suggested worse case values are only guidelines. If in doubt, compare the measured ESR value to a new part, on the same meter.

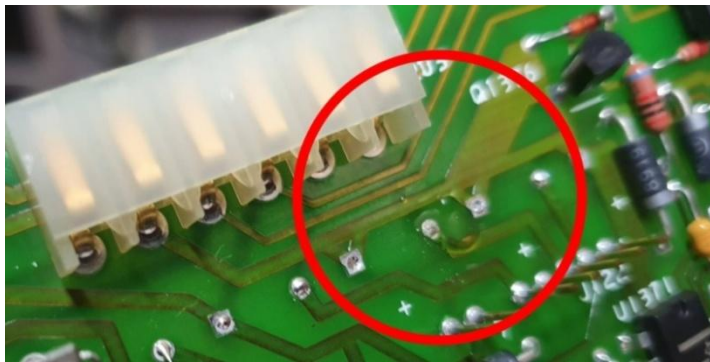
The damage on the A2A1 board indicated one capacitor had probably leaking for longer than the one that caused the failure preventing the scope from powering up. There was damage to the board's conformal coating and the electrolyte had started to attack the copper traces. Also where the electrolyte had dried out there were white crystalline deposits:

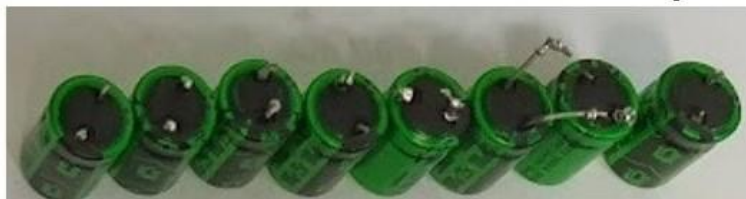
**ESR's ranged from 0.19 - 0.25 Ohms
8930 Date Code. Low Hours Scope**

In the case of these parts, the rubber bungs were in good order without softening and they were not electrically conductive, meaning that it was unlikely they had leaked electrolyte in the past. Their ESR's were a little above the normal range compared to new parts tested (but within the meter guidelines of 0.5 Ohms maximum) and their capacitance was normal on the meter and there was no significant electrical leakage. Testing indicated they were probably ok. Likely, in the next 5 years or so, they will also leak and damage components and the PCB, so I elected to replace these ones. Although, they all had an ESR above the 0.14 Ohm value of my unused stock capacitors.

No VL or BL detected

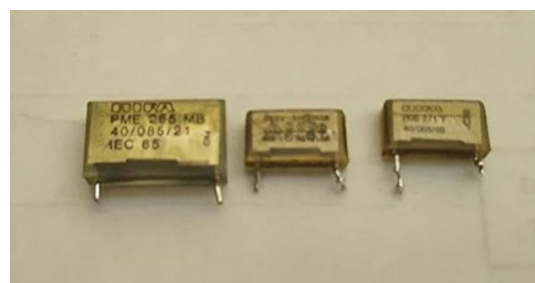
Y Capacitors to be replaced:

Looking at the photo below, it is easy to see the horizontal cracks in the bodies of the two 2200pF capacitors on the right. The 0.01uF capacitor's body is starting to swell up on the left:

The 35+ year old Rifa Capacitors should always be replaced. This is because their outer plastic casings crack. They absorb moisture and swell up widening the cracks. The positive feedback
