## A TALE OF TWO ALINCO's - DJ-V17 & "The Trick"

(H. Holden. 2025)

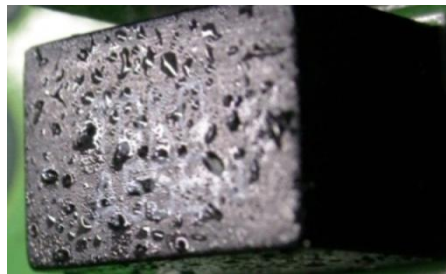
On disassembling the defective unit I found something odd had happened to a 450kHz ceramic filter module. Its casing was wet with multiple small water droplets on its plastic surface. This is a photo of another similar unit affected, where it was found that for some reason, the casing on these Toko filter units was Hygroscopic. It turned out that this was a known pathology for these modules:

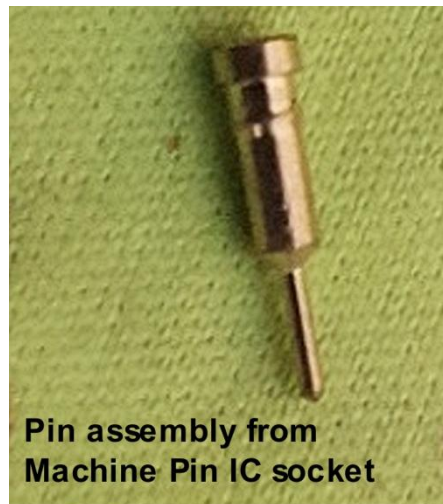
Firstly a Machine Pin assembly is removed from an IC socket by cutting away the plastic. The assembly contains a miniature Gold plated 4 prong spring contact system that hides within it:

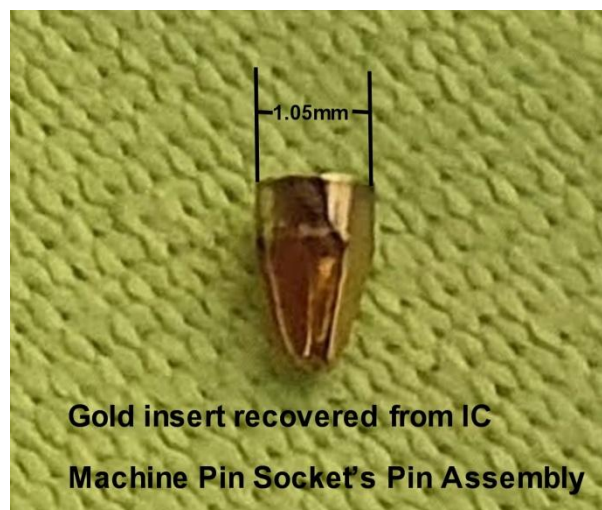
Acquiring the part above is the easy bit. The more difficult part is recovering the internal Gold plated contact assembly without damaging it. I do this in my mini-Lathe by machining the outer shell until it just breaks through. Then the Gold plated insert is recovered undamaged:
