THE ASTOR "DIAMOND DOT" CJ-12 CAR RADIO FROM 1966 AND EXTRAORDINARY AUSTRALIAN MADE TRANSISTORS OF THAT ERA. (H. Holden July 2021)

RESTORING THE ASTOR DIAMOND DOT CAR RADIO:

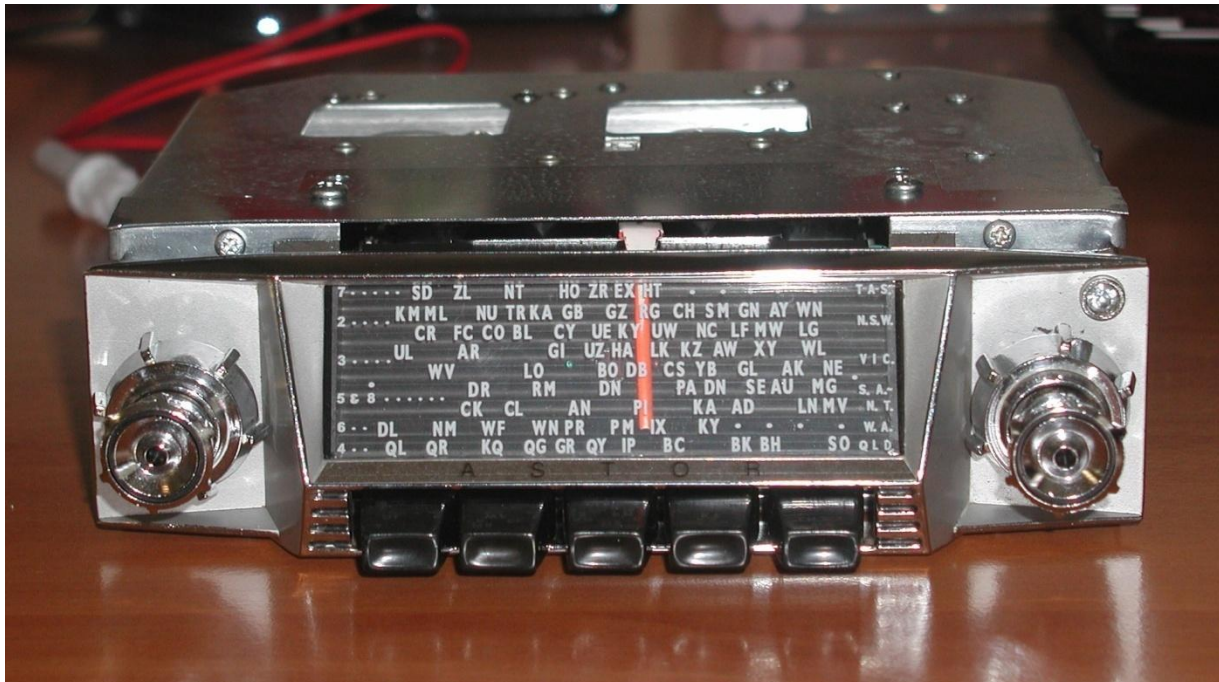
The photo below shows the restored Astor Diamond Dot radio:

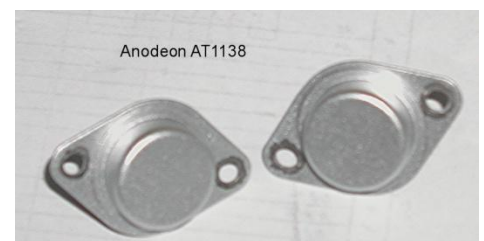
The two original germanium output transistors, the Anodeon AT-1138 types were rusted, so I replaced these with an excellent matched pair of AD149 germanium transistors which are equally good if not superior. I kept the original Anodeon transistors and painted them, in case some day somebody would prefer to use them.

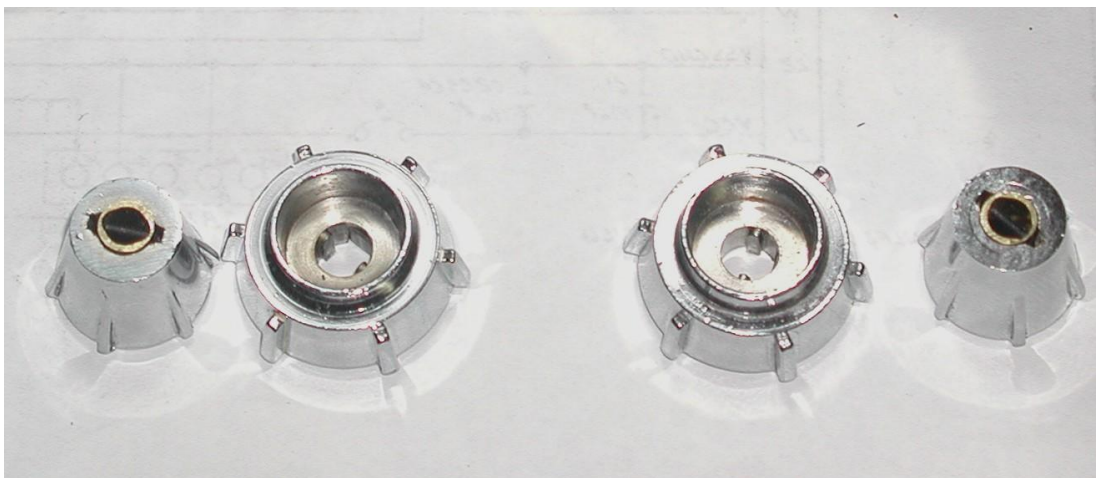
I bought some "plastic" replica knobs on ebay, but was disappointed with the quality. After a while I found some original metal knobs from another model of Astor transportable car radio. Almost perfect but the centre knob was designed to push onto a 1/4" shaft. This radio had 3/16" shafts for the centre knob, so I machined some brass inserts to fit into the centre knobs to make them compatible, these inserts are visible in the photo below:

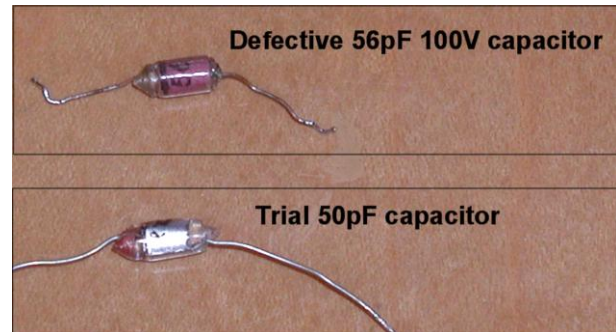
I tested the 56pF Polystyrene capacitor, zero leakage and read 57pF on my YF-150 capacitance meter, yet I found when I replaced it with a new 50pf “trial capacitor” the oscillator ran normally. How could that be when the 56pF capacitor tested normally?

The tests, as shown above, indicated that the capacitor had gone high ESR to the tune of about 22k. Of course ESR meters cannot measure low value capacitors like this. Then I tried placing resistors of this value, in series with good low value capacitors in the range of 50 to 100pF, my YF-150 capacitance meter is unable to detect significant series resistance.

Presumably inside the capacitor, the bonds or connection between the lead in wires and the foils have come oxidised or corroded.

The implications of this sort of failure could be interesting, if a capacitor with this fault was used instead in a tuned circuit in an RF amplifier. It would not throw the centre frequency off to any significance, but it would certainly lower the circuit Q, lowering the gain and increasing the bandwidth. Since, after alignment, this radio is now working normally and is a sensitive receiver, I have not removed any of the other polystyrene capacitors for testing.
