RESTORATION OF THE NATIONAL 1-10A RADIO.

(H. Holden, Jan. 2020).

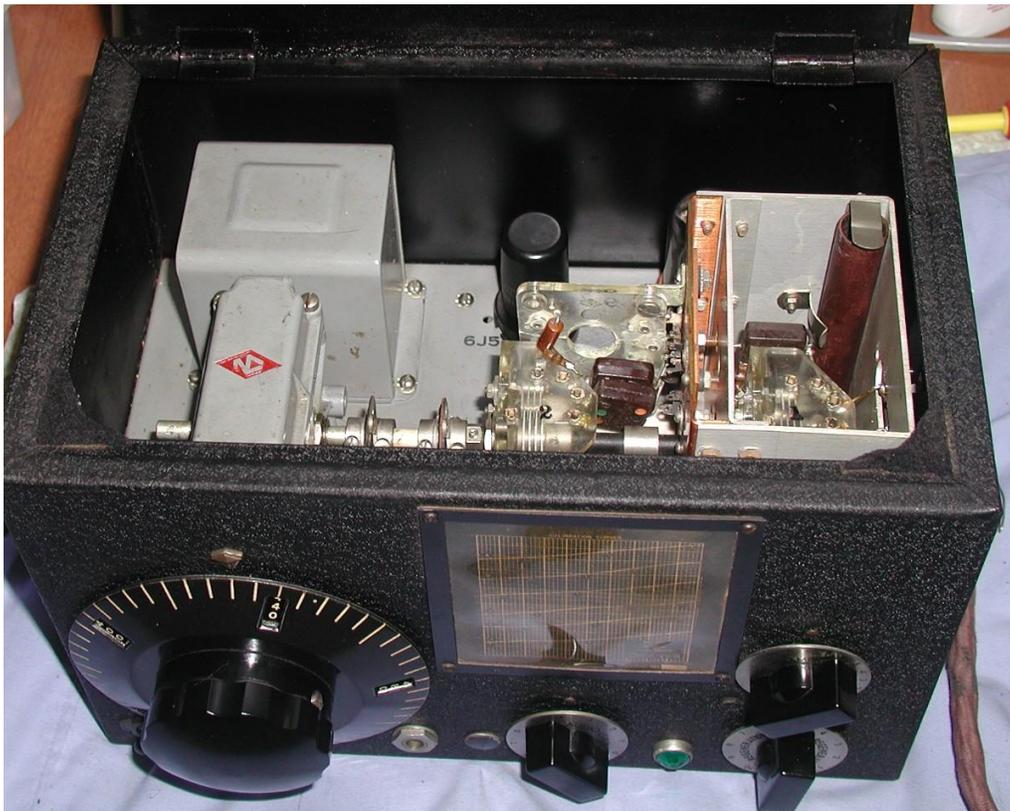
Photo of National's 1-10A radio, sans the two Acorn Valves and coil pair:

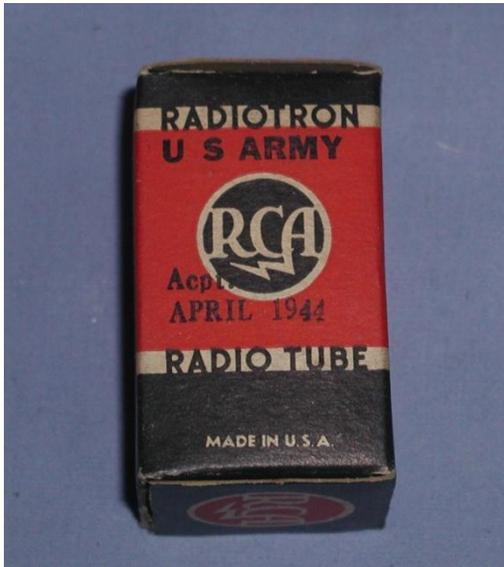
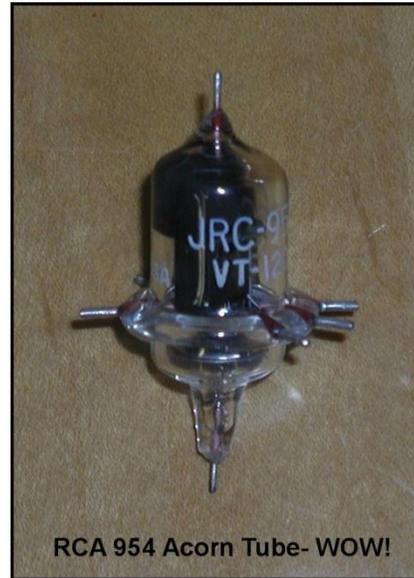
I had almost forgotten how beautiful the Acorn tubes were, until one arrived in the mail in its original RCA box dated 1944:

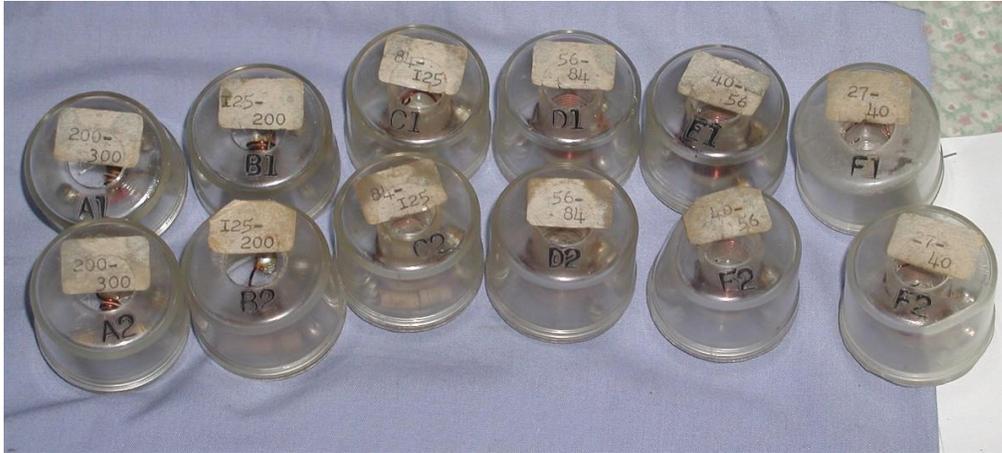
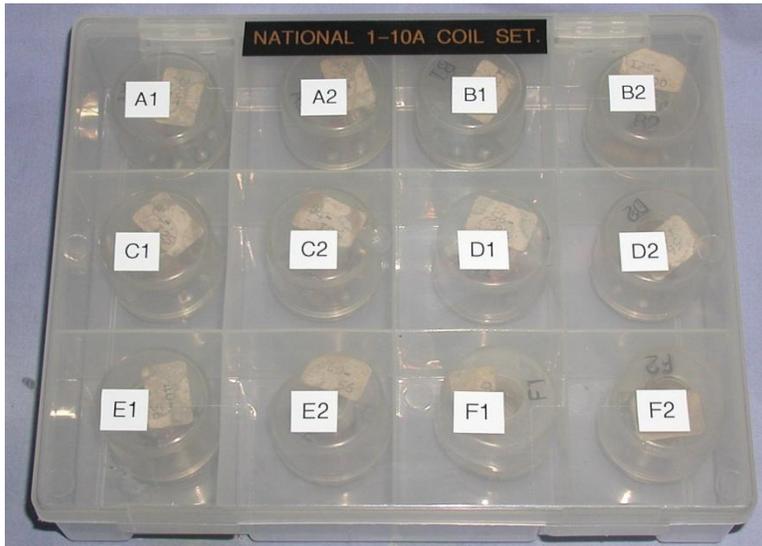
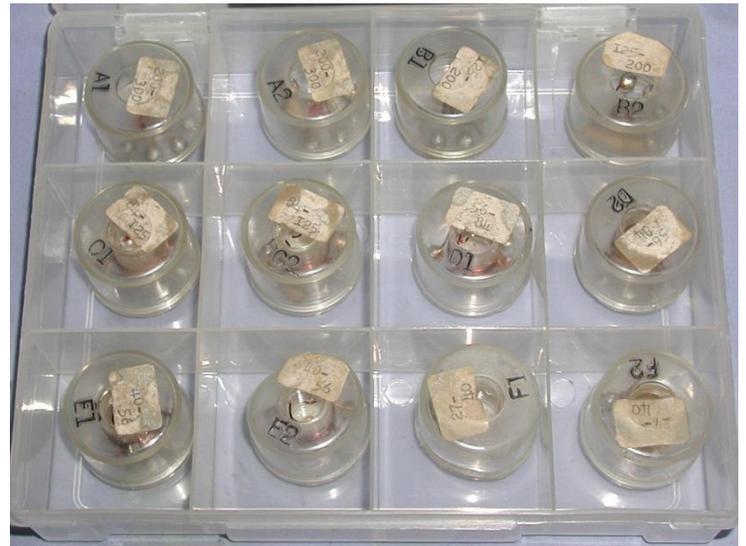
Firstly I cleaned and polished the coil set and found a suitable container for them. There was a moderate amount of black oxidation of the silver plated pins.

Some had a distorted housing, however it won't affect their function.

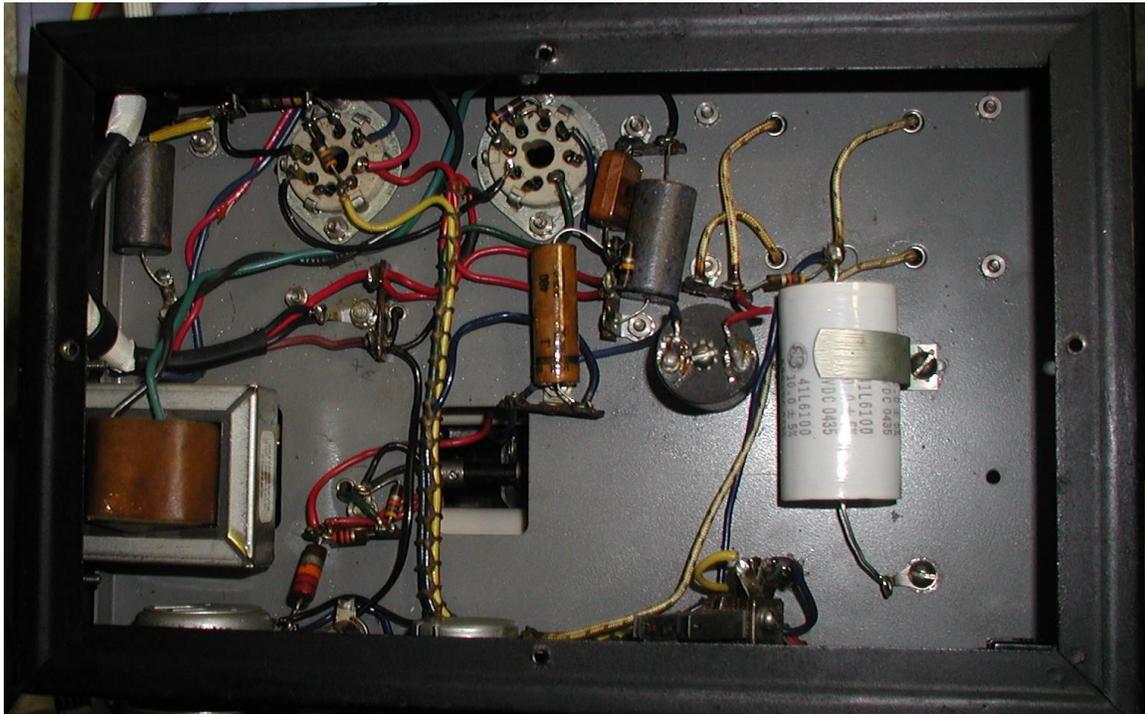
The first thing I noticed about the electrical side of things was that National made a little blunder by having the radio's 180V HT on exposed connectors on its rear panel. This is because they designed the 1-10A radio to power an extension speaker that contained the audio output transformer. So the 180V HT and the plate connections were exposed on the radio's rear panel. I cannot see that being done today. So this unacceptable situation is better remedied by putting the audio output transformer inside the radio and disconnecting the high voltage connections from the connectors on the radios rear panel, along with another HT connection. The transformer I added can be seen on the lower left. Photo with the metal base removed:

It is important when you fit the audio output transformer to connect one side of the voice coil winding to ground, or otherwise it is still possible to receive a shock from the speaker connections if there are issues with the output transformer's insulation.

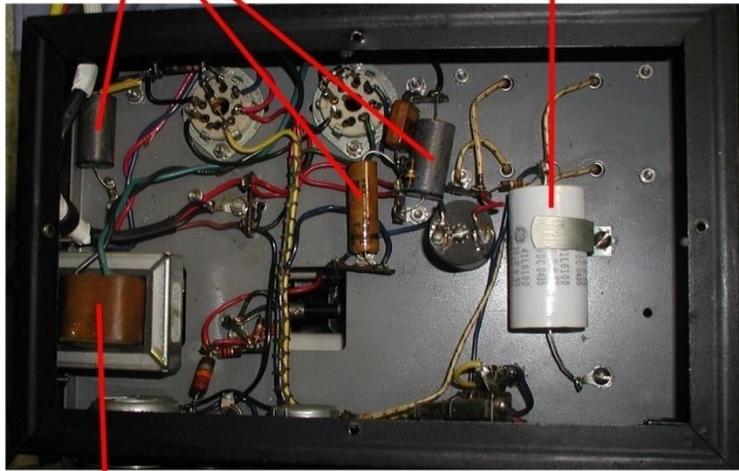
Re-built capacitors

**Replaced part:
Original 8uF 200V Electro Missing.
Used 10 uF 600V Poly made by GE
as replacement.**

Audio Opt transformer added to avoid high voltages rear panel connectors. 5.5k to 8 Ohm.

Also, the capacitors were rebuilt or replaced. I avoided an electrolytic in the HT section, but stuck with electrolytics for the cathode bypass capacitors for the 6J5 and 6V6:

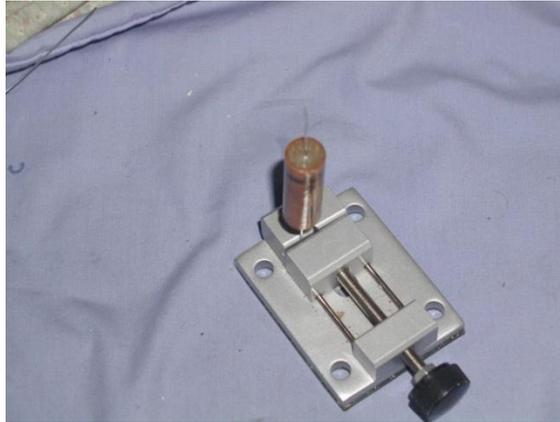
For the most part, doing large batches of waxies for TV restorations, I re-seal the ends by pouring them on alternate days with Polyester Resin. In this case for a one off I used 24 Hr Araldite. Also, I varnish the waxie with marine grade spar varnish (after the wax is removed, the varnish is miscible with the residual wax). This way they look good and the surface is non tacky and they don't stick to dust.

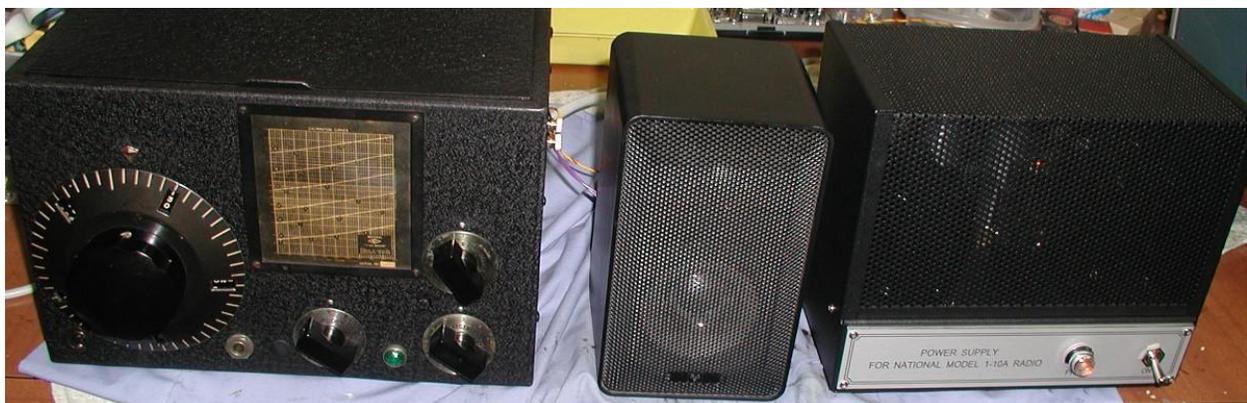
The photo below shows the setup with the home made power supply and an extension speaker:

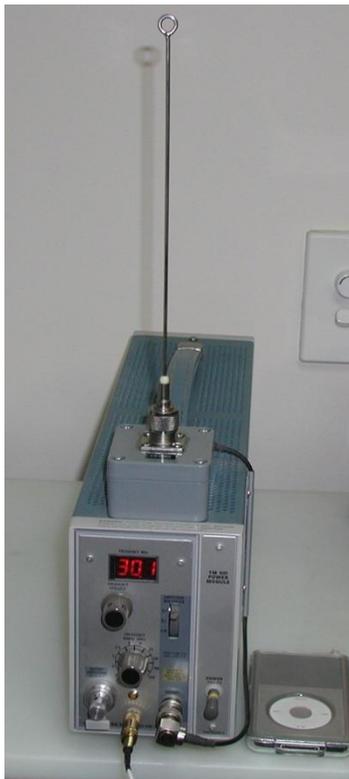
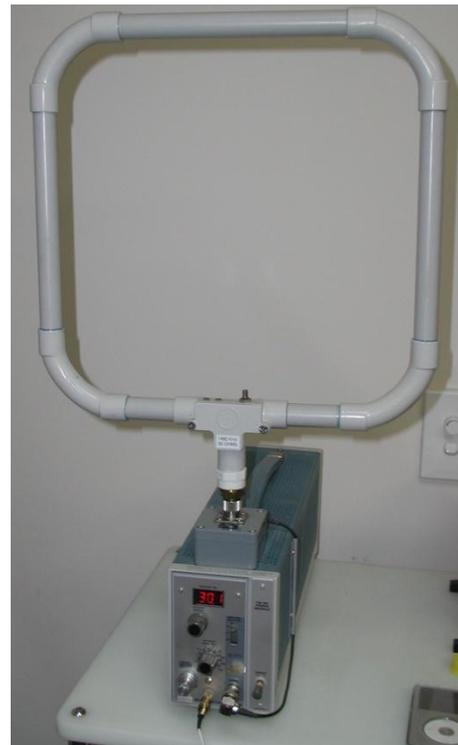
Then the next test was to transmit a low power AM signal to the radio to simulate a radio station. For this application I have a modified Tek SG503 sine wave generator.

(Very briefly this particular Tek unit has been modified to amplitude modulate the output level. Normally its output amplitude is controlled by an internal feedback loop to level it. This loop is disconnected. A processor circuit board, a professionally made pcb, fits on existing mounting holes in the unit. This board volume levels the output from an iPod using NE571 compander IC's, before it modulates the oscillator, by controlling the oscillator transistor's emitter current. This gives fairly linear amplitude modulation. It transforms this Tek unit to a 250kHz to 250 MHz variable frequency low power short range radio transmitter. For lower frequencies (MW band) I used resonant loops, for the higher frequencies whip antennas. It has become a very useful workshop tool as I also have sine wave recordings on the iPod and can control the modulation level too. The grey box on the top contains a 300 to 50 Ohm matching transformer because my all my home made resonant loops have a 50 Ohm input impedance. So this generator can be used to test many AM radios, MW,SW,VHF types over a wide frequency range. The VFO in this Tek unit particularly impressed me and it has a handy digital frequency counter. This unit, unlike my other SG503's, had a damaged area on the front panel, so I placed the 3mm panel socket and peak clipping LED there. I would have been reluctant to have modified it / made holes in it otherwise)
