RESTORING THE SONY MICRO-TV MODEL 5-303E.

H. Holden. May 2020.

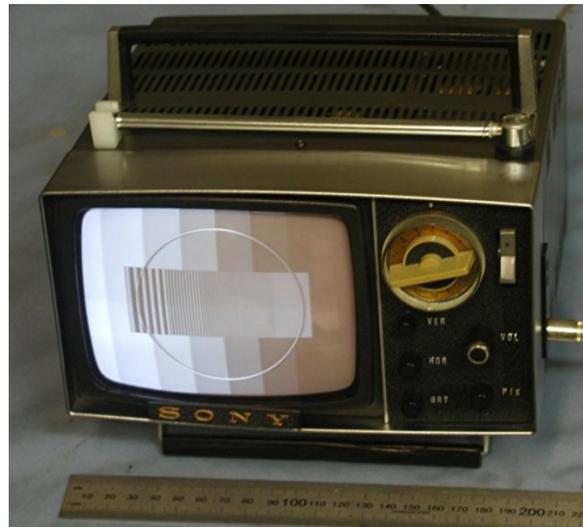
The photo above is of the TV I restored. The photo below is a page from Life Magazine, March 1963, showing this amazing little TV set:

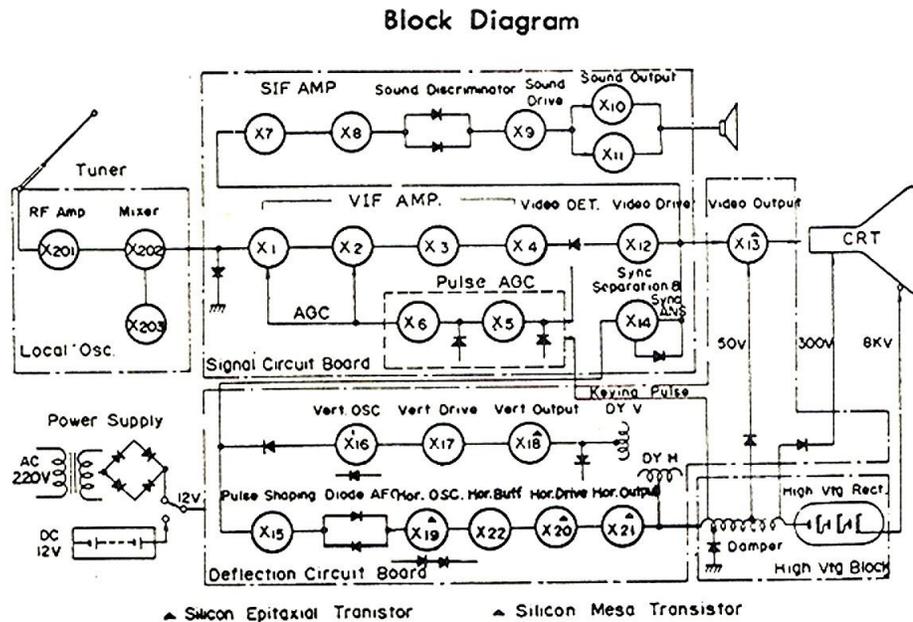
SYSTEM BLOCK DIAGRAM:

It was customary in the manual of the times to include a block diagram. The block diagram provides a helpful overview before consulting the schematic. Sony indicated where the diodes were as well as the transistors. Also the label on the rear of the TV says how many diodes & transistors the TV contained. Since these were expensive items, perceived value was in the number of semiconductors inside, 25 transistors and 20 diodes (5 of the transistors were Silicon types).

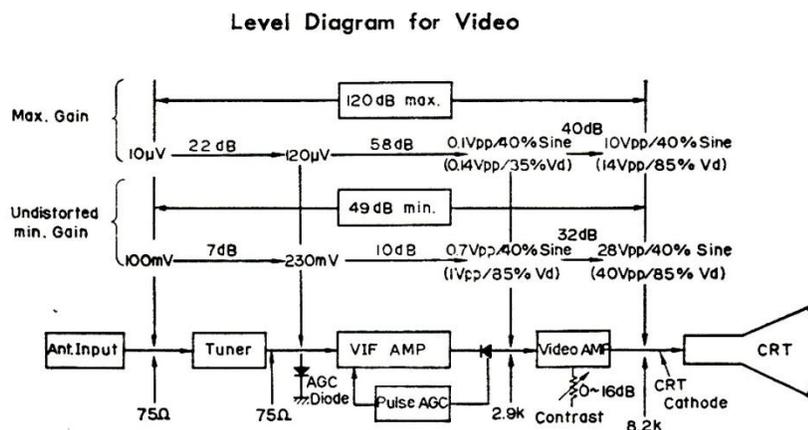
(Fig. 8)

Sony also published a very unusual and helpful signal level summary that is seldom seen on other manufacturer’s TV service manuals:

As indicated, the maximum signal gain is an astonishing 120dB. In practice I have found that for a stable visible picture and sync it requires about 100uV input at the set’s 75R input connector and by about 150uV to 200uV it is driven just out of the snow and a super clean video image results.

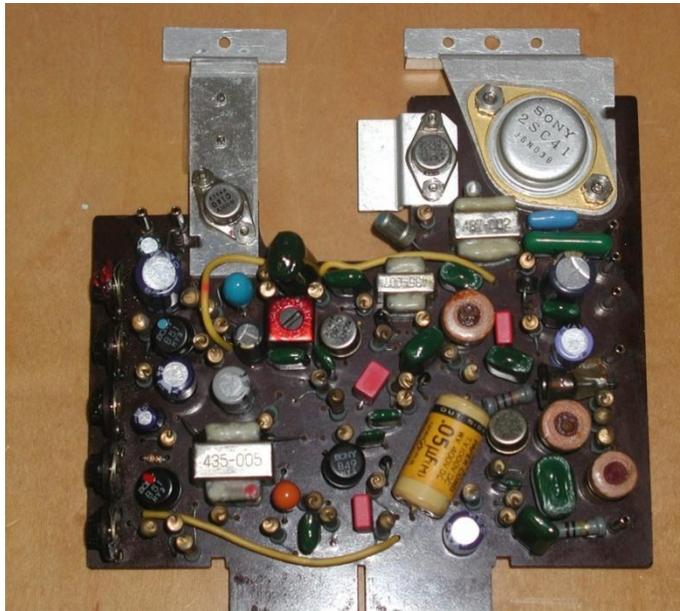
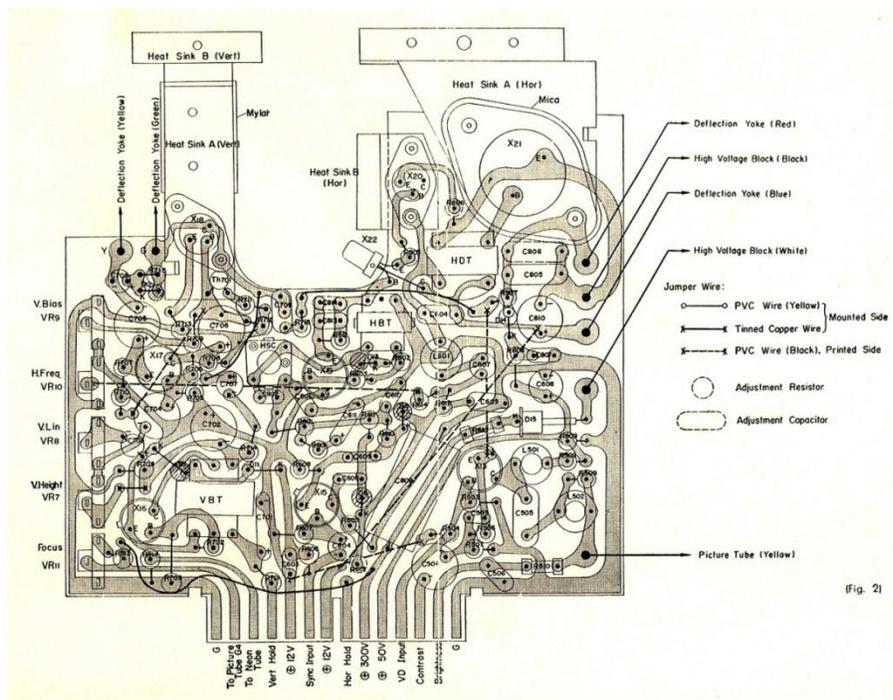
(Fig. 2)

Cleverly, to help servicing, Sony broke the set into two pcb's, one above near the top of the chassis and one below. Both of these pcb's had a similar geometry and a cut out near the front near the CRT bulb area and a pcb connector at the rear. Looking at the upper (top board) first, it contained the AFC (automatic frequency control for the horizontal hold system), the Horizontal and Vertical scan oscillators and the Horizontal and Vertical scan power output stages. On account of this, Sony created aluminium flanges that extended from the pcb area, to the front metal escutcheon of the set, to drag heat away from the power output devices. A photo of this board from my set is shown below:

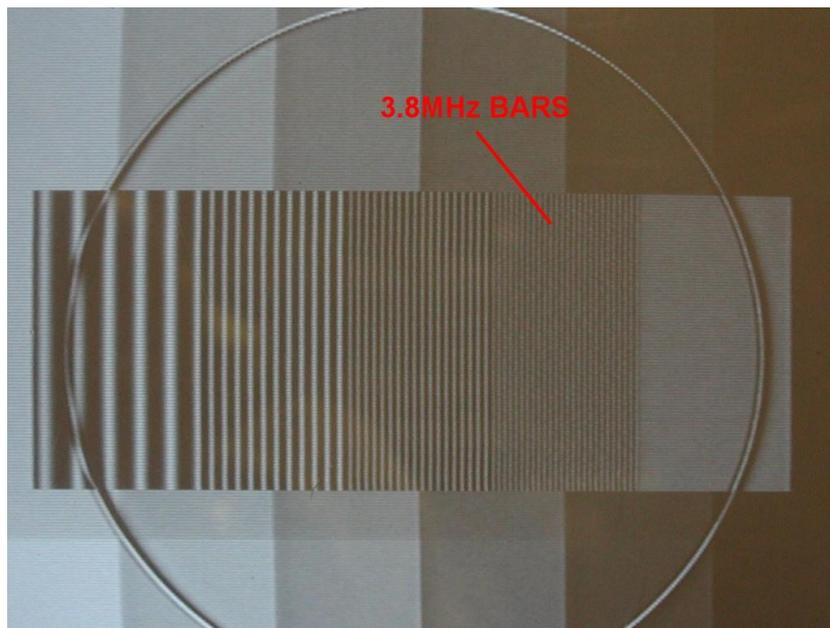
The bandwidth of the IF was set at 3.75MHz (as per Sony specs). With it done this way I found that the 3.8MHz bars from my pattern generator were easily resolved. The 4.8MHz bars are not visible, as expected:

The above is the sort of performance you can expect to get with the video IF correctly set up with a sweep generator and oscilloscope. Latter day TV restorers often try to get the video IF set up by other methods, but I'm afraid there are no shortcuts here and for excellent results there is no escaping the need for the sweep generator & scope.

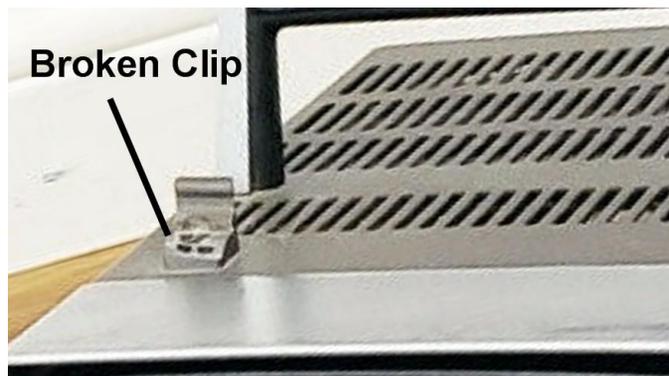
Fortunately the set I acquired had few mechanical issues. One known weak point with these sets is the antenna clip. The plastic hardens and cracks with time:

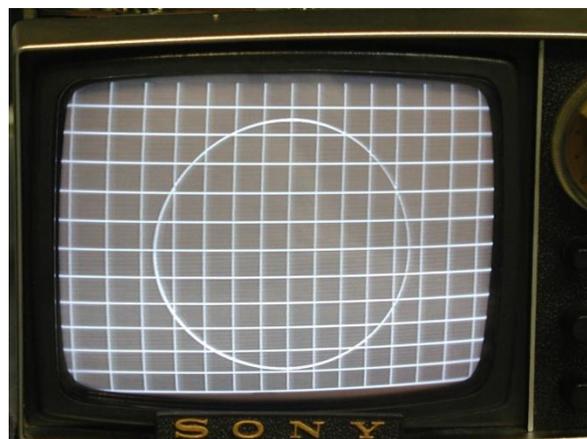
In the case of the vertical linearity issue, I checked the power supply, the resistors & electrolytic capacitors in the vertical stages, none were out of spec or defective, including the vertical yoke coil's coupling capacitor. A photo below shows the V linearity issue (The Horizontal linearity is also not ideal, this is discussed later as it is intrinsic to the design and not easy to adjust).

As can be seen, the raster lines are compressed toward the bottom. In this set there is plenty of height control and the raster will easily double in height and there is plenty of dynamic range in the output stage. The V Linearity control though only has a significant effect at the top of the raster. One might think that to acquire a linear vertical scan, that the current in the vertical output transistor, during scan time at least, should be a linear

The repair to correct the poor scan linearity was achieved by increasing the value of R704, from 330 Ohms to 750 Ohms. This reduced the amplitude of the sawtooth voltage across R704 to 2.4V pp, close to the manual's suggestion of 2Vpp. (Also the most negative part of the sawtooth waveform, with these values sits at 6.6V for future reference).

This meant that the height control could be adjusted for a lower resistance (more height). This improved the positive feedback. To further improve things I altered the value of C707 from 10uF to 15uF increasing the positive feedback.

Another helpful change was to parallel a 3 Ohm resistor, with the existing 3 ohm resistor in the emitter of the vertical output transistor. Normally there, the voltage across the existing resistor is 0.33V, making an emitter current of 110mA. With the additional resistor added the voltage drops to 0.22V across 1.5 ohms, and the new emitter current is 146mA, an additional current of about 36mA and an additional power dissipation of 0.43W, taking the transistor's power dissipation from about 1.32W to 1.75W.

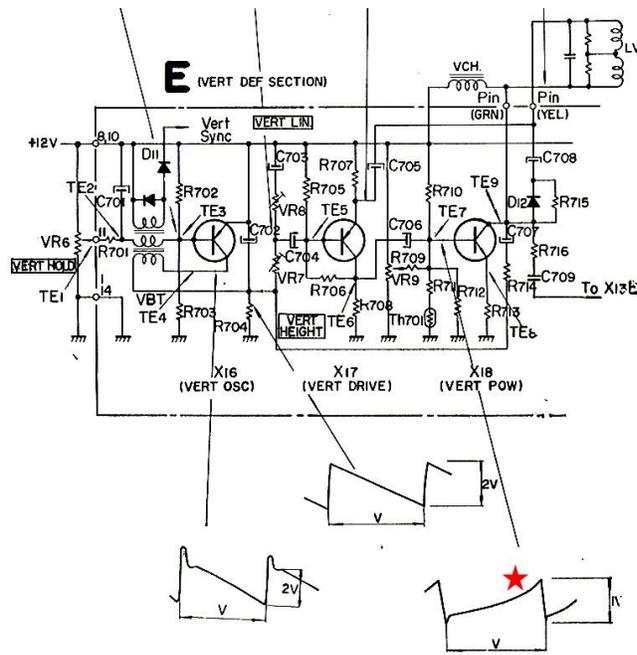
However, to get a linear scan in reality the properties of the vertical yoke coils, the yoke coupling capacitor and the collector load choke need to be compensated for. So in fact the current and transistor base drive voltage that is required, for a linear raster scan, needs to flare upwards toward the end of the scan. This is shown with the required waveform (red star nearby in the diagram above) in Sony's manual.

Sony achieved the upward curved waveform by placing *positive* feedback around the vertical output stage with the two components, C707, a 10uF electrolytic capacitor and R714 a 620R resistor. This feedback is not enough to cause the amplifier to oscillate, but resulted in the upward rise of current in an exponential like manner toward the end of scan time. The positive feedback also helped with a fast flyback.

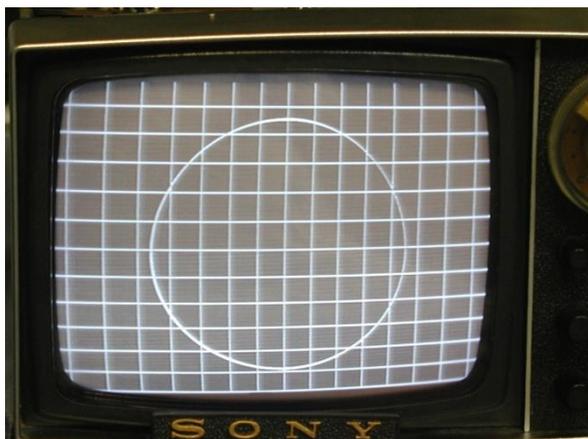
BEFORE

For the 2SC140 transistor, as Sony advised, it is capable of 1.75W *without* a heat sink, and in this case it has a heat sink and only runs warm to touch. Probably, there are some aging effects on this transistor over time. I do not want to replace it because of its historical significance. The result, of the before and after the Vertical linearity corrections are shown below:

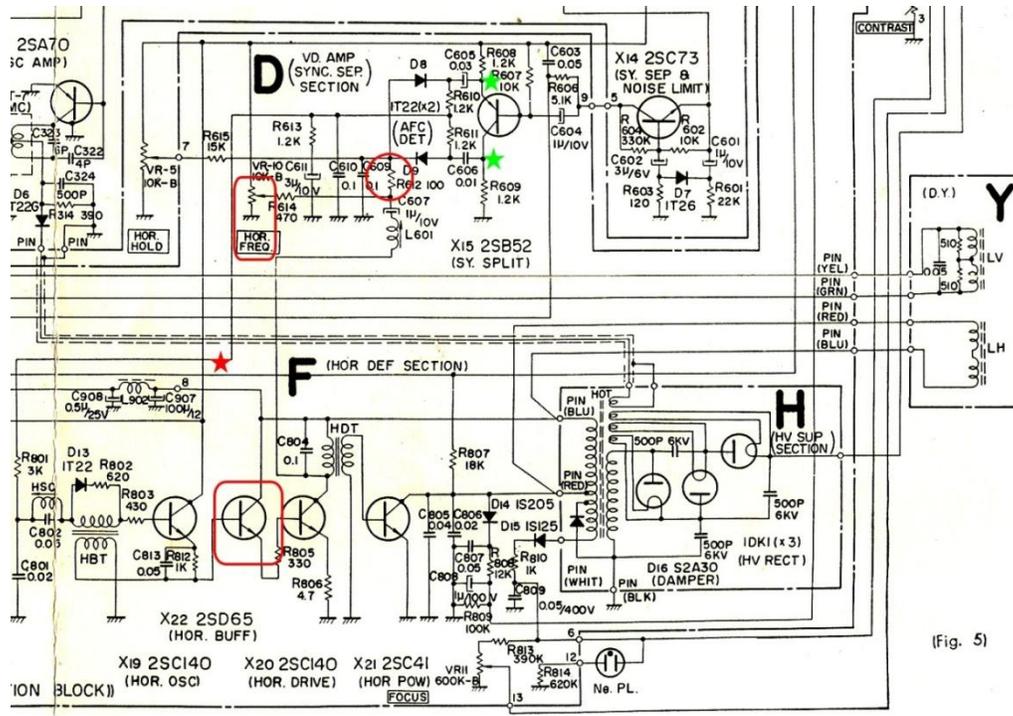
(Fig. 5)

Once the vertical scan linearity issue was solved, I moved onto to the Horizontal image instability and hold issues. To solve this problem was trickier than usual. There were three problems. The circuit, with some boxes and stars to help explain it:

I decided the better move was to break the loop (red star in the diagram) I fed a clean DC control voltage via R801(3k) to the H oscillator and watched the test pattern float by horizontally. The oscillator appeared very stable, certainly with no jitter in the frequency, so at least that part of the circuit was ruled out.

I also tried feeding clean syncs from the generator directly into the phase splitter X15, the fault remained. At that point I disconnected the two coupling capacitors on one of their legs on the output of the phase splitter (green stars on the diagram) using solder wick and a temp controlled soldering iron (helps to avoid any pcb damage, these old phenolic pcb's are very heat sensitive) The fault remained, so that ruled out the phase splitter transistor & its resistors and the two disconnected capacitors.

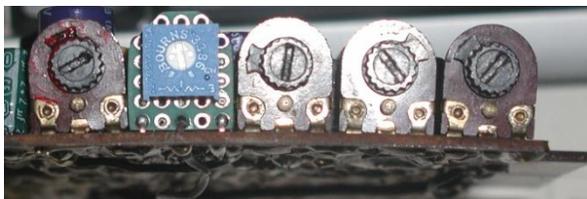
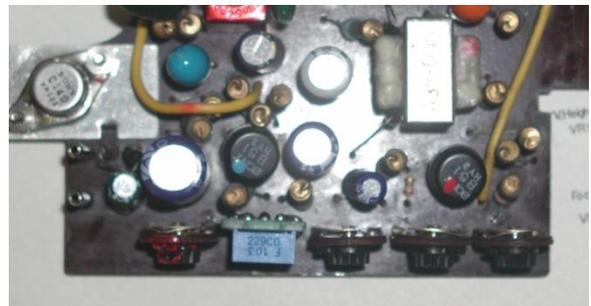
Firstly, on the simple side of things, the H.Hold preset was defective and at a certain point of its rotation, the resistance value suddenly altered (not corrected by cleaning). If it was set near that position, the resistance value was erratic. So this was replaced by mounting a modern 10k preset pot on a small piece of plated through hole spot board so as to mount it correctly:

Notice that the resistors are radial type to stand up off the pcb, most are 5% tolerance parts, all but one of these resistors in my set were in excellent condition.

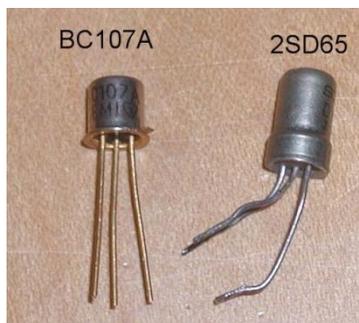
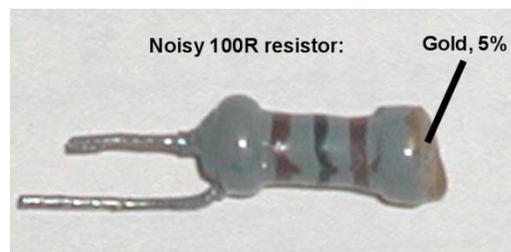
Secondly, the cause of the sudden massive change in horizontal frequency was very interesting. The Germanium NPN buffer transistor X22, a 2SD65 was intermittent, it suddenly loses its ability to buffer and the sudden loading on the H oscillator forced the scan frequency up very high to around 20kHz, well outside the capture range of the AFC.

I concluded that one of two things was happening to this transistor, either the collector connection inside the transistor was intermittently going open circuit, or the base to emitter terminals inside the transistor were being intermittently shorted out by a Tin Whisker for example. Both mechanisms result in the same failure to buffer. Of the two, I'm very suspicious that it is tin whisker disease, because I could not detect any voltage drop at all across the B-E connections at the time of the failure and one would have expected about 300mV.

A suitable NPN Germanium transistor replacement for the 2SD65 is an AC127. In this case though, since it is a switching circuit, not an analog circuit with specific bias requirements and the transistors around it are Silicon types, I simply replaced it with a high quality gold plated leg vintage BC107A. Normally though in signal process circuits I would replace a Germanium with an equivalent Germanium type, to avoid any other changes in the biasing.

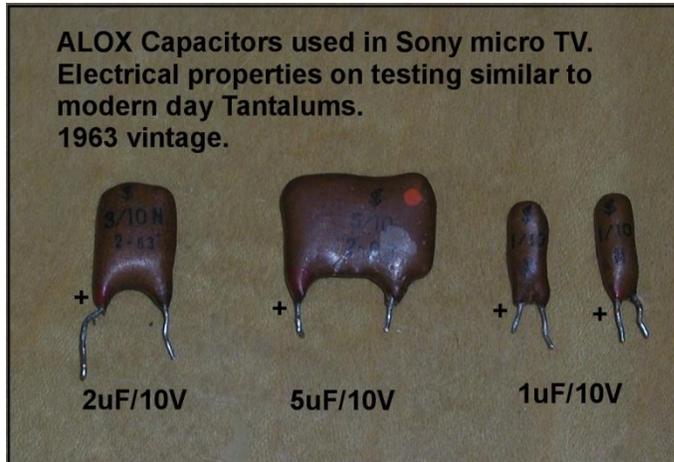
These capacitors are very interesting. They are potted in a brown resin, somewhat reminiscent of a modern day Tantalum capacitor, but they have a wax coating over the resin too. They appear to have a Logo I cannot recognise, it has some similar features to the Siemens logo, but it is not exactly the same, I copied it as best possible for the image below:

On testing the leakage properties of these Alox capacitors, they are very similar to a Tantalum capacitor.

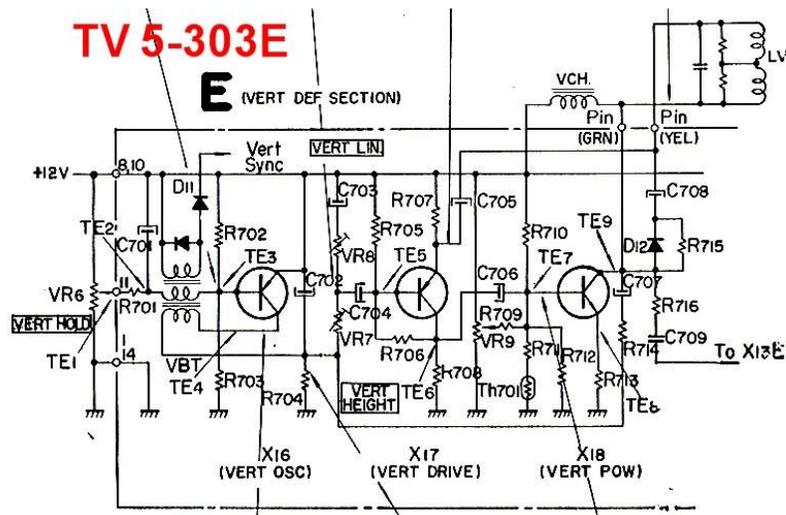
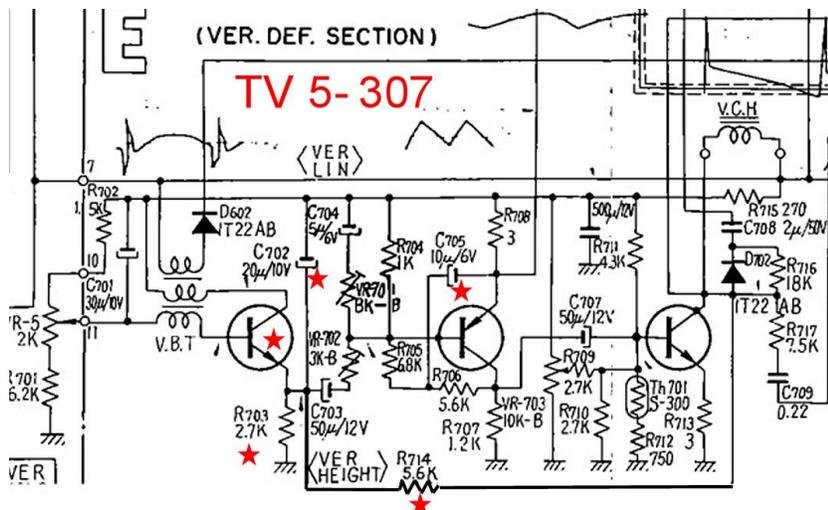
Sony modified the positive feedback loop design in the 5-307 (as I had to in my 5-303, but in a different way eliminating C707) and they went to a Silicon oscillator transistor and lowered the value of the sawtooth capacitor C702 from 100uF to 20uF and used a higher value charging resistor, 2.7k vs 330R. On top of this they modified the collector to base bias resistor R706 on the input transistor X17. Split now into two resistors with a 10uF capacitor to bypass the AC component off the negative feedback. This has the effect of increasing the signal AC gain of the input (drive) transistor X17. Also some other value & transistor type changes. The two circuits are shown below for comparison:

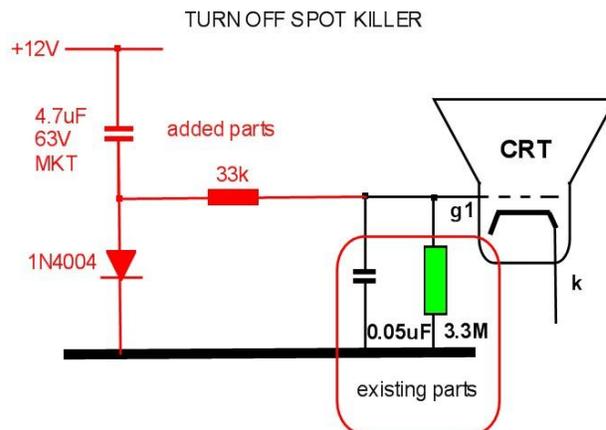
So for this little set, I added as I often do if it is not already there, a small turn off spot killer circuit. It simply works by charging a capacitor from the power supply via a diode. The impedance of this pathway is low so that if the TV gets turned of & on rapidly (or has a bad power supply connection) the capacitor charges very quickly. Then when the power is switched of, the TV’s 12V supply collapses fairly quickly to zero as it still has all the loads on it. This takes the diode side of the capacitor negative with respect to ground by about -12V at turn off, then after a while, the capacitor discharges via the 33k & 3.3M resistor. This creates a long duration negative voltage pulse at the CRT grid at turn off, helping to extinguish the beam current, especially if the user has not turned the brightness control down first.

These three components are simply mounted on the lower pcb connector pins where the existing 3.3M resistor and 0.05uF capacitor reside. There is plenty of room there.
