# RE-CAPPING THE ZC1-MK2.

Dr. H. Holden. July, 2020

## **BACKGROUND:**

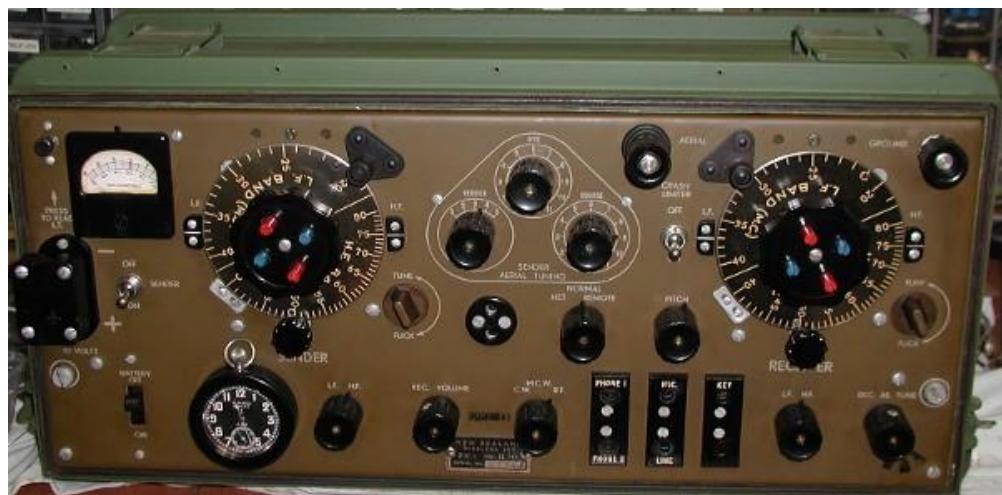
Below is a photo of my amazing ZC1 MK2 from my homeland in NZ, circa early 1940'a, which at that time cost 450 NZ pounds, or about \$40,000 in today's money:

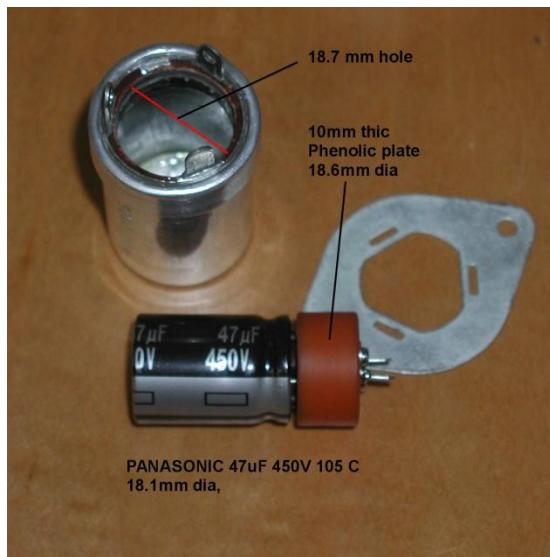
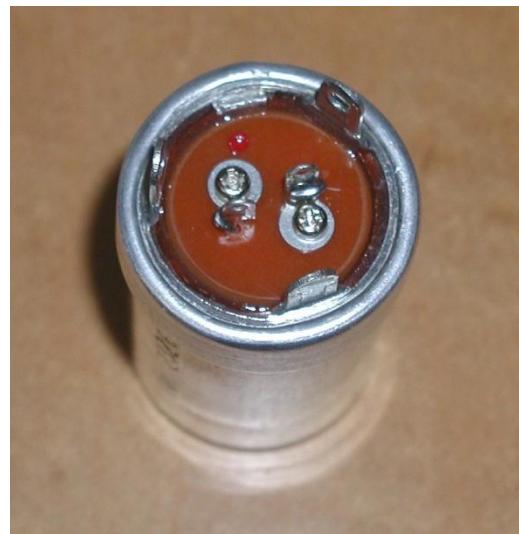
I generally start by machining out the base of the capacitor on the Lathe. If any Latex is found it must be discarded and the inside of the canister cleaned, latex can contain Halides which attack aluminium. The general principle of how I do this is indicated in the photos below. A 10mm thick plug made of phenolic material is machined to fit. And two 2.0mm metric threads are cut in the material for screws and lugs. Also holes are drilled beside those screws with a 1.0mm drill to pass the wires from the replacement electrolytic capacitors. The plug is glued in place with 24hr epoxy resin. Don't forget to label the polarity of the pins before it is assembled. I drill a small countersink and fill it with a dot of red paint.

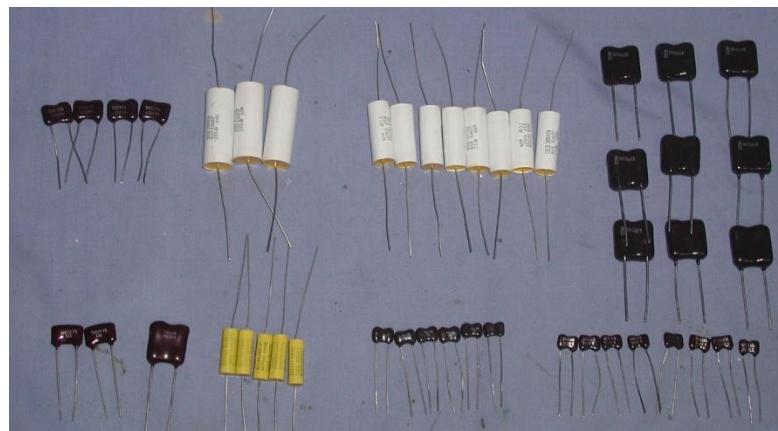
There are a good number of capacitors in the ZC1 on account of it being both a radio and transmitter. It pays to order what you require first. I use new resin dipped 500V Silver Mica types and for the wax paper types I replace with Polypropylene film and these are fitted inside the metal canisters.

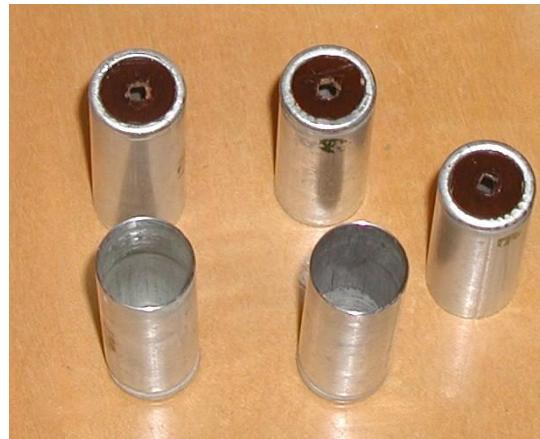
The photo below shows 5 of the cleaned out 0.1uF 400V capacitor canisters. Also the rivet and tag in the phenolic insulator is drilled out and discarded. I found these tags were in fairly poor order, the Brass being quite brittle where it was sharply folded and prone to cracking.

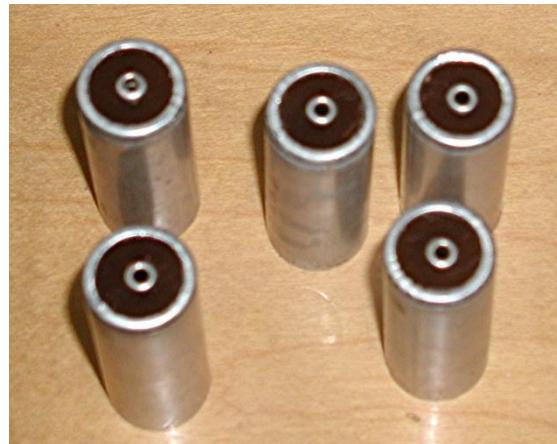
After that I fit 1/8" diameter silver plated brass eyelets in the phenolic end:

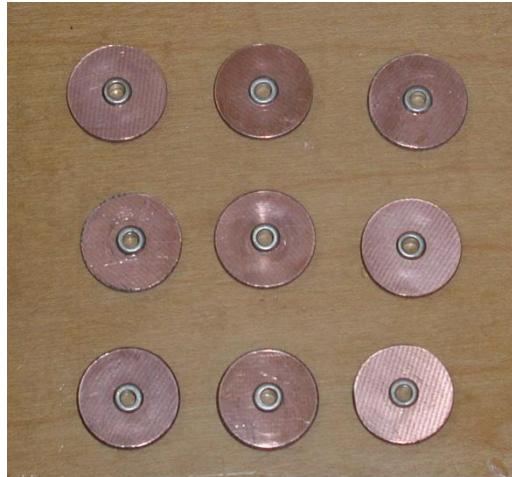
Then there is the issue of replacing the end of the capacitor which was cut off. A convenient choice is fibreglass pcb material. It is easily cut into discs using a 22mm diameter hole saw on the drill press. Then I make a 1/8" central hole and attach a screw & nut to secure it and rotate it, to machine the perimeter down to 16.8mm to be a close fit inside the end of the metal

canister. The photo below shows some of the discs. The same principles apply to re-building the 0.2uF can capacitors, except that I used a 25mm hole saw initially to make a larger disc. These discs are then also fitted with 1/8" eyelets:

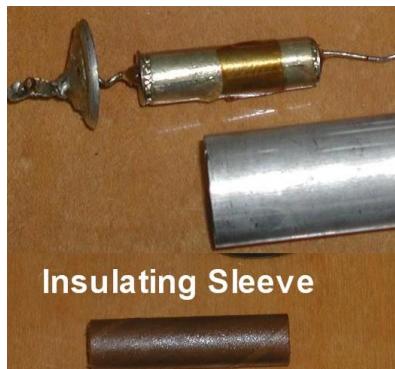
The 0.02uF types were clearly custom made by Radio Corporation with a brown paper tube over them inside the canister, also filled with wax. But they must have been running low on their own production because one of these capacitors turned out to be like Russian Doll, with a capacitor inside a capacitor. The photo shows the typical insides of the 0.02uF type with a plain brown sleeve:

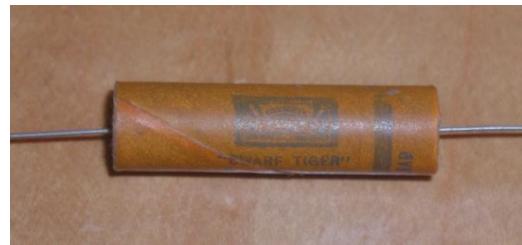
But just one of the four capacitors had a commercial 0.02uF 600V "Dwarf Tiger" capacitor hiding inside it. So I re-built this capacitor and inserted inside the metal canister just as it was before.

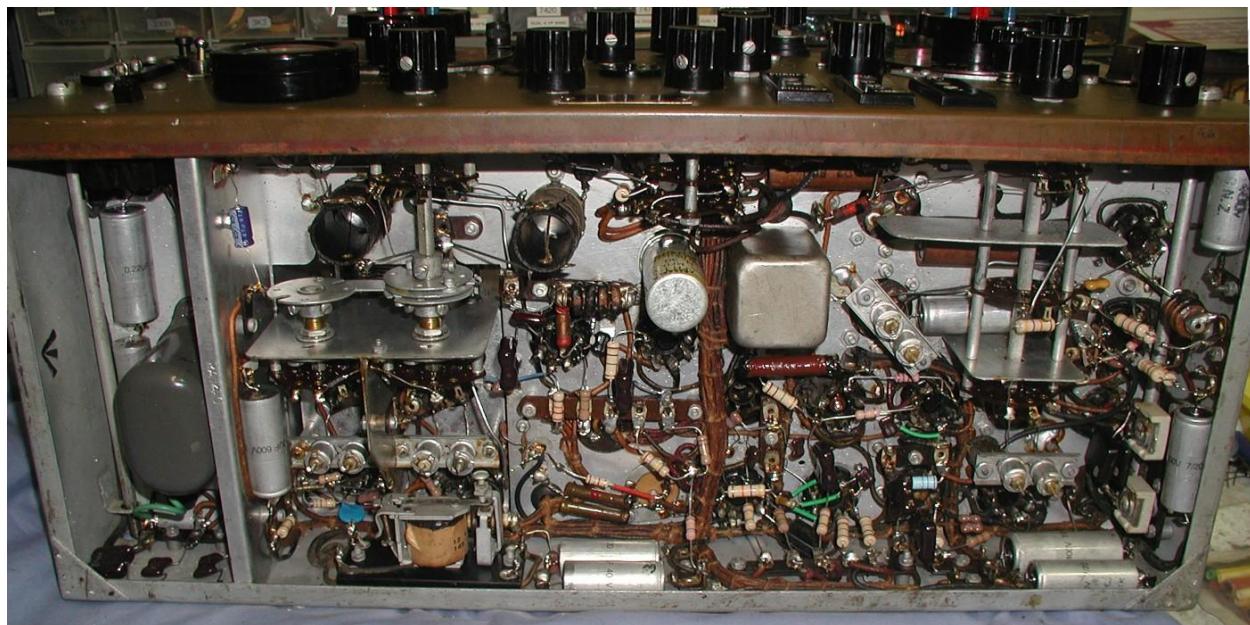
The photo below shows the underside of the ZC1 after re-capping. Of note nearly every carbon resistor except just a few in this radio, were way out of spec and I had replaced them in the past.
