SANYO's Amazing 8-P2 Tevelevision from 1962.

(H. Holden. July 2020.)

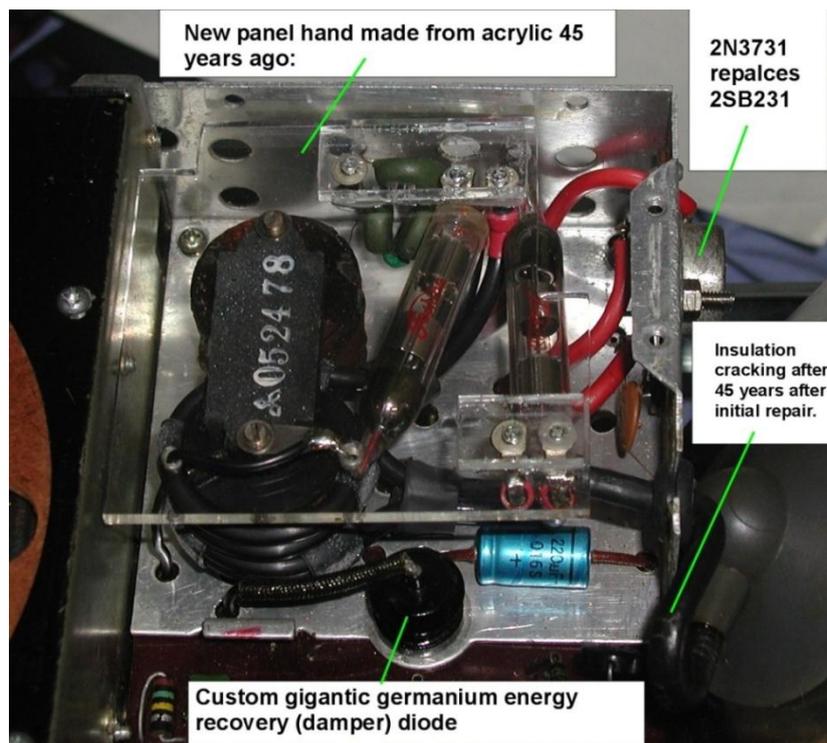
After a while the phenolic plate that supported the two tube EHT rectifiers became conductive with arcing on its surface. So to fix that I hand crafted a new plate out of acrylic, this repair is around 45 years old now and it still looks ok:

There appears to be a Mitsubishi Logo on the LOPT core in this set. Sanyo must have acquired it from them. It is the only place inside this set where this logo occurs.

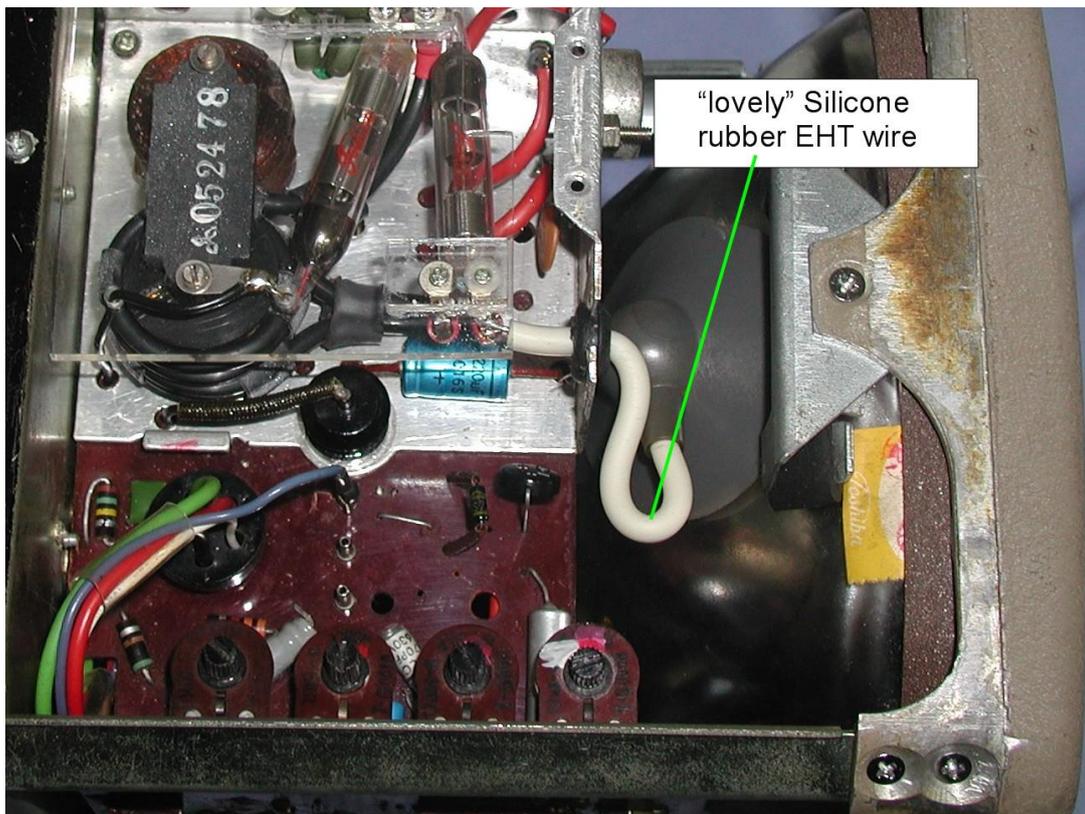
It is interesting that the rubber covered EHT cable, which I had replaced back in the 1970's has now started to crack, so I replaced it again, this time with very high quality white silicone rubber covered wire. As a teenager I did not have access to good wire like this back in the 1970's:

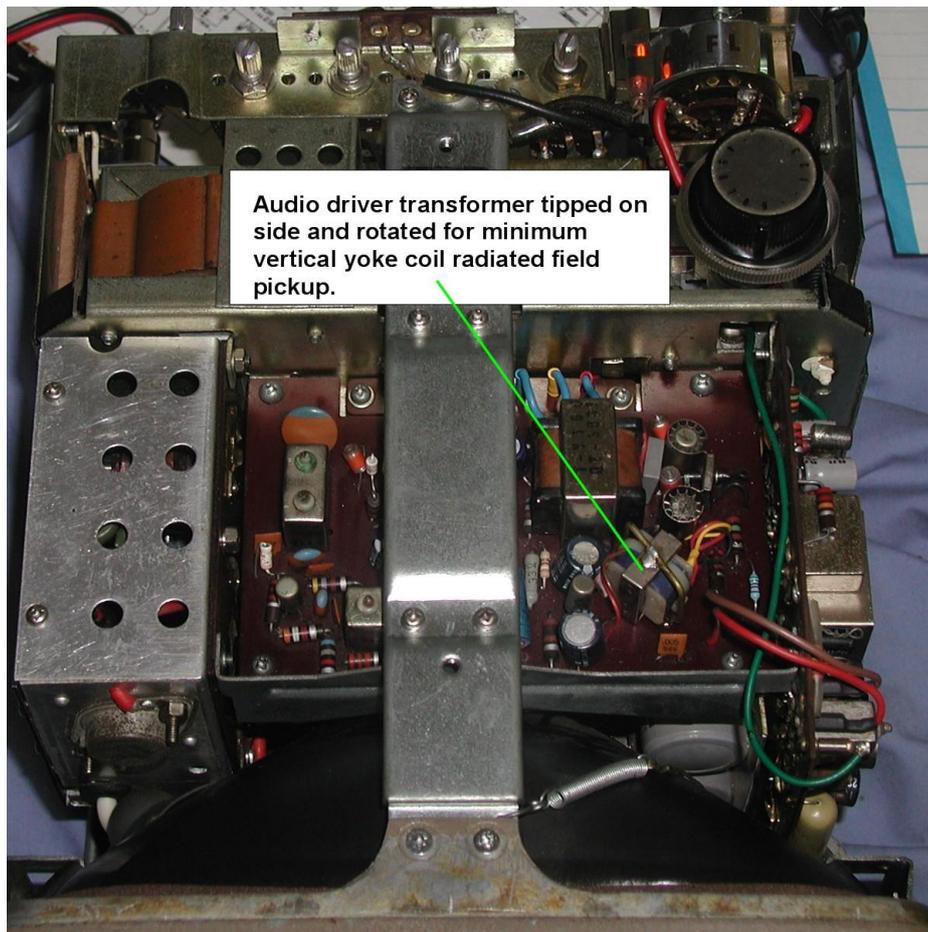
There was an annoying vertical buzz in the audio caused (after a lot of investigation) by the audio driver transformer core picking up radiated magnetic fields from the vertical yoke's coils. The audio amplifier and audio IF board being mounted fairly close to the yoke.

The designers must have been aware of this as they had the transformer at an odd angle on the pcb. But I found that by tipping it on its side and rotating it to a very specific angle I could reduce or null the interference to a very low level. So I fitted a small brass hoop on the old bracket mounting and soldered the transformer to the better angle. Of course later, when inter-stage transformers got abandoned in audio amplifiers, this potential problem also vanished.

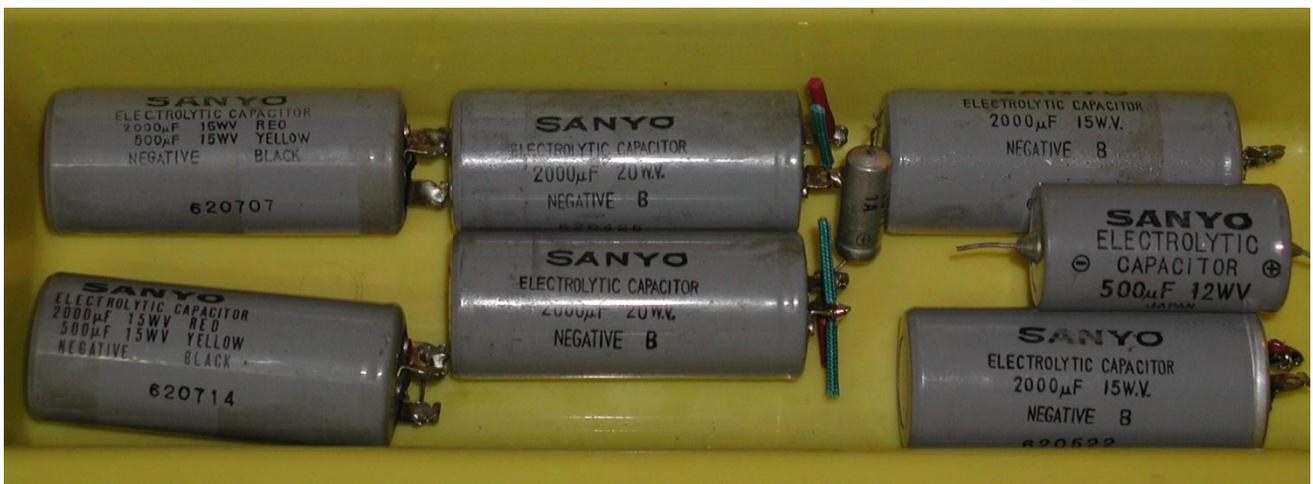
Photos of the old original Sanyo capacitors and they were fairly generous with the number they used. The set requires good filtering of the power supply as there is no electronic regulator for the 12V supply, merely a transformer and bridge rectifier when running from line power. The larger 500uF axial electrolytic in the photo is the Vertical yoke coil’s coupling capacitor.

The capacitors in the photo are very physically large for the voltage and uF values compared to modern day equivalents which have about 1/5th the volume or less.

The CRT required removal from the set to replace the 500uF 12V rated vertical Yoke coupling cap. I replaced this one with a 125 Deg C 40V rated 1000uF Rifa Automotive rated capacitor that will never likely need replacing. I replaced the 2000uF 15V units with 4700uF 80V Nichicon types. This was the closest I could find with a large enough 1" diameter canister size to approximate the original appearance. The extra capacity is not unhelpful running from line power and improved the noise rejection running the TV from a 12v switch-mode psu too.

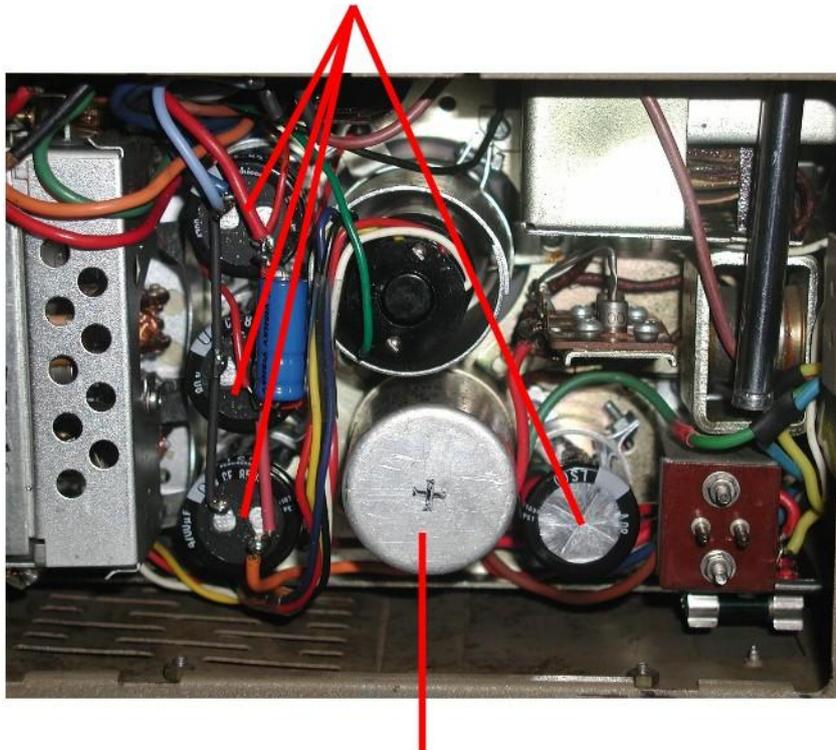
Replacement 1 inch diameter Electrolytic Capacitors

The photo below shows the replacement 1 inch diameter capacitors on the rear chassis. This is the view into the battery compartment. This compartment once held, of all things, a 12V wt Lead Acid cell, much like a small motorcycle battery.

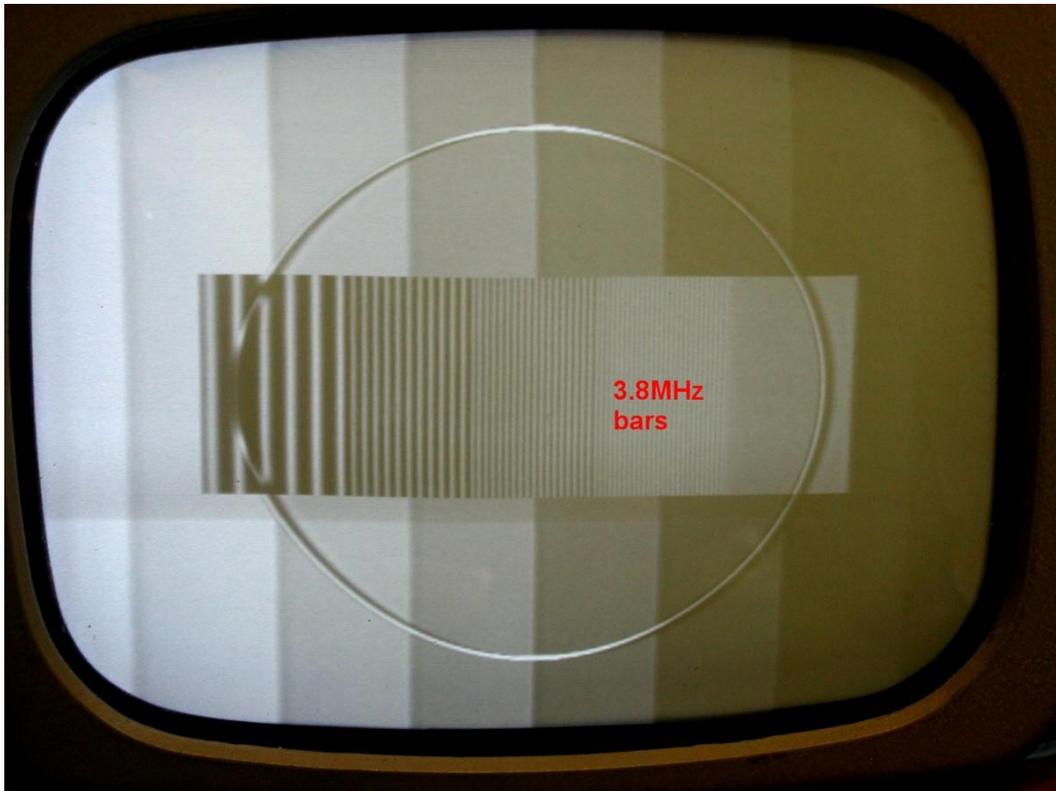
The high frequency video performance of this set is reasonable, the photo below shows when its tuned in properly the 3.8MHz bars are just visible, which is an adequate resolution for the 8 inch screen:

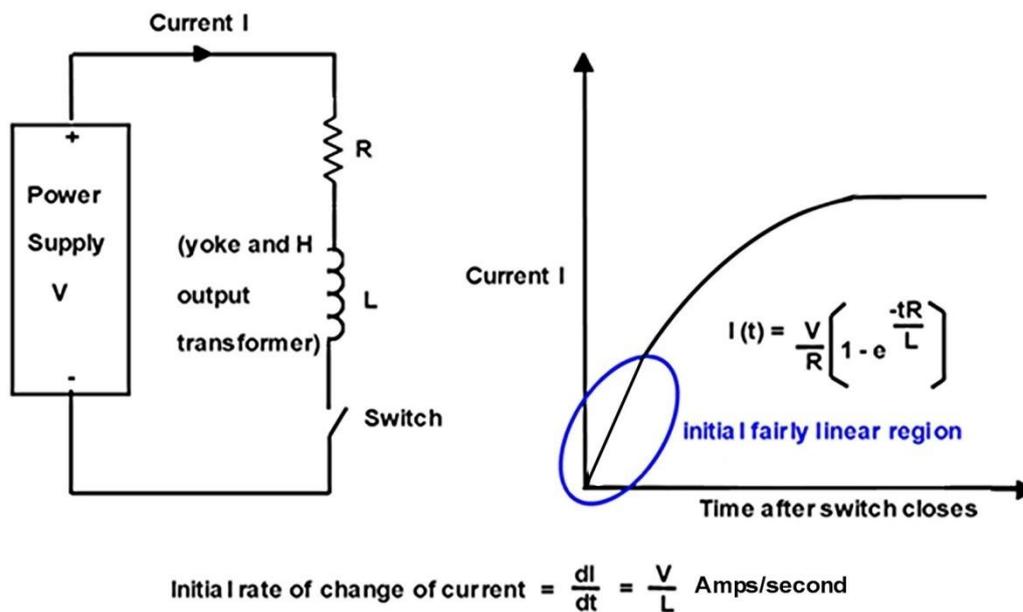
When a fixed DC voltage is applied across an L-C-R circuit, the current rises initially linearly with time and flattens off in the usual inverted exponential manner.

Initially at least, when an un-energized inductor is switched across a power supply, the rate of rise of current is linear and rises at a rate of V/L Amps per second, where V is the power supply voltage and L the inductance.

Notice that this very initial linear rate of current rise does not contain the variable R . The graph below shows these features:

The yoke's coils and the power supply for that matter are not free from resistance, so as time passes the rate of rise of current flattens off (in the usual inverted exponential form) and settles to a value of V/R amps and in this case the variable L has now vanished.

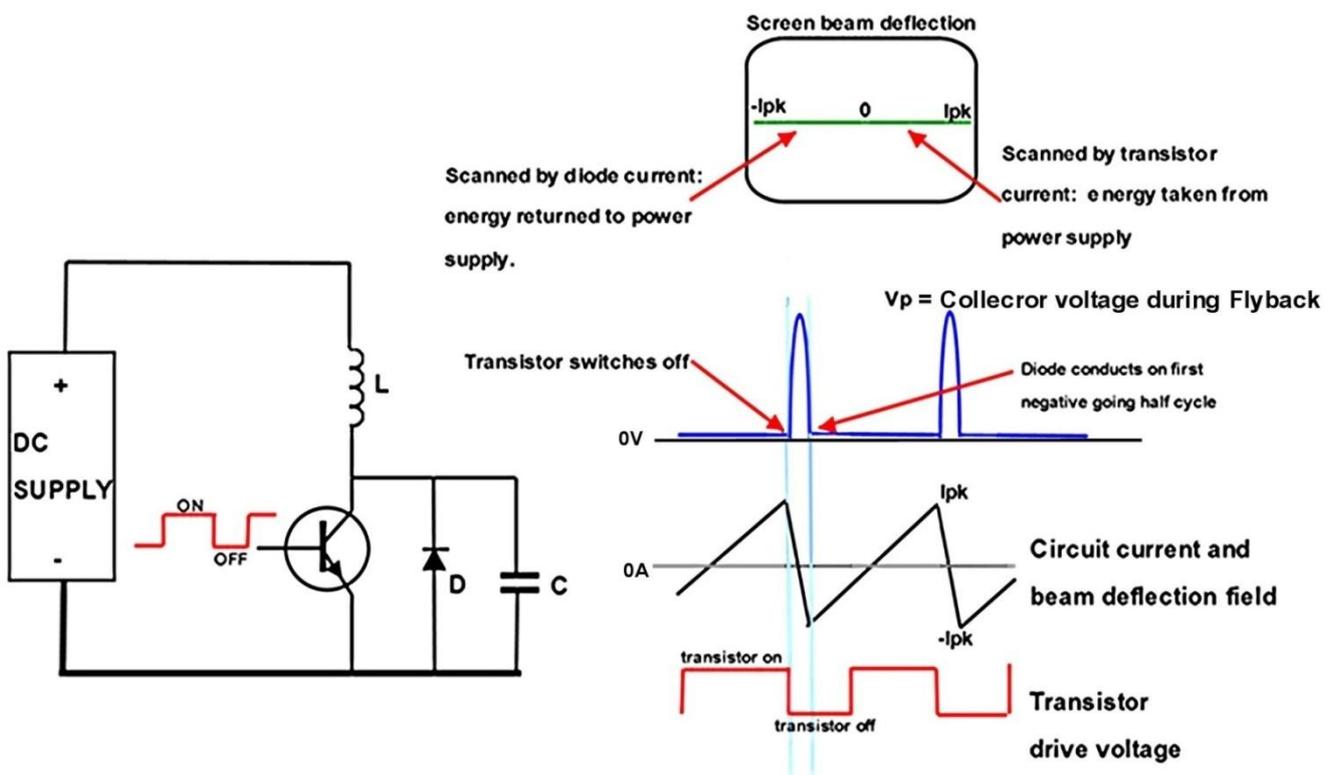
The diagram above shows a typical simplified Horizontal deflection system, with a switching transistor, a damper diode, an inductance L, representing the horizontal yoke coils and a tuning capacitor C, which tunes the flyback frequency, of which only a half cycle is seen.

The transistor's current scans toward the right side of the raster, the damper diode current scans the left hand side, the peak horizontal yoke currents I_{pk} and $-I_{pk}$ are indicated.

The idea is very old and is the basis of some modern SMPS power supplies. The stored *energy* in the magnetic field of the yoke and the associated horizontal output transformer, at the end of each horizontal scan line, on the right hand side, is given during flyback (initiated by the switch opening or the switching transistor cutting off) to the electric field energy of the tuning capacitor. All this energy is in the capacitor's electric field half way through the flyback pulse, when the voltage on the capacitance peaks.

At this point, half way through flyback, all the stored magnetic field energy has been given to the capacitances, the yoke current is zero and the beam at the CRT's centre position. The flyback voltage pulse is seen as a half cycle of high voltage oscillation on the transistor's collector terminal, over the flyback time of typically around about 12µs. These peak voltages can be in the range of 100V for a small monochrome TV and over 1kV in a large colour TV.

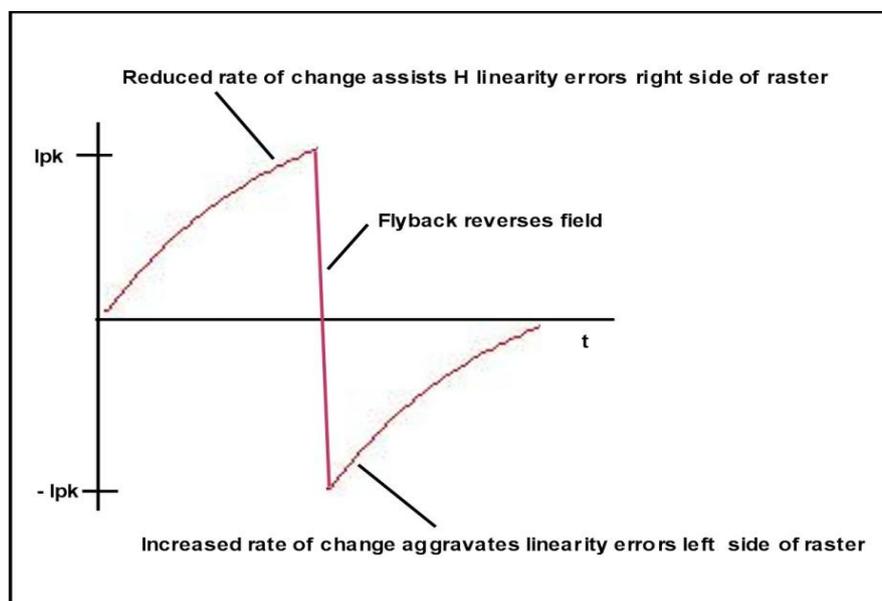
However, in this case, unfortunately, on the left hand side, the damper diode's current tapers off with time toward the scan centre, *starting with an initial high rate*, rather than having a tapered or lower rate of change at the start of the scan on the left hand side (which would be ideal to mirror the shape of the current wave on the right hand side). This effect aggravates, rather than cancels the Yoke's sensitivity issue for high deflection angles, as it does on the right side. The result is expanded linearity on the right hand side.

Therefore, without any *linearity correcting components*, the horizontal scan will have expanded linearity on the left hand side. The graph below indicates the features explained above:

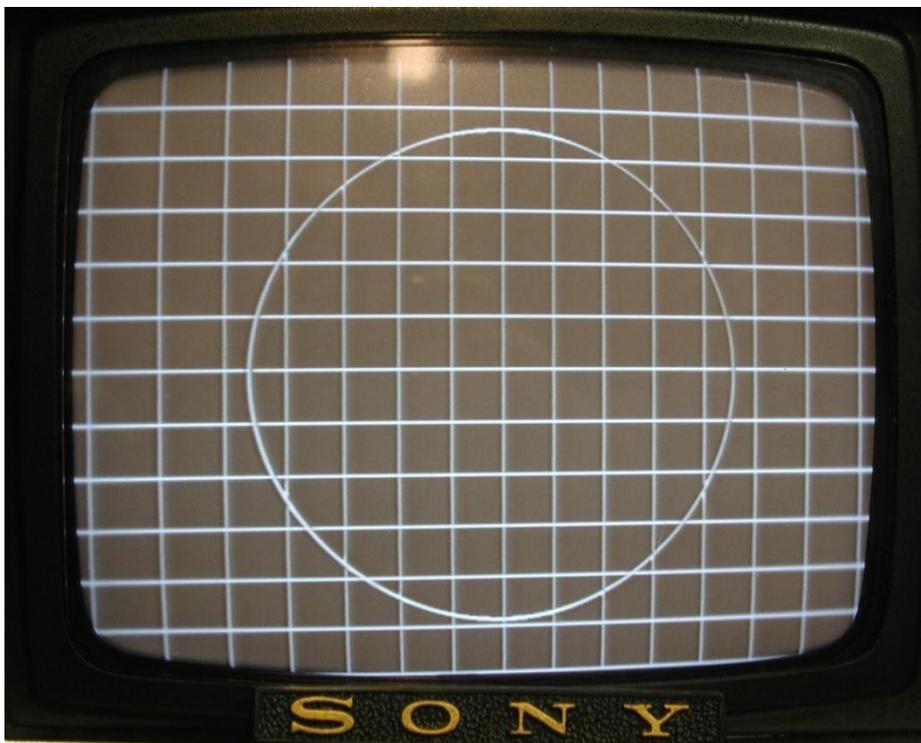
SONY 5-303E

The image below shows the horizontal linearity on the Sony Micro-TV, inspect the horizontal linearity very closely because:

The Sony Micro-TV makes an excellent case in point to study horizontal scan linearity issues because the horizontal linearity result it produces is devoid of any linearity correcting components (neither an S correction capacitor nor a magnetic linearity coil).

Its horizontal scan linearity properties show beautifully the intrinsic asymmetry of the linearity at the end of the line scan on the right with respect to the linearity on the left (as shown in the graph above) but on top of this it also demonstrates the deflection sensitivity issue with the yoke, showing the average central compression of the linearity, compared to the sides.

Close inspection therefore is expected to show, and it does, that the vertical lines are compressed together a little at the centre area, slightly expanded with respect to that on the right hand side and significantly expanded on the left hand side of the image.

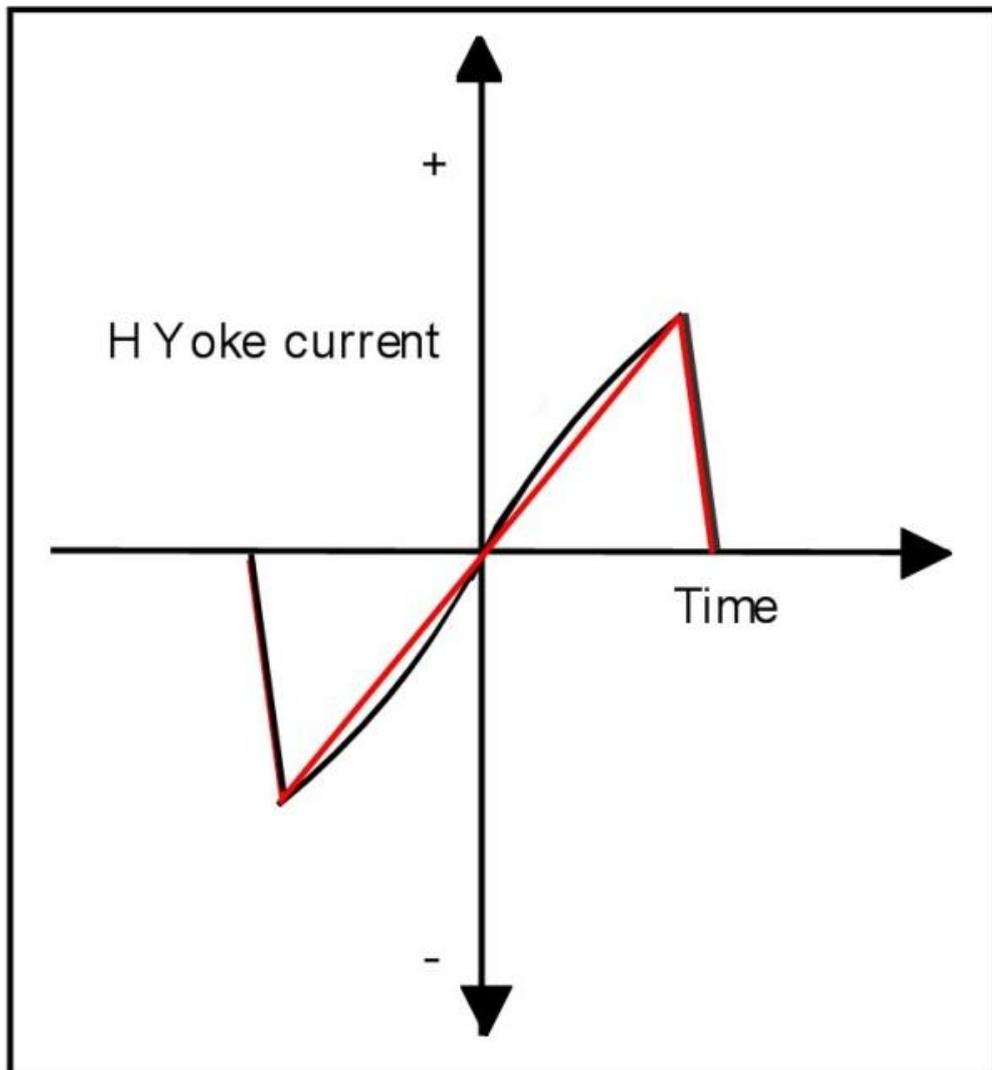
The effect of the S correction capacitor (black line in diagram below) when present, alters the linear yoke current (red in the diagram), if it was perfectly linear sawtooth current beforehand:

The S correction increases the rate of change of current with time near the centre of the scan, expanding the linearity there and compressing it at the right hand side and left hand side. One other advantage of an S correction (or another coupling capacitor) in series with the Yoke's coils is that it isolates any DC voltage present. This means that the return point of the yoke connections could either be to the 12V supply or to ground.

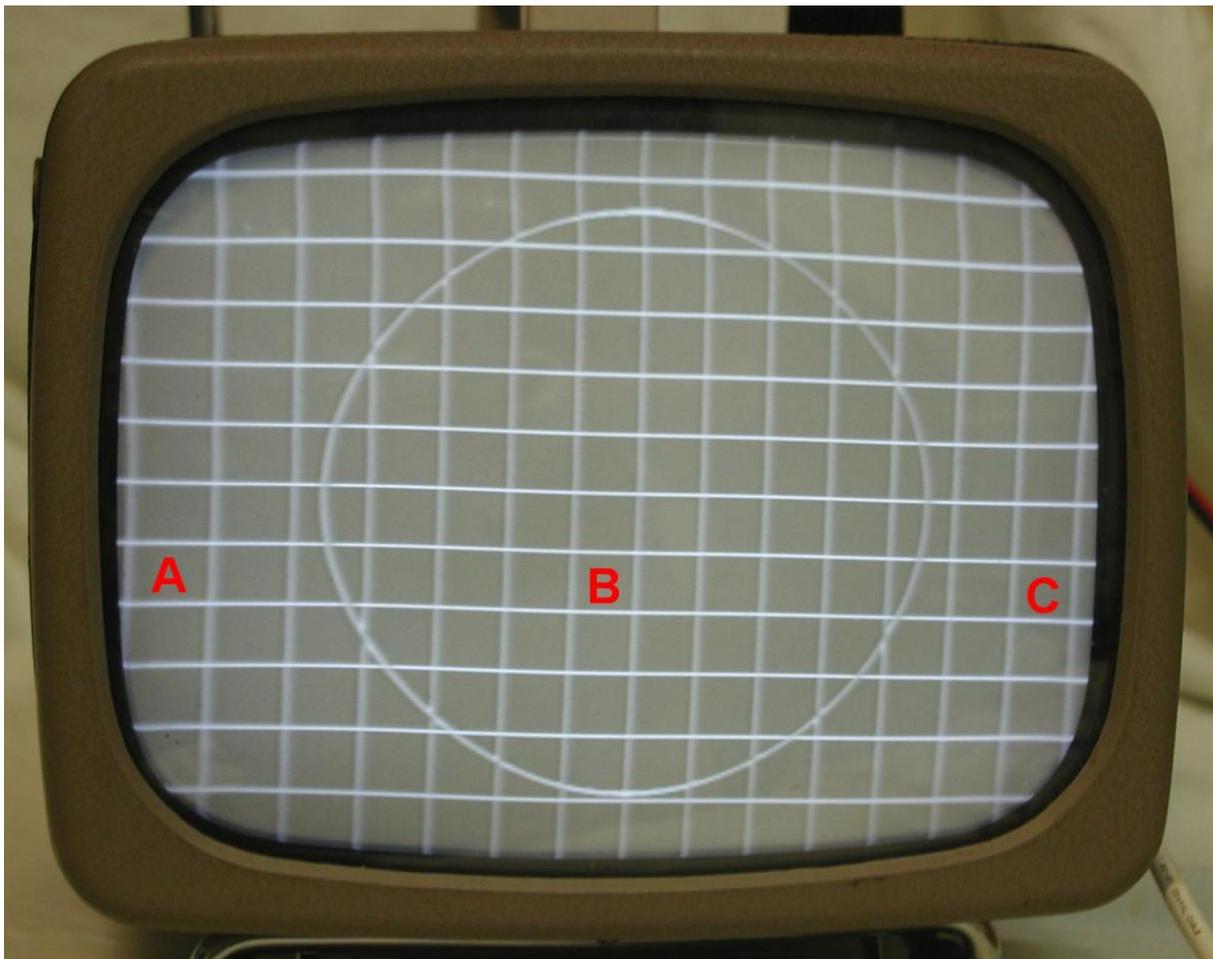
SANYO 8-P2

A photo of the linearity of the image on the Sanyo-8P2 with its S correction capacitor:

As noted here, unlike the Sony Mirco-TV, the horizontal linearity of the central area of the screen B, is very similar to that near the right hand side C (thanks to S correction), but still expanded in the region A on the left hand side, due to the magnetic field reversal and the shape of the current wave ae.

The left side expanded linearity relates, as noted before, to the shape in the current wave after flyback aggravating the linearity, rather than helping it and also another factor related to the circuit resistances.
