# IMMORTALIZING THE DALLAS DS1225 - ANOTHER APPROACH TO THE PROBLEM for 2465B SCOPES.

Dr. H. Holden. Oct. 2024.

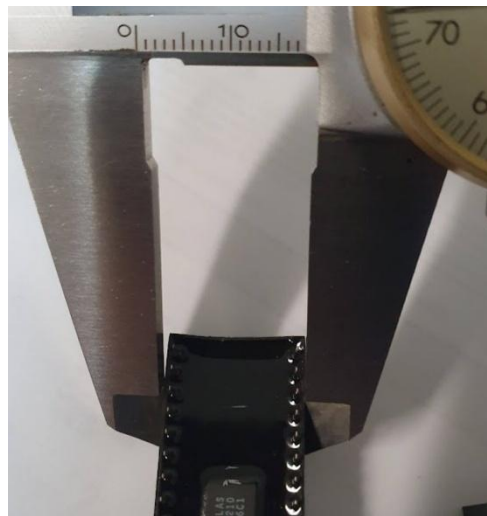
There is variability in the width, so it is measured and then the callipers reset to half the value found

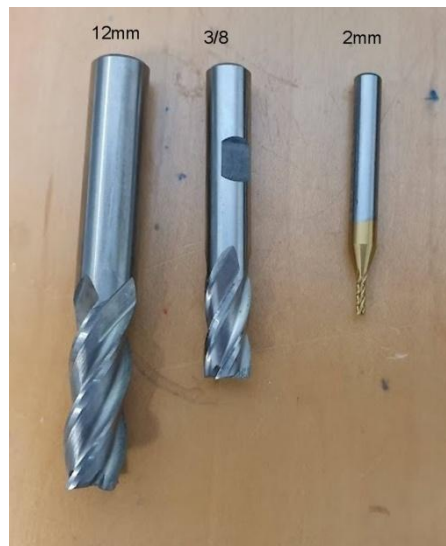
To complete the task the required milling tools are a 2mm diameter, a 3/8" and a 12 mm diameter tool, all readily available on ebay. Don't be tempted to substitute any other

sizes. For example, due to the variability of the exact battery position, and the internal anatomy of the battery, going from a 3/8 to 10mm size causes trouble.

Even though the battery is not exactly on centre, the 12mm milling tool must be, so as to avoid the pins on either side.

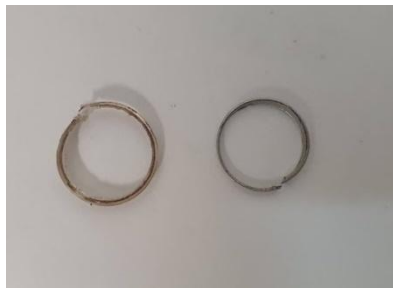
The inner ring needs to be removed because the internal diameter is either the same size or in some cases smaller than the donor battery at 10mm. Note: the inner metal ring cannot be removed by prizing it out, it must be split first. To do this the side of the 2mm tool is used to split the ring and just not quite tough the battery's positive outer shell. As soon as the metal ring is cut, it usually just jumps straight out of the shell:

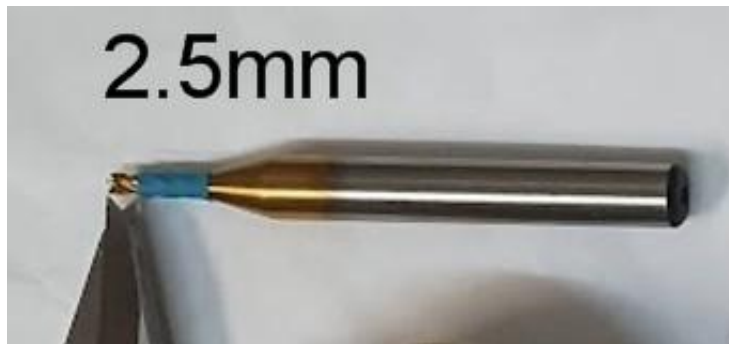
The Hole for a 2mm brass bush can then be made again aligning the centre with a small drill and using the 2mm milling tool.

Of note, the particular drill press might not be very accurate in advancing a tool or a drill to some specific depth. And it is important that the hole for the 2mm diameter Brass bush is not inserted more than 2.5mm below the resin's surface (which in the location the surface is close to 0.5mm below that of the control IC's top surface) it is better to apply coloured Heat shrink sleeve to the 2mm tool, so it is easy to see the depth, especially with a close up view with magnifying glasses and bright light while the tool is being advanced into the resin.

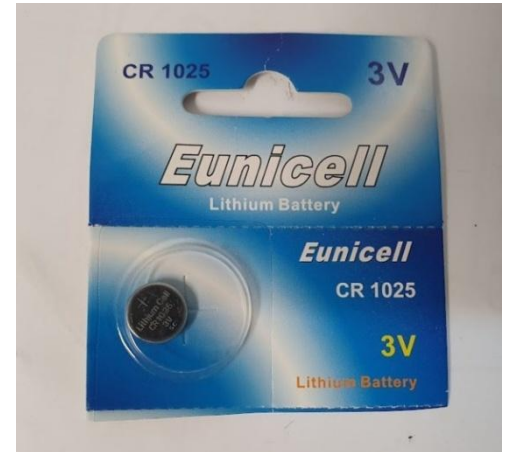
A very dark deposit will be found in the base of the battery's casing over the Collector Electrode. This electrode is spot welded with two welds to the battery casing (positive terminal) It is important therefore that the 3/8 tool, when it is used, is not advanced too far into the battery body or it can engage the electrode and tear it off. It is better left there, due to the thickness of the replacement battery.

The deposits on the Collector electrode, resembles Carbon physically, but it is Manganese Dioxide. It is completely insoluble in IPA and contact cleaners of any type. The way to remove it is with a stream of running water and a combination of tooth picks for the edges of the rectangular collector electrode and cue tips. It must be cleaned until no more black material appears on the cue tip. After that it can be sprayed with contact cleaner to displace the water.

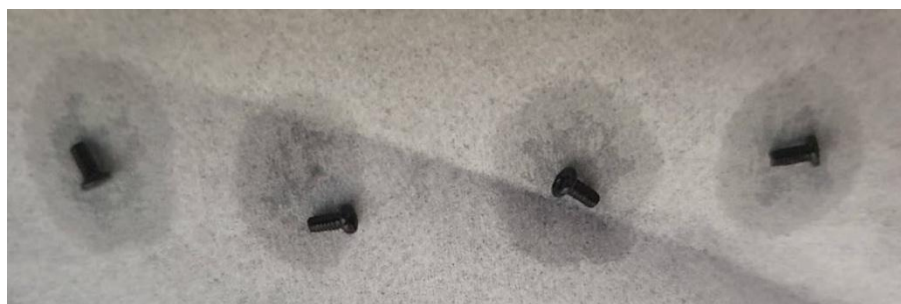
The screws are sprayed with Inox's MX-3 then placed on a tissue to remove the bulk of the lubricant:

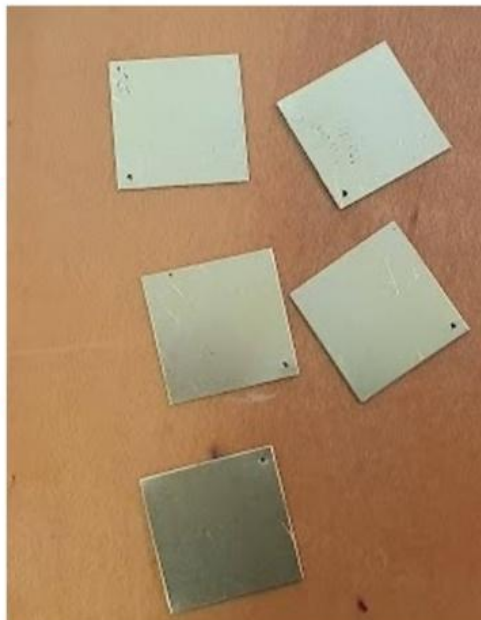
#### 0.5mm diameter corner hole

I made a batch of battery contacts to make five immortalized DS1225's. To make the thin spring contact, start with 12 x 12mm squares and make the corner (0.5mm diameter) hole first:

### K & S Metals 0.005" Shim Brass

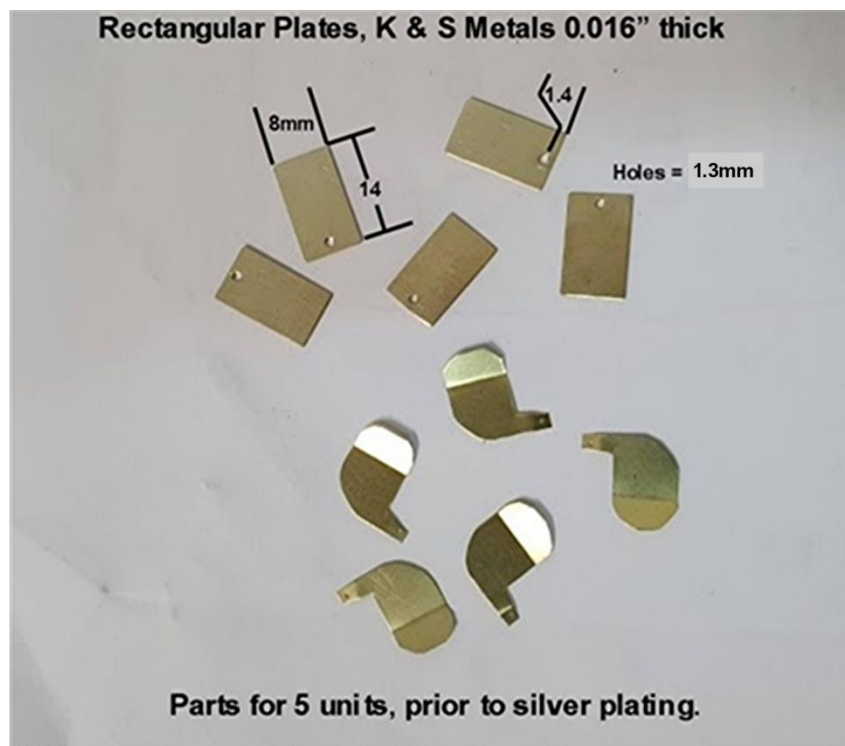
The second required piece is merely a strip of 0.016" thick Brass with a hole for the screw:

Some small low angle bends are placed in the battery's terminals as shown in the photo.

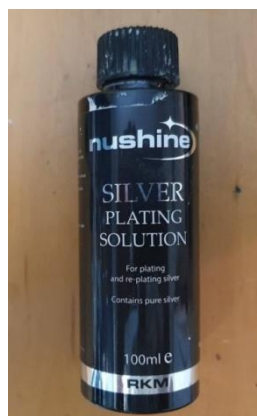
One issue with brass, it tends to be fairly reactive and tarnishes over time. One solution would be Gold or Nickel plating at the electroplater. I elected to use a product popular with the British for Tea Post restoration. The solution is rubbed on with cue tips and Silver plates the Brass without the requirement of an electric field. It is available on ebay.

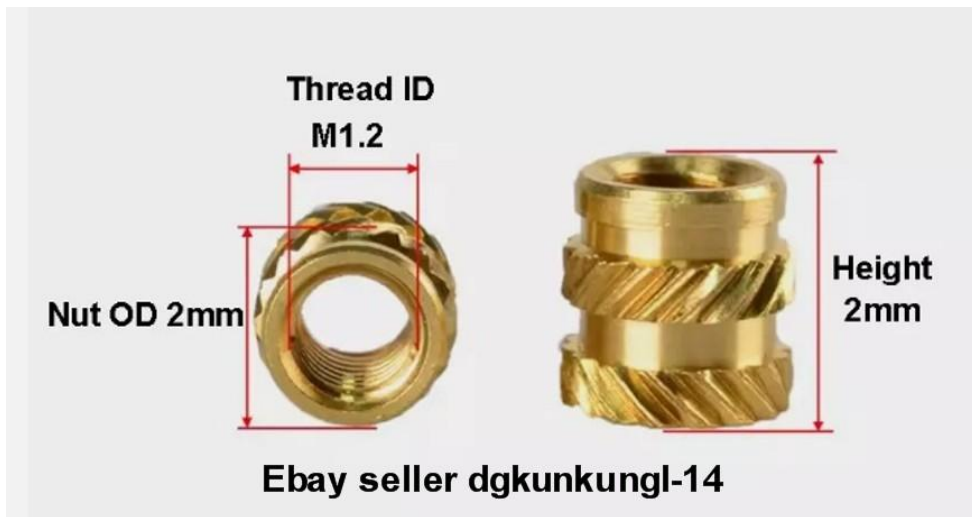
A closer view of the brass insert:

It is important that the hole depth, below the resin surface does not exceed 3mm under any circumstance, because the pcb inside the unit sits at about 4mm below the top surface of the control IC, which sits proud of the resin surface by about 0.5mm.

Therefore a hole depth, below the resin surface of 2.5mm has its base about 1mm away from the pcb surface inside the module. This is satisfactory clearance. If the pcb surface is drilled into, there are tracks there and it destroys the module.

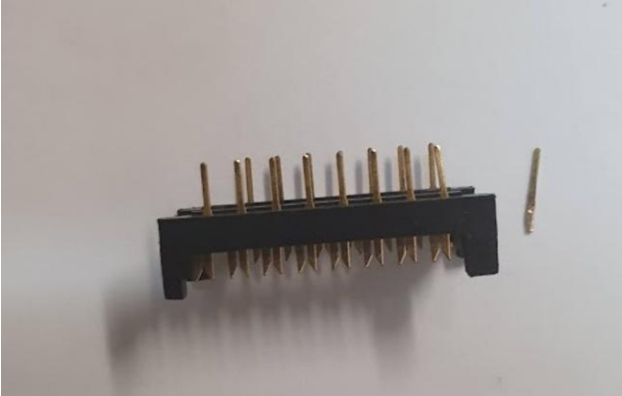
Once the short section of tube is placed around the broken pin, a donor pin can be added. It is important that the donor pin has the same geometry as the one you are replacing. In this case close to 0.26 x 0.48mm. I found some pins on a plug assembly extracted one and cut it down to make a donor pin.

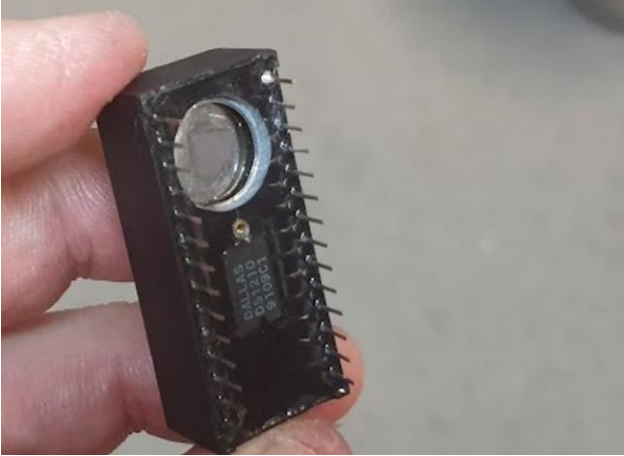
The pin is then slipped into the hole inside the section of Brass tube, adjacent to the broken pin, and soldered. This is the better way to repair a broken pin on a DS1225:
