## THE TAYLOR-WILSON PET COMPUTER UNIVERSAL PRINTER INTERFACE

#### A Reverse Engineering & Restoration Project.

Dr. H. Holden. Oct. 2022

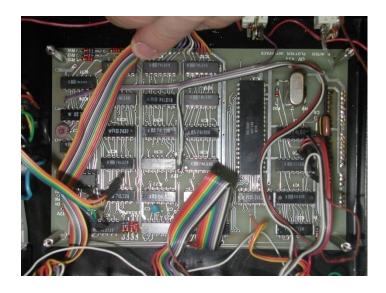
One thing initially, which complicated the study of the PCB, was that it was hard wired into the housing. The ribbon cables joining the PCB to the rear panel connectors were soldered directly into the PCB. It was not possible to unplug anything to remove the pcb from the housing.

Also, the same applied to the power supply PCB, which sits above the main PCB. It was hard wired in making access nearly impossible. This was modified by adding 0.9mm gold plug-socket connectors for individual wires and "connector arrays" for the ribbon cables.

Since the plated through holes in the main board were only 0.6mm diameter where the ribbon cables were connected, they could not receive standard sized header pins for a connector. This required the use of some 0.55mm Gold header pins and a "custom connector" manufactured from some IC sockets and some PCB material.

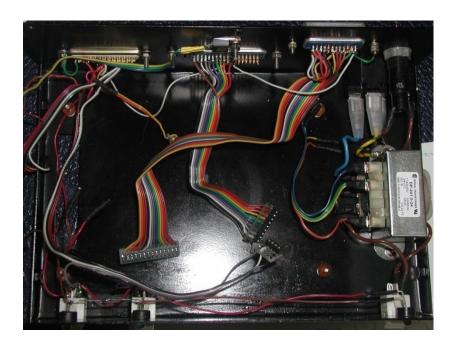
The image below shows all of the plug fittings added and the PCB's removed. Of note, the power transformer in this unit has been replaced by me. The original was, in fact, inadequate, but not faulty. This is explained in the section on the power supply nearer the end of this article. Later I plan to re-solder and sleeve the connections of the wires to the rear panel connectors, which were not sleeved by the manufacturer and appear messy. Also note the exposed wires on the LED's and the somewhat messy wiring (See article end).

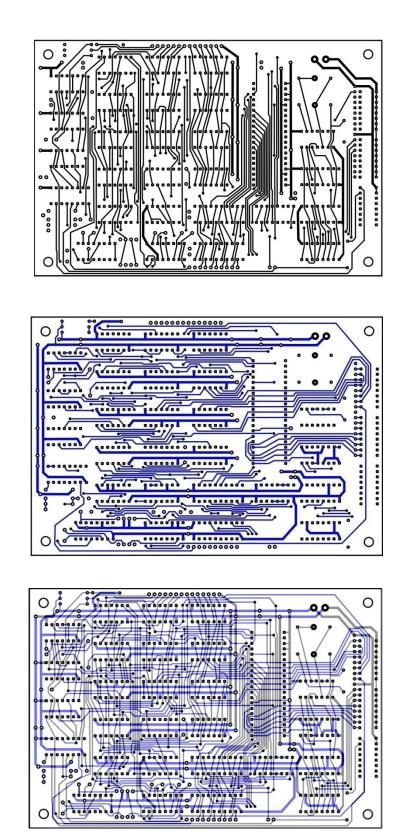
## 3) MAIN PCB FOIL PATTERNS AND LAYOUT:

Тор

Bottom

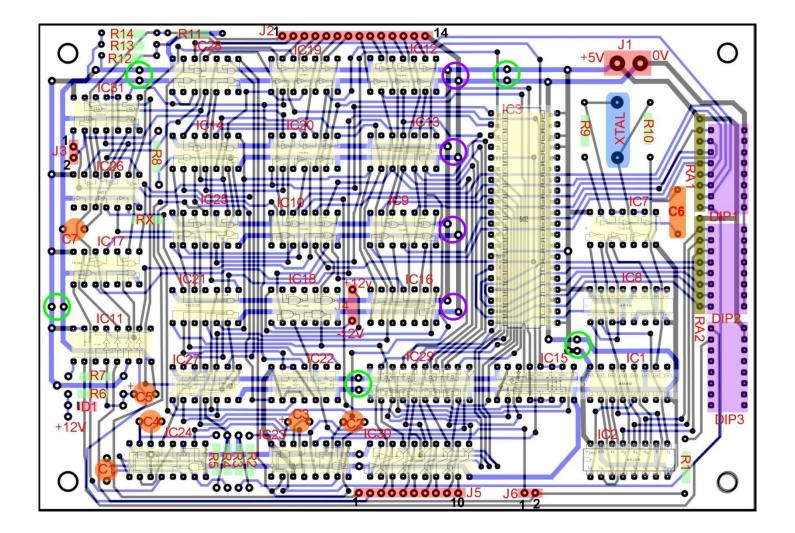
To enable rendering of the schematic from the PCB foil pattern, I used a modified type of component overlay image. I pasted in the IC's internal logic diagrams where possible. Then I had it printed out (by commercial printing company) to a size about 4 times the surface area of a piece of A4 paper. This made it easier to initially draw out the schematic by hand on paper and then later draw it as a tidy image on the computer.

One peculiar oddity with this pcb, it does not contain a single 0.1uF bypass capacitor on its 5V IC power rails *not a single one* despite 28 IC's ! This is very unusual in my opinion.

Four capacitors could be added to the original board, shown where the existing PCB via holes are, within the purple rings on the diagram above. I decided (some nerve) to modify the PCB design and I added the holes & pads shown inside the green rings, which are not there on the original PCB, where 0.1uF ceramic capacitors could (probably should) be added. So that there are at least 5 bypass capacitors for the 28 logic IC's, but even that doesn't sound very generous.

I addition I had to name what were now "PCB Connectors" with numbers J1 to J6 and assign them pin numbers. The connector J1 is the 5V power input and the holes here fortunately were large enough to fit the standard 0.9mm diameter Gold pins and single socket connections (from Jaycar Electronics). The same type of pin & connector were added to the power supply PCB.

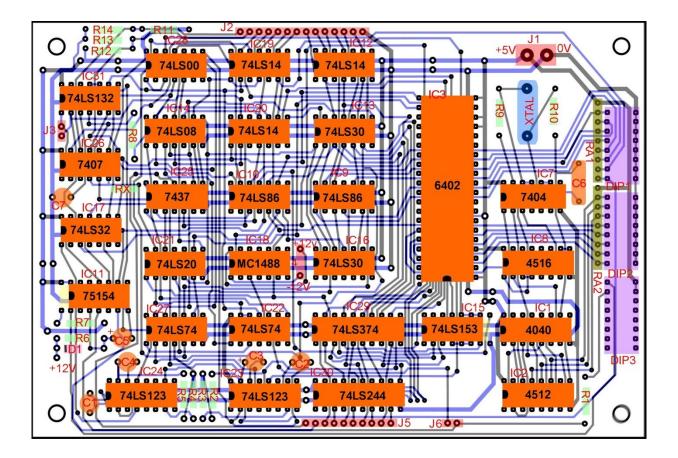
The following diagram makes the IC type numbers easy to identify:

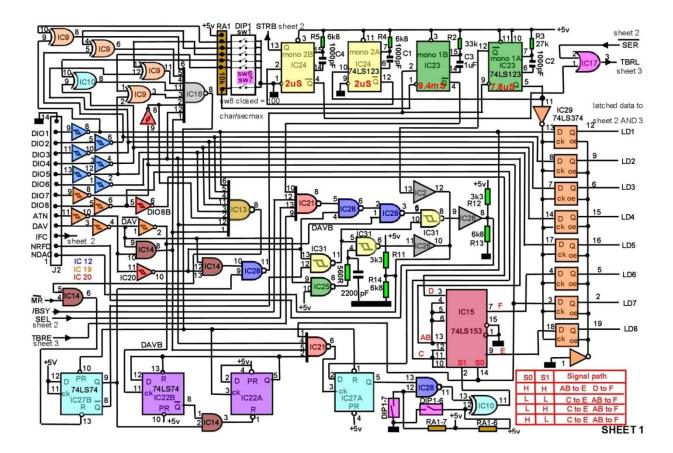
## Sheet 1:

This shows the main circuitry. The circuit operations are discussed in the section on operating theory. I added a small table here in Red, lower right on the diagram of sheet 1, to indicate the signal flow via the 74LS153, IC15. This part of the circuit is in charge of the PETSCII to ASCII conversion.

The 14pin array (now a connector now labelled J2) leads to the GPIB panel connector on the rear of the unit. A later diagram shows which pins are which in that connector. The switches sw-6 and sw-7 in the DIP switch block DIP-1 are located in the circuitry below IC15.

Essentially there is a nest of gates in the central part of the diagram which have three basic modes of operation depending on; 1) receiving addresses 2) when data bytes are transported to the output latch and 3) when the unit is in a "not ready" state. This "gate array" is supported in its operations by four Flip Flops and four Monostables or "one shots" the functions of all of these will be explained in the theory section.

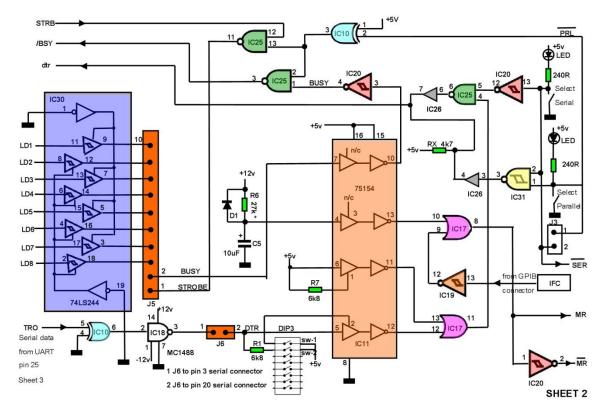
## Sheet 2:

This schematic contains the power up reset circuitry, the logic for the parallel and serial front panel select switches and the connection to J6. This connector connects to the RS-232 serial connector on the rear panel of the unit.

The connector J5 leads to the Printer connector on the rear panel of the unit.

Of note there is a significant issue with the value of R6 (27k), hence the \* near its label, which was evident in conjunction with the issue involving the inadequate power transformer. This is discussed on the section about the power supply. When I first received the T-W unit it was not working due to an interesting combination of circumstances, explained later.

One interesting thing happened; the low voltage (11V) on the 12V supply rail "unmasked" a borderline condition in the Reset circuitry, where one might not have expected that a change from 12V to 11V should have made any difference at all. As noted in the power on reset circuitry, on sheet 2, the value of R6 is 27k (as T-W fitted to the pcb). This must either be an error of design, or the wrong resistor fitted at the factory by mistake. There are no values marked on the board, so this is quite plausible. Possibly the original value might have been 2.7k and a 27k got fitted in error.

With the +12V rail slipping down to 11V, the logic level at pin 4 of IC 11, the 75154, did not quite reach a logic high for the IC. It was determined that the IC was normal (replaced with another) and the 10uF capacitor not leaking. The +11v & 27k combination was simply not providing enough current to get the IC's input pin to threshold, if the supply voltage was 11V and not 12V.

Because the UART remained in reset, this explained why there was no serial data coming out of the UART. I regarded this condition as a little "marginal", even with the 12V regulator issue fixed, so I reduced the value of R6 to around 13.5k, by simply paralleling another 27k resistor with R6. Although lowering the 27k to half its initial value halves the time constant of the power on reset pulse, it is still long enough to perform a solid power on reset. If there is any concern about this the 10uF capacitor, C5, can simply be increased to 22uF. In this location it is better to use a Tantalum capacitor than an Electrolytic type too, as they have lower leakage.

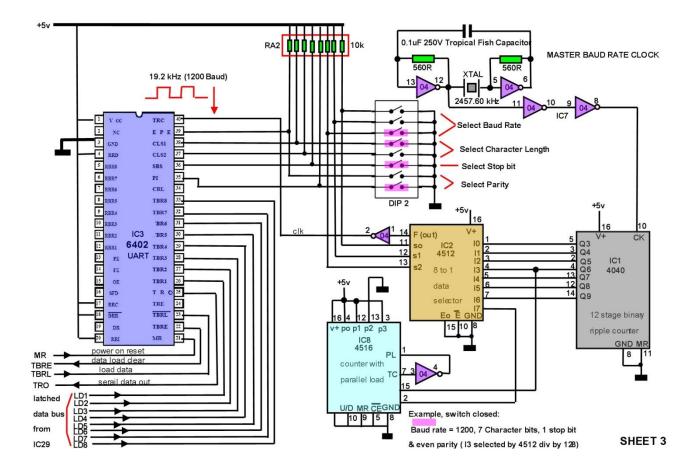
#### Sheet 3:

The UART's Baud Rate control circuitry has been very nicely done and is far superior to an RC based oscillator.

"Tropical Fish" capacitors (if anyone is unfamiliar with them) are a type of decorative looking striped film capacitor made by Mullard in the UK and have very brightly coloured stripes and resemble Tropical Fish, so they acquired this "nickname" in popular electronics culture.

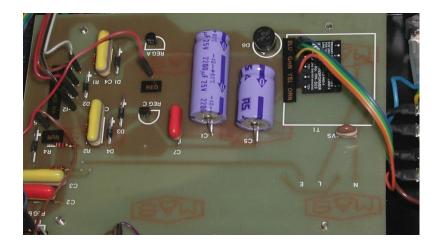
The power supply board in the W-T unit sits on top of the main PCB, spaced away from it by 1" long spacers. Also, there is a 1/8" thick grey PVC plate separating it from the main PCB. The PVC plate is screwed to the spacers and the power supply board is attached to extra screws on the PVC plate, which are separated from the spacers. Probably one reason for this was that in some cases, instead of the line power transformer being screwed to the chassis, it was a 6W rated PCB mounted transformer, RS part number 196-303 seen on a label on the PCB.

Previously, all the wires were soldered directly into the PCB, before I fitted the single pin 0.9mm Gold connectors to allow the wires to be unplugged and free the PCB.

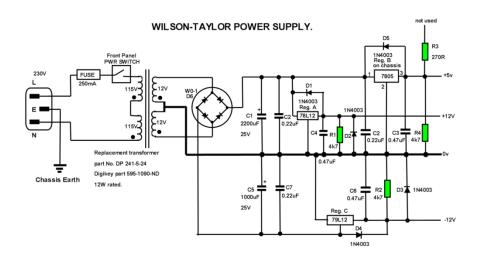
Of note, the electrolytic capacitors have RS logos too (like the IC's) and there are high voltage rated Tropical Fish capacitors, much higher than required. Perhaps there was a surplus of these capacitors at the time. The circuitry is very straightforward to generate the +5V and the +12V and -12V supplies. The +/-12V supplies are required for the serial interface only.

Of note: The 0v connection of the power supply (common) was not connected to the metal housing (chassis and line power Earth). I changed this by removing the mica insulator under the 7805 regulator and screwing the regulator's tab directly to the chassis. The reason for doing this is explained later.

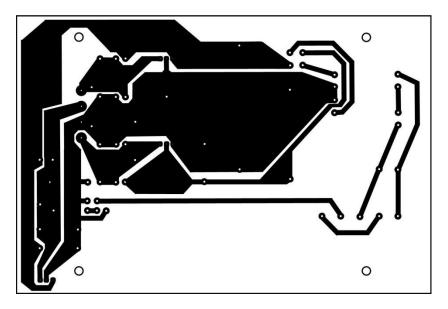
As can be seen, the power supply board is single sided. This image shows the track-work as if one were looking through the top of the board:

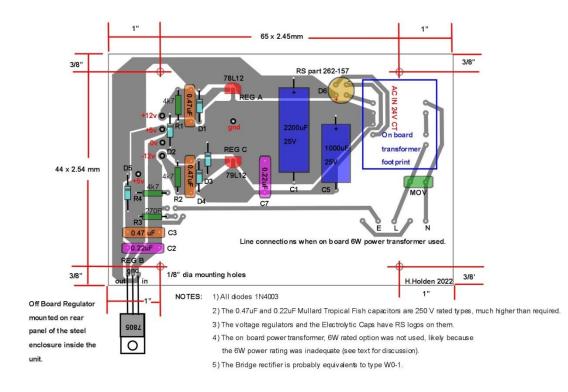
The diagram below shows details of the PCB's geometry and component overlay and some additional notes:

I found, that running the unit here in AU, that there was a problem with the +12V supply. The reason was that the DC input to the +12V regulator was too low to allow the 78L12 regulator to regulate properly.

It was quickly determined that with a 230V line power input (that I what have here) and with the loading on the transformer via the 5V regulator, supplying the 28 IC's, the transformer's secondary voltage was too low for the 12V regulator's input. The output of the 78L12 being about 11V and the regulation had failed.

I replaced the power transformer in the T-W unit with the Digikey 12W rated part and this solved the problem for two reasons. One being that it has a much lower internal resistance (about 3 Ohms per 12V winding) and its voltage drops less under load and two, that its primary windings (in series) are designed for 230V, being 115V each. Probably the original transformer had a primary designed for 240V I suspect. This solved the voltage regulation issue, however:

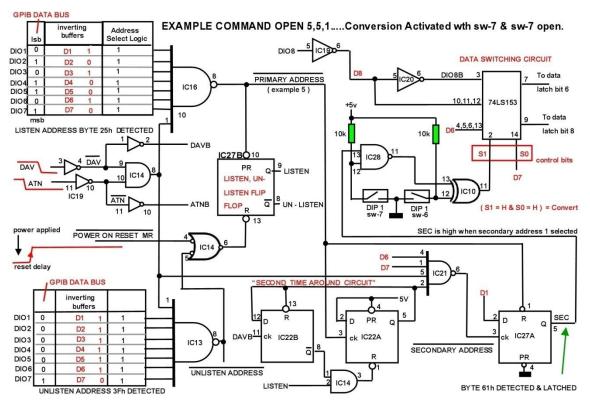
## FIGURE 1.

There is some very interesting circuitry here involving data reorganisation & switching. The data bytes making up the contents of the text message and how these bytes are transferred from the unit to its output connectors is explained. Unlike the C-M printer adapter units, the T-W unit has an 8 bit output data latch. This 74LS374 latch is used to drive a 74LS244 buffer for the Printer output data and is used to feed the UART's data input pins too.

Figure 1 above is a start to look at the circuitry involved in the primary and secondary address decoding.

If the primary address placed on the bus, in this case byte 25h matches, then the output of IC8 pin 8 goes low, this is the /PRIMARY ADDRESS signal. It sets the flip flop IC27B pin 9 to logic high into the "LISTEN" condition. And pin 8 of this flip flop is goes low.

(The flip flop IC27B stays in this Listen state until all the data bytes are received , passed through the unit to the Printer or terminal and until the Unlisten byte, 3Fh, is transmitted by the PET and is received and detected by the T-W unit. Unlike the Print# 5, "some message" example for sending data to the T-W unit, the CMD command does not transmit the 3Fh, so the unit remains in the LISTEN state. This is useful for LISTing BASIC programs. IC 13 is configured to recognise the byte 3Fh and this causes pin 8 of IC 13 to go low, resetting the Listen-Unlisten flip flop IC27B, via IC 14's pin 5 input & 6 output).

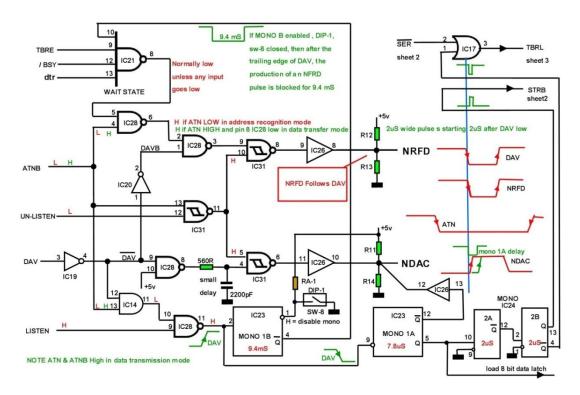
FIGURE 2.

The circuitry in this initial **addressing mode** is fairly simple, when the ATN line low, shown as the red logic levels on the diagram of Figure 2 below.

When ATN is low (and signal ATNB low), during the recognition of the primary and or secondary address, some of the gating that is operational when data bytes (message content) are being sent is disabled. In this "address receive mode", the DAV signal passes to become the NRFD signal in a non-inverted form and to the NDAC in an inverted form. However, in the NDAC signal case, there is an added small time delay for the NDAC signal, acquired from the 560R & 2200pF RC network shown in Figure 2 below on pin 8 of IC28. In this "address receive mode", none of the monostable one shot generators are active (triggered) because pin 11 of IC 28 is stuck high due to the low ATNB signal:

In the case that the primary (and or secondary) addresses are specified and the ATN (and ATNB) signal goes high (shown in green H in figure 2), then the T-W unit is ready to receive the message byte data. The LISTEN line is high. The DAV signal passes via IC 19 pins 3 & 4, IC14 pins 12 & 11, IC28 pin 10 &11, to trigger the Monostables. The Monostables are one shot pulse generators. IC23 pin 2 is strobed and responsive to the DAV line going high (IC23 mono 1B responds if enabled by DIP-1 sw-8). When DAV goes low (mono 1A responds).

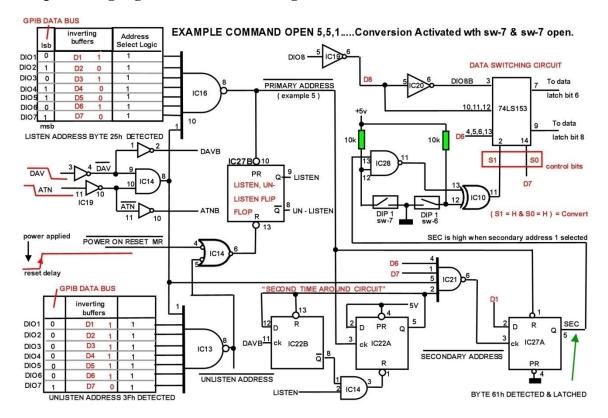
FIGURE 1. (again)

#### Re- presenting Figure 1 to avoid scrolling back to it:

Since the /primary address line going high, clocks IC22A, which then releases the reset on IC22B *after DAV has already gone high*, then IC22B is not in a condition soon enough to respond or be clocked by the rising edge of the DAVB signal during the end of the primary address handshake.

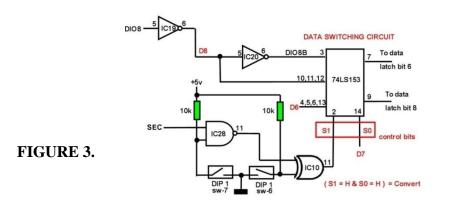
Figure 3 below repeats the circuit fragment:

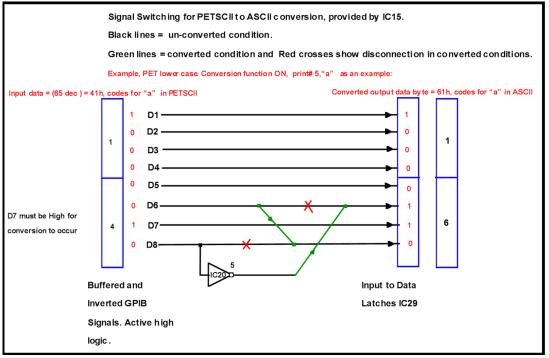
FIGURE 4.

Figure 4 below shows the two conditions of conversion, versus no conversion achieved by the condition when D7 is high and the conversion enabled by SEC (secondary address of 1 specified in the OPEN command).

In essence data bit D6 is disconnected and routed out as data bit D8.

Data bit D8 is "disconnected" and it is signal inverted by IC20 and routed out to replace data bit D6.

The example below indicates that a PETSCII lower case "a" (code 41h) gets converted to code 61h which is ASCII lower case "a". With this conversion in operation, with the PET in the lower case mode, both upper and lower case letters appear correctly in the ASCII receiving system (such as a modern computer terminal on a serial link connected to the T-W unit instead of a printer).

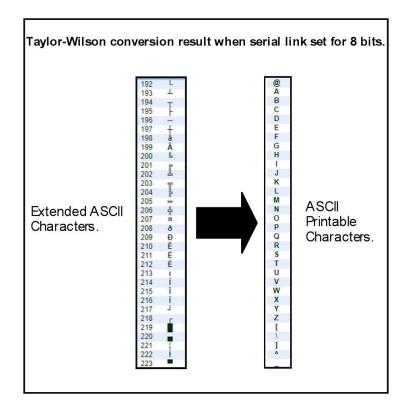
However, with the T-W's PETSCII to ASCII conversion running, these come out as upper case letters:

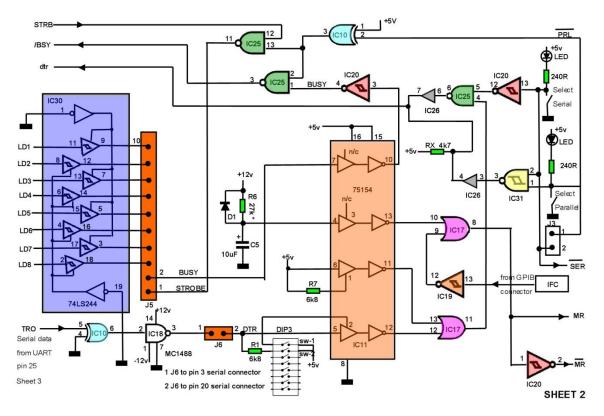
Serial Printer & Parallel Printer modes. These are selected by the front panel switches. Looking at sheet 2 again:

The two front panel select switches select the unit to interface with a parallel or series printer. Both connectors are provided on the rear panel.

In the case that the Serial switch is closed, this illuminates the LED above it on the panel. This takes pin 5 of IC25 high and this allows the signal from pin 2 of connector J6 (which is pin 20 of the RS-232 panel connector = **DTR**) to pass via IC17 pin 12 & 11 to pin 4 of IC25 and then to pin 6 because it has undergone two inversions. So pin 6 assumes the logic state of DTR. This signal, via open collector buffer IC26 pins 6 & 7 create the **dtr** signal, which is responsive to the signal on pin 2 of J6 and 20 of the rear panel serial RS-232 D connector.

However, *if neither select switch is on*, IC 31's in 3 output goes low and the low generated in IC 26 pin 4 causes **dtr** to go forced low. This activates the wait IC28 (output pin 8). So the default state with neither of the front panel select switches closed, the T-W unit cannot respond to the PET because NRFD is inhibited and stuck low. The command OPEN 5,5 Print# 5, "some message" for example causes the PET to hang, because after the PET puts data on the bus, it checks if NRFD is high, if low, it goes into a waiting loop, prior to setting DAV low. I would think that the logic behind doing this was to alert the user of the T-W unit, that something was wrong when neither of the printer panel switches were selected.

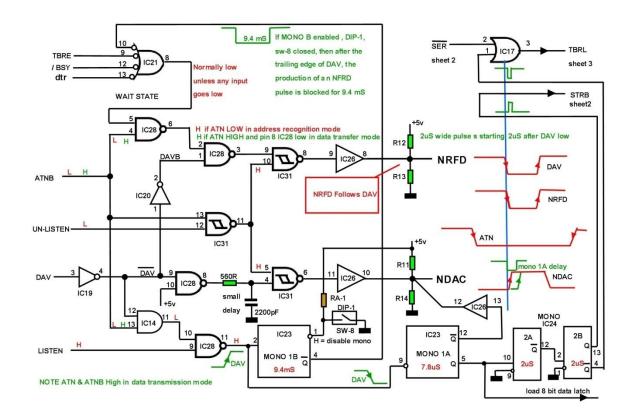
Repeating Figure 2, but with IC21 drawn in its De Morgan equivalent:

The Logic levels of note when the ATN and ATNB line (buffered ATN) is high, in data transfer mode, are shown in green.

When mono 1A finishes it 7.8us pulse, the NDAC signal is released and goes high. The PET detects that the NDAC has gone high (indicating the T-W unit has accepted the data). The pet then asserts DAV high, which would cause NRFD to go high too, unless any of the wait state lines feeding IC21 were low, not allowing NRFD to go high.

TBRE is possibly low for a clock cycle, at 1200 BAUD that could be up to 52uS. Since this causes IC21's pin 8 output to go high, this disables the NRFD (holds it low) for at least this time period, even if DAV has already gone high. So during this time, the T-W unit cannot accept the next new data byte because it is not ready for new data.

In addition, if the serial output data from the UART, has started to near over-fill in the buffer in the printer, the **dtr** signal (as noted before) falls low. This takes pin 13 of IC21 low and its output high and this also disables NRFD going high, until that condition is resolved.

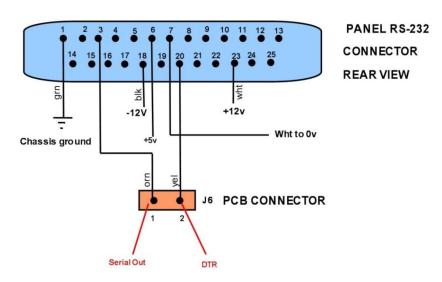
As noted these were done with multi-coloured ribbon cables. It required that these be unsoldered from the PCB and some connectors made to be able to free the main PCB from the unit for examination.

Notice how T-W applied the 3 power supply rails to pins on the RS-232 connector: +5V applied to pin 6 which is the DSR pin.

-12V applied to pin 18, which is an undefined pin.

+12V applied to p in 23, which is a data signal rate selector in some modern systems. (These had no obvious application in serial printers of the time, so they are better disconnected to avoid any issues)

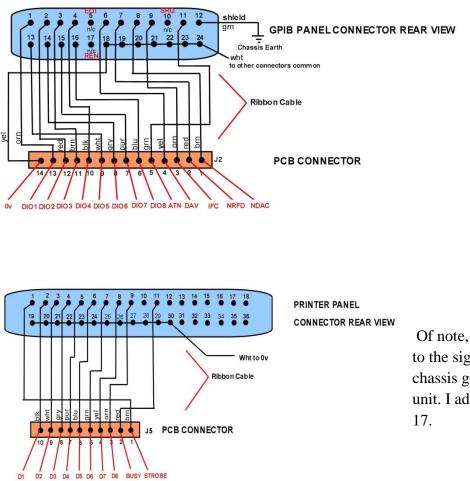
Of note, T-W made no connection to the signal ground pin 16 or the chassis ground pin 17 in the T-W unit. I added a chassis ground to pin 17.

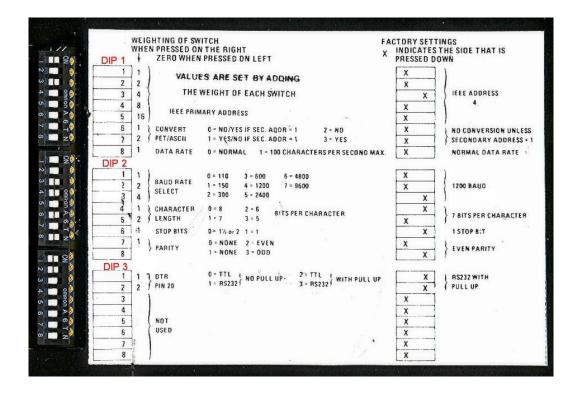
Fortunately this is straightforward because T-W put a large sticker on the base of the unit with the DIP switch settings. This makes the unit very easy to configure:

As can be seen above the DIP switches have been replaced with high quality OMRON types, the original blue CTS switches had significant internal corrosion.

Also, on this original unit I replaced the original DIP switches. These original pale blue CTS types are not sealed to the ingress of moisture and fumes. After they were removed, I cut the CTS switches open and the corrosion on the contact surfaces was fairly severe. I replaced them with 16 pin (machined round pin sockets) and into those I lugged in high quality new OMROM brand DIP switches. The overall height profile matches the original CTS switch and it has the advantage that later a defective switch is easily replaced.

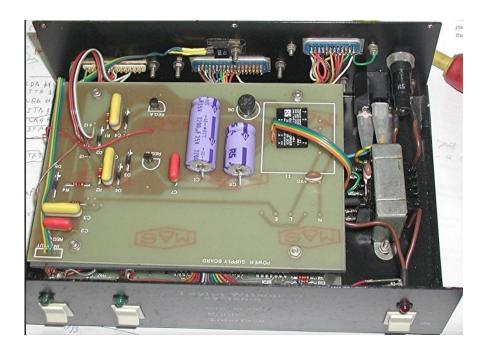
The photo also shows the original power transformer (that was inadequate) and the wires soldered to the RS-232 connector, the Printer connector and the GPIB connector. None of which contained any insulating sleeves and the soldering quality was not ideal.

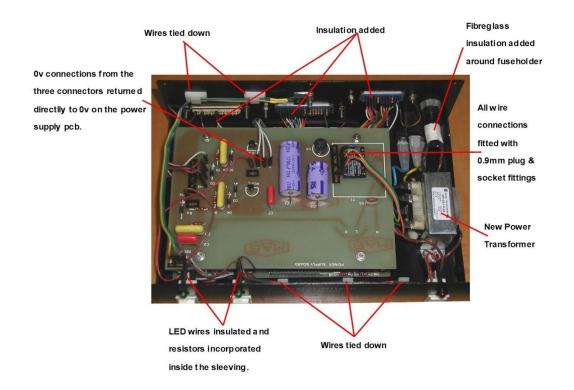
The photo below shows the modifications I made to the unit to improve access and serviceability:

As noted previously, connectors were fitted to the main board. This allowed removal of the main board but also the connectors from the rear panel. This made it easier to re-solder and sleeve the connections. The 0v connections were previously daisy chained between the three connectors, however I modified that by sending the connections to the 0V power supply PCB area on 0.9mm connectors.

The above modifications make it much easier to service the unit and remove the PCB's as required for repairs, or study.

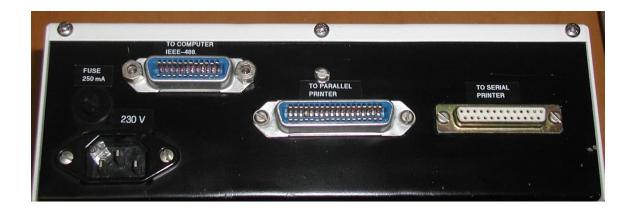
As noted there were no markings of any kind on the rear panel. When I received the unit I had no idea about the connectors, so labels were added. I made them with a Brother Label machine:

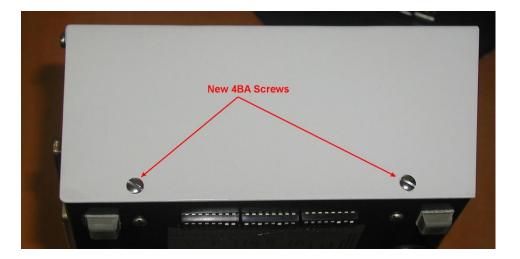
As mentioned the original case side fixing screws were missing and replaced by someone with self threading screws. These screws thread into a 4BA threaded nut located inside the unit. On the other hand the three screws along the rear upper edge of the enclosure are self tapping types and screw into a thin steel panel. I replaced those with Stainless steel versions.

I was able to obtain original ¼ inch long 4BA screws. Chrome plated, countersunk, domed & slot head types from a UK eBay supplier, which give a very tidy look:
