THE 1972 DIGEEC NIXIE CLOCK FROM EUROPEAN ELECTRONIC COUNTING LTD (EEC) AND THE MYSTERY 28 PIN CMOS LS/ CHIP. Dr H. Holden. 2015.

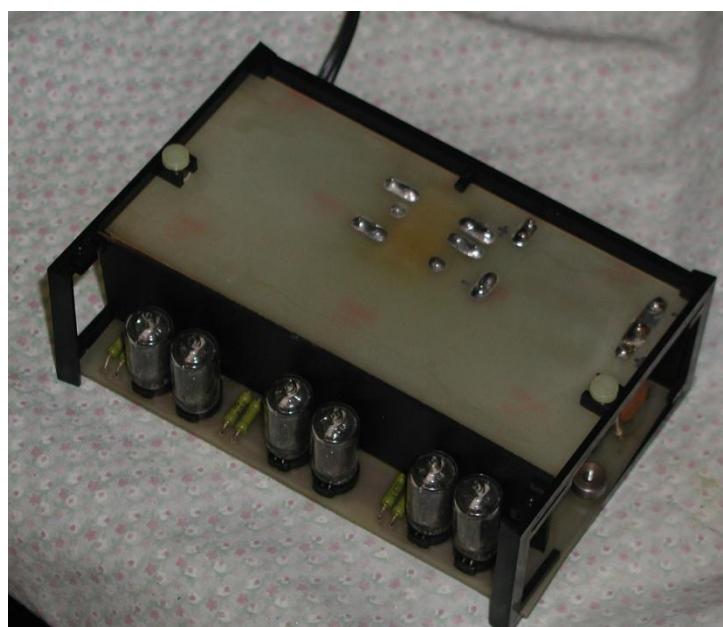
The clock is a 12 or 24 Hr clock which is a good feature. The photo below shows the clock removed from its housing:

The housing is elegant, unpretentious and cleverly put together. There are two side plates, the rear and front panels and the two PCB's. When assembled as shown in the photo above they fit neatly into the external housing. The top PCB contains the power supply components. The photo below shows the two PCB's on the component surfaces:

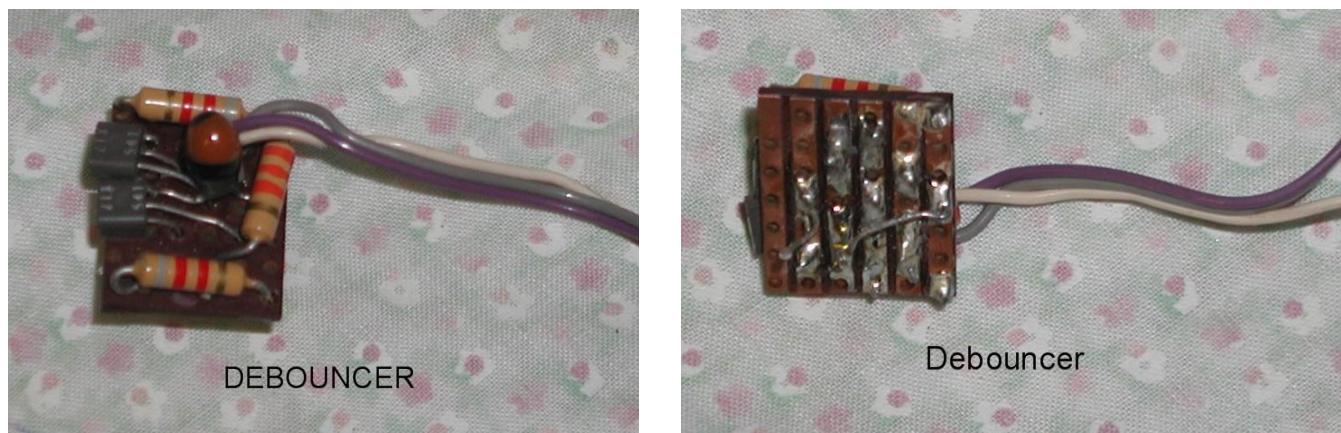
Of note is the two transistor circuit added by the manufacturer. It was they who added it because the ZTX541 pnp transistor and the resistors match those in the rest of the clock. They did a pretty poor job of making it in my opinion, looking just thrown together on a small section of vero board:

Looking at this added circuit, it is two stages of logic inversion with the output coupled back to the input. This is a contact debounce circuit. I removed it and connected the set time switch input back into pin 10 directly, as it had been before this modification had been made. The clock set function still works, but occasionally, coming out of set mode, the seconds value resets to zero. So clearly this debounce modification was an after thought perhaps to satisfy the American market where the owner might have wanted to exactly synchronise the indicated seconds value by waiting for the real time seconds value to match that on the display before coming out of set mode, since there is no seconds set button on this clock.
