## THE 1956 ZENITH ROYAL 500 TRANSISTOR “OWL’S EYES” RADIO.

Dr. H. Holden. Feb. 2018.

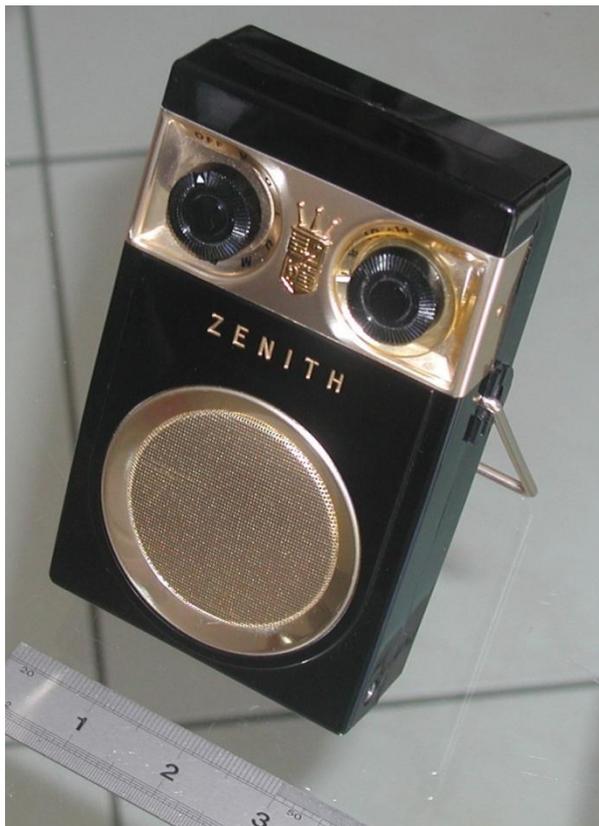
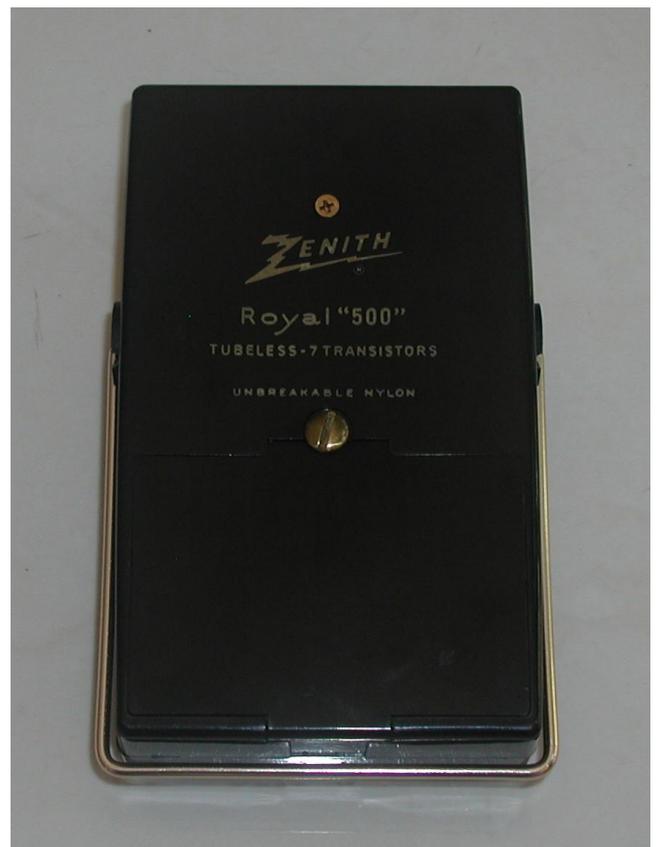
These radios have been dubbed “Owl's Eyes radios” because of the appearance.

As the photos show, the case on this radio is interesting. It is made of Nylon. And it says "Unbreakable Nylon". That might be asking for trouble. It does appear to have lasted well and in this radio specimen there are no cracks in the case.
