Tek Oscilloscope 2465B: The Power Supply's Electrolytic Capacitors - The Alkaline Shift.

Dr. H. Holden Jan. 2025.

THE 2465B's PSU:

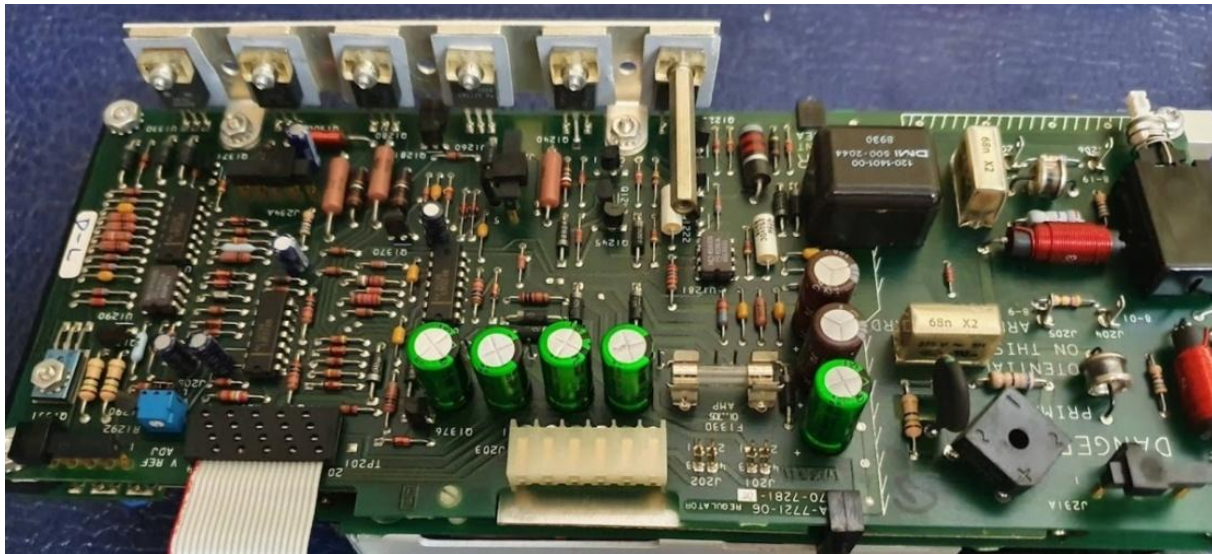
The two brown jacket electrolytic capacitors on this board are 10uF/100V parts which seldom if ever give any trouble. The smaller electrolytic capacitors seen with the black jackets are 1uF/50v Bipolar types. They appear very reliable. If they require replacement I recommend using 1uF/63v MKT film capacitors instead. The two small dark blue jacket capacitors are 47uF/25V Nichicon types that in my scopes at least, are still ok. On the right hand side where the Line power is initially processed and rectified, are a pair of Rifa 0.068uF X2 capacitors, more will be said about these later.

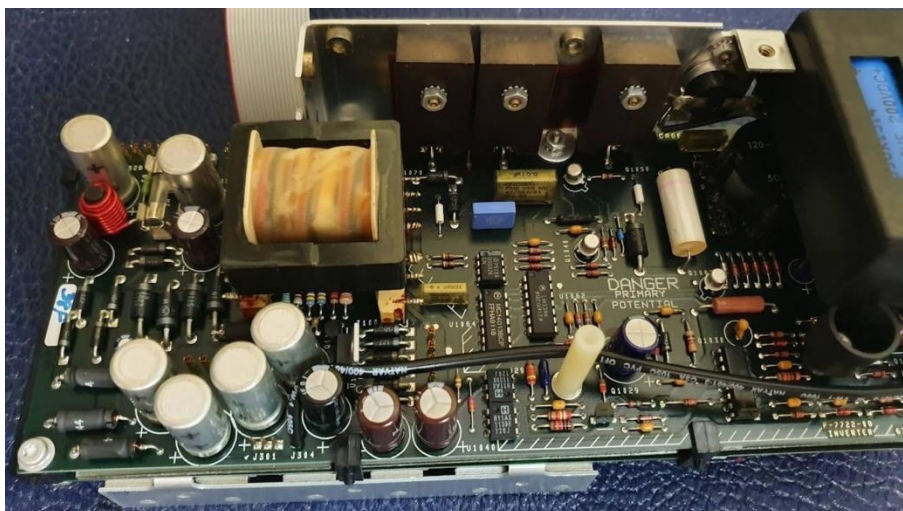
A3 Inverter board below is a 1990 vintage specimen and they had moved to 100uF/50V brown jacket Nichicon capacitors .The view with the shield removed. This board also contains some Rifa Y capacitors:

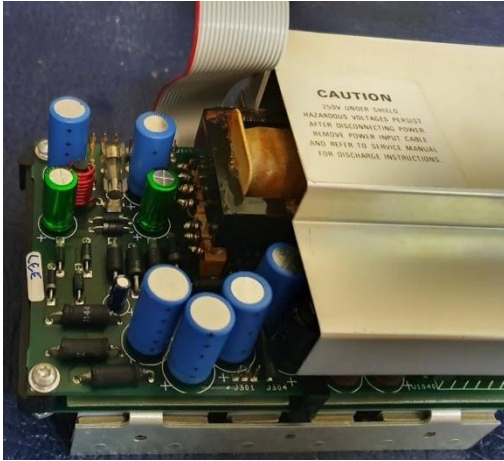
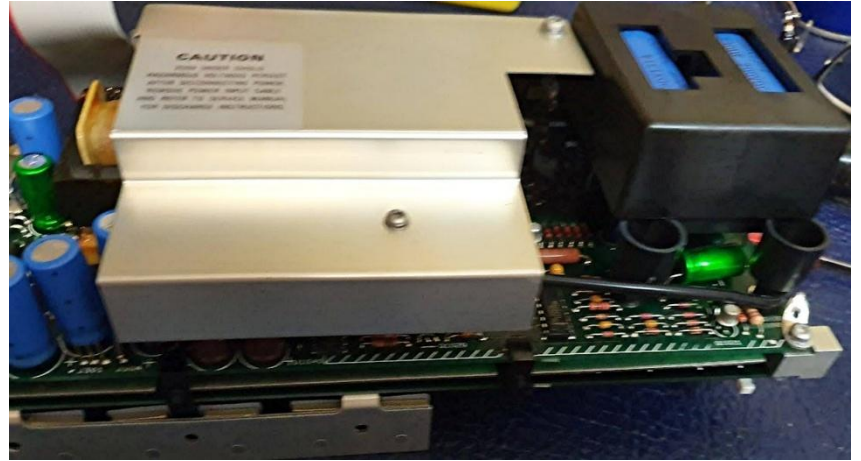
The early 1989 vintage PSU's tended to have the 100uF/25v Green jacket Nichicon capacitors:

On the right upper corner in the photo on the right above, there two large blue axial capacitors suspended in a black plastic carrier. These are the main filter capacitors on the bridge rectifier outputs. In every 2465B scope I have assessed, these 290uF/200V parts have been perfectly normal with an ESR in the order of 0.04 to 0.06 Ohms, normal capacity & electrical leakage, no electrolyte leakage and not required replacing. Along with other high voltage rated electrolytic capacitors in the 2465B scope these parts appear, for reasons unknown, to have much better longevity than the lower voltage rated electrolytic capacitors. It likely relates to the lower range ripple currents that higher voltage parts experience over the course of their lives.

In terms of capacitor failures in the 2465B, the surface mount electrolytics, if present, fail first on the A5 computer board (physical leakage) followed by physical leakage of the 100uF/25V Green Jacket Nichicon parts in the PSU. Some A5 boards were fitted with Tantalum capacitors, and while these can fail short circuit, they do not usually leak corrosive liquid.

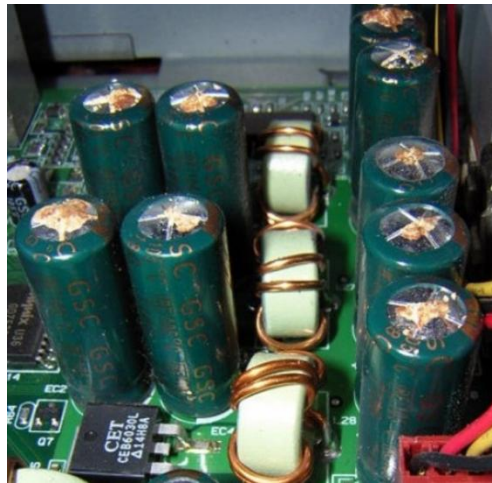
There was an episode of the "Capacitor Plague" around 25 years ago. A Scientist stole a proprietary electrolyte formula from the Rubycon Corporation in Japan and took it to China. But it was incomplete. The formula ended up later in Taiwan made capacitors and many were made there, ending up inside many computers and appliances. They pressurised in short order with Hydrogen, doming their tops and blowing electrolyte out of their tops. They had other faulty electrolyte related failures including increased electrical leakage and increased capacitance. Investigators found evidence of Hydrogen gas and hydroxide in the failed capacitors:

A picture of some of the Taiwanese made capacitors affected by the faulty electrolyte:
